FOSM Cycle 6

Road Inventory and Condition Assessment of Paved Routes Fort Smith National Historic Site

**Federal Lands Highway
Road Inventory Program**

Report Date: July 2018

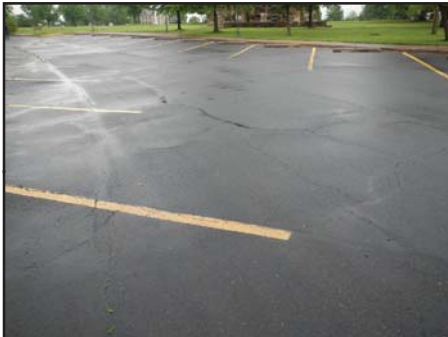
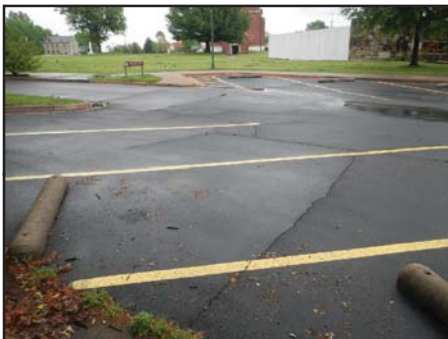
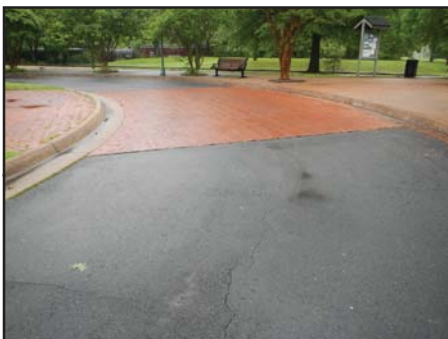
Inspection Date	FMSS Number	User Access	Surface Type
5/4/2018	78853	PUBLIC	ASPHALT
Area (Sq. Ft.)	Lane Miles (11' Widths)	Curb Reveal (Inches)	Curb Recommendation
28,419	0.489	NOT APPLICABLE	DO NOTHING
Curb Type		Curb & Gutter Type	
NO CURB		CONCRETE	
Pavement Recommendation		Condition Rating / PCR	
LIGHT 3R TREATMENTS		FAIR / 73

Note: Parking area consists of multiple surface types: 1 part Asphalt at 27,904 square feet; 1 part Brick at 515 square feet.

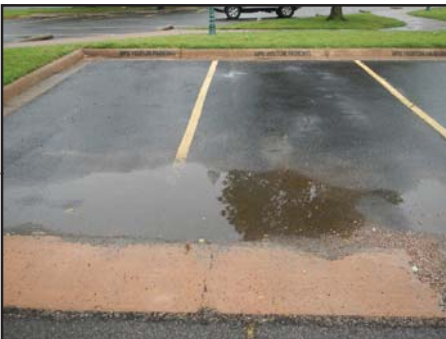
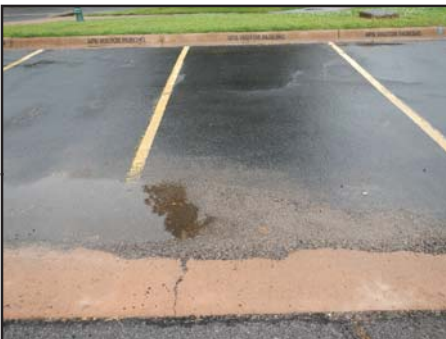
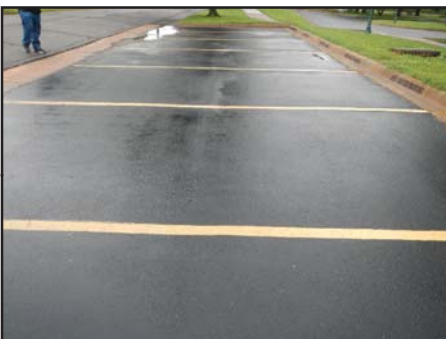
ROUTE 0901A: VISITOR STREET PARKING A

Inspection Date	FMSS Number	User Access	Surface Type
5/4/2018	102763	PUBLIC	ASPHALT
Area (Sq. Ft.)	Lane Miles (11' Widths)	Curb Reveal (Inches)	Curb Recommendation
1,172	0.02	NOT APPLICABLE	DO NOTHING
Curb Type		Curb & Gutter Type	
NO CURB		CONCRETE	
Pavement Recommendation		Condition Rating / PCR	
PREVENTIVE MAINTENANCE		GOOD / 90

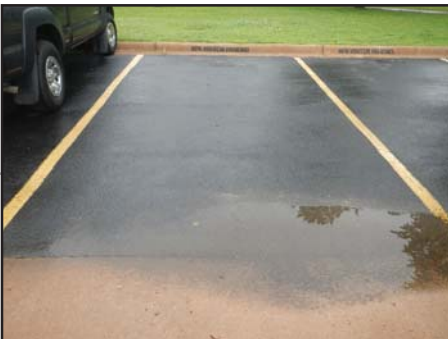
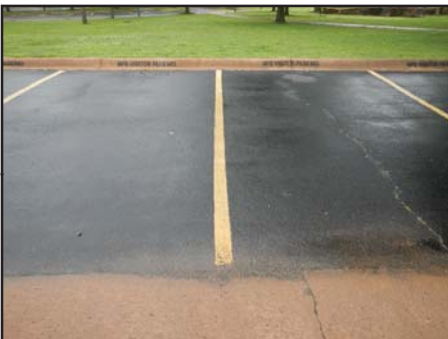
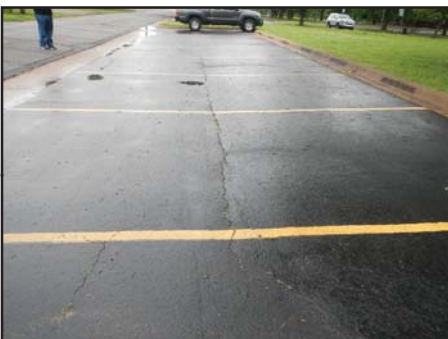
ROUTE 0901B: VISITOR STREET PARKING B

Inspection Date	FMSS Number	User Access	Surface Type
5/4/2018	102764	PUBLIC	ASPHALT
Area (Sq. Ft.)	Lane Miles (11' Widths)	Curb Reveal (Inches)	Curb Recommendation
1,654	0.028	NOT APPLICABLE	DO NOTHING
Curb Type		Curb & Gutter Type	
NO CURB		CONCRETE	
Pavement Recommendation		Condition Rating / PCR	
PREVENTIVE MAINTENANCE		GOOD / 90

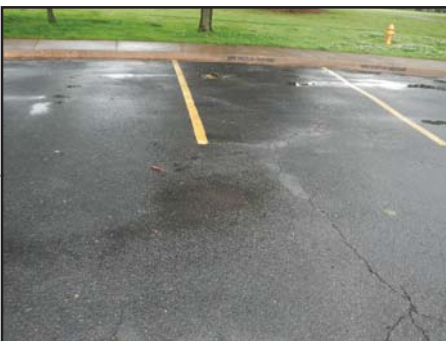
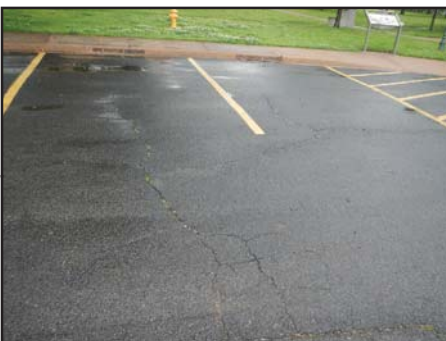
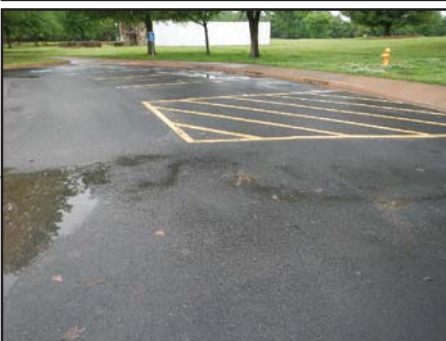
ROUTE 0901C: VISITOR STREET PARKING C

Inspection Date	FMSS Number	User Access	Surface Type
5/4/2018	102765	PUBLIC	ASPHALT
Area (Sq. Ft.)	Lane Miles (11' Widths)	Curb Reveal (Inches)	Curb Recommendation
1,827	0.031	NOT APPLICABLE	DO NOTHING
Curb Type		Curb & Gutter Type	
NO CURB		CONCRETE	
Pavement Recommendation		Condition Rating / PCR	
PREVENTIVE MAINTENANCE		GOOD / 90

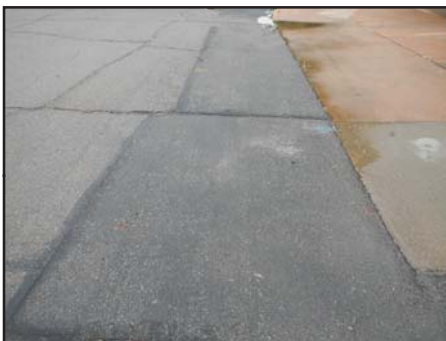
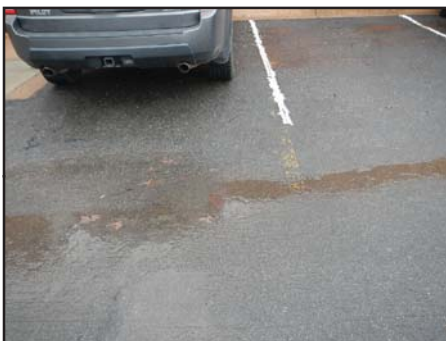
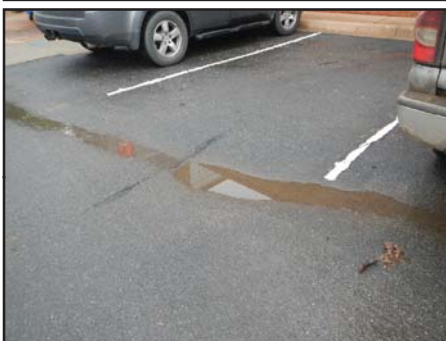
ROUTE 0902A: EMPLOYEE STREET PARKING A

Inspection Date	FMSS Number	User Access	Surface Type
5/4/2018	102766	PUBLIC	ASPHALT
Area (Sq. Ft.)	Lane Miles (11' Widths)	Curb Reveal (Inches)	Curb Recommendation
853	0.015	NOT APPLICABLE	DO NOTHING
Curb Type		Curb & Gutter Type	
NO CURB		CONCRETE	
Pavement Recommendation		Condition Rating / PCR	
PREVENTIVE MAINTENANCE		GOOD / 90

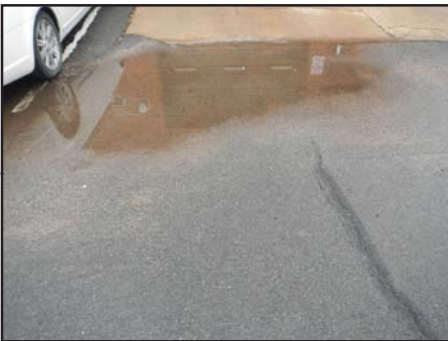
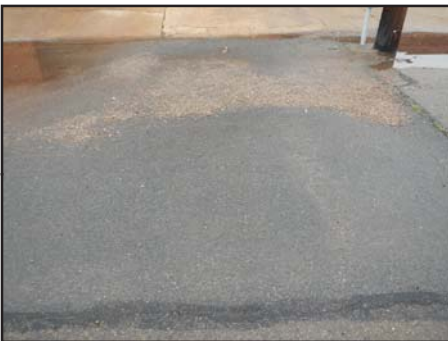
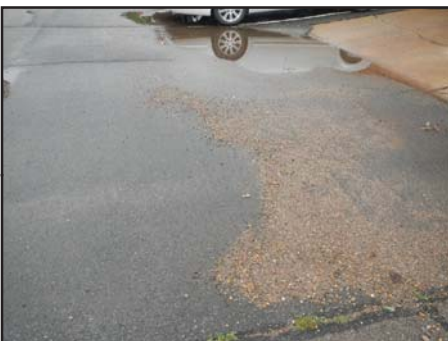
ROUTE 0902B: EMPLOYEE STREET PARKING B

Inspection Date	FMSS Number	User Access	Surface Type
5/4/2018	102767	PUBLIC	ASPHALT
Area (Sq. Ft.)	Lane Miles (11' Widths)	Curb Reveal (Inches)	Curb Recommendation
894	0.015	NOT APPLICABLE	DO NOTHING
Curb Type		Curb & Gutter Type	
NO CURB		CONCRETE	
Pavement Recommendation		Condition Rating / PCR	
PREVENTIVE MAINTENANCE		GOOD / 90

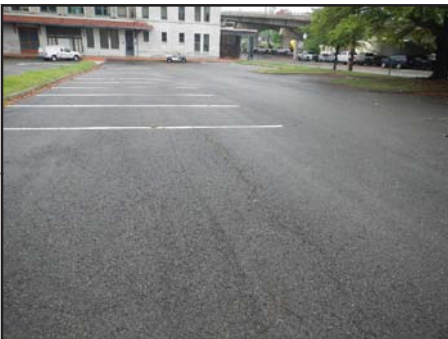
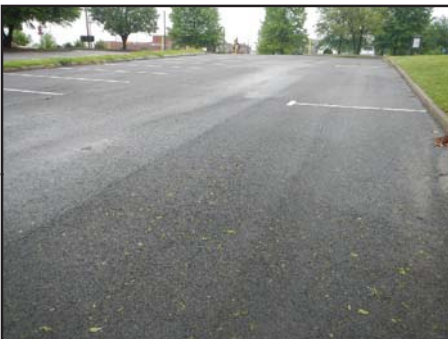
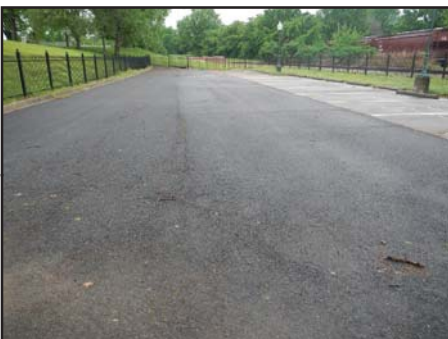
ROUTE 0903A: FRISCO STATION PARKING A

Inspection Date	FMSS Number	User Access	Surface Type
5/4/2018	102768	PUBLIC	ASPHALT
Area (Sq. Ft.)	Lane Miles (11' Widths)	Curb Reveal (Inches)	Curb Recommendation
22,569	0.389	6	DO NOTHING
Curb Type		Curb & Gutter Type	
CONCRETE		CONCRETE	
Pavement Recommendation		Condition Rating / PCR	
PREVENTIVE MAINTENANCE		GOOD / 90

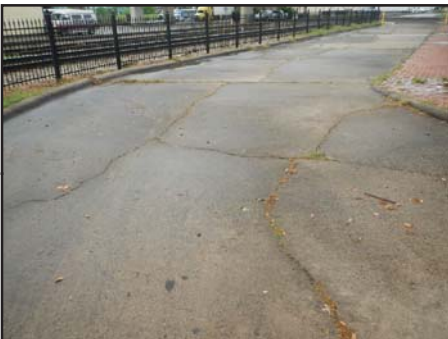
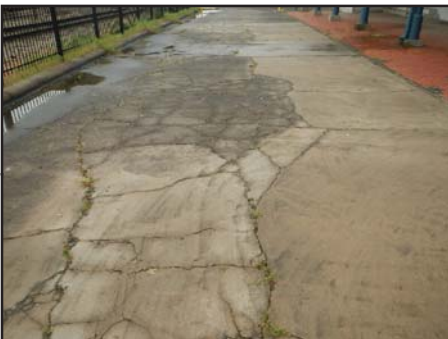
ROUTE 0903B: FRISCO STATION PARKING B

Inspection Date	FMSS Number	User Access	Surface Type
5/4/2018	102769	PUBLIC	CONCRETE
Area (Sq. Ft.)	Lane Miles (11' Widths)	Curb Reveal (Inches)	Curb Recommendation
11,627	0.2	4	LIGHT REPAIR
Curb Type		Curb & Gutter Type	
CONCRETE		NO CURB AND GUTTER	
Pavement Recommendation		Condition Rating / PCR	
RECONSTRUCTION		POOR / 30

Note: Parking area consists of multiple surface types: 1 part Concrete at 7,186 square feet; 1 part Asphalt at 4,441 square feet.
