# FOSU Cycle 6

## Final Report

### Road Inventory and Condition Assessments for Fort Sumter and Fort Moultrie National Historical Park

**Report Date: April 2021**

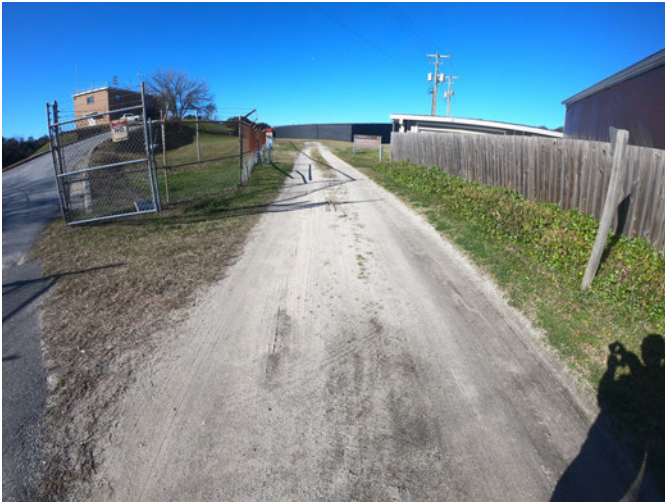
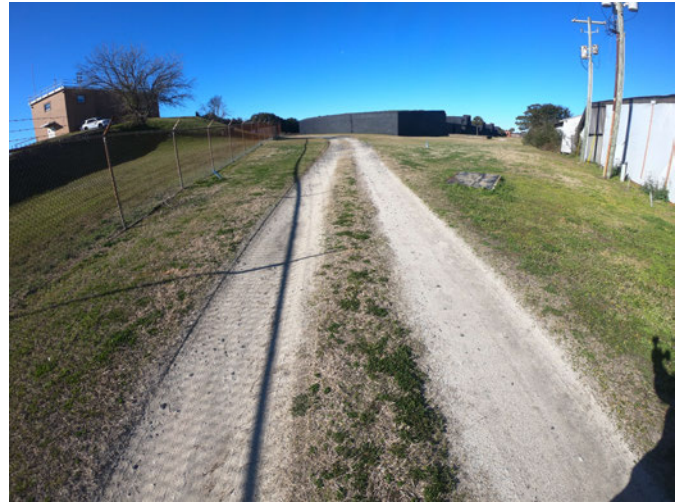
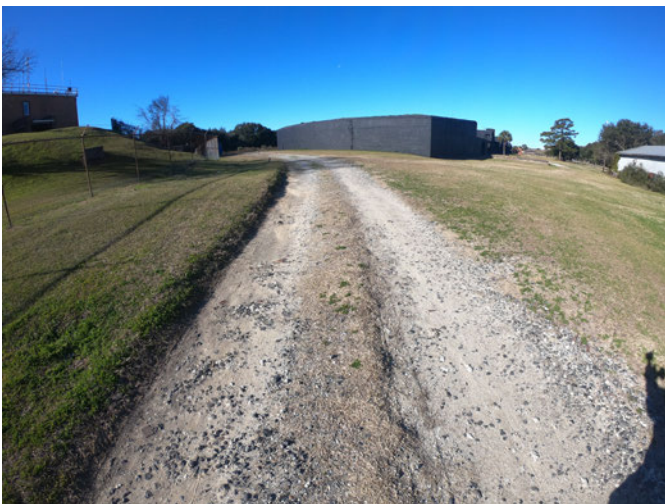
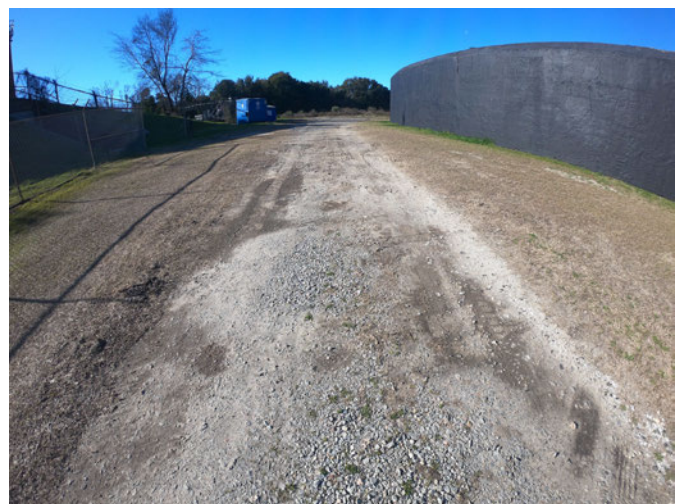
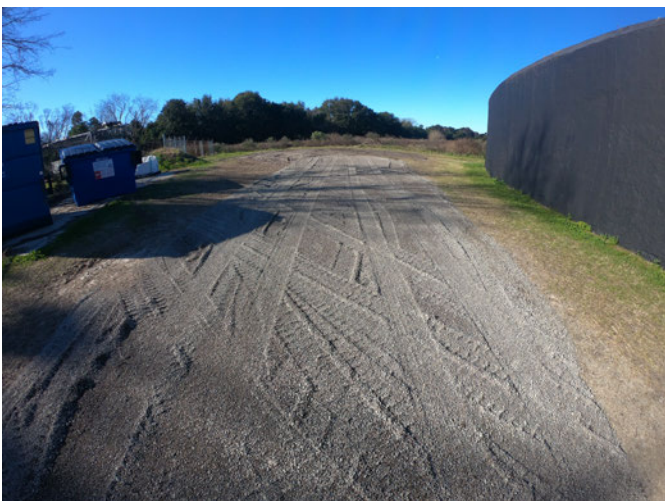
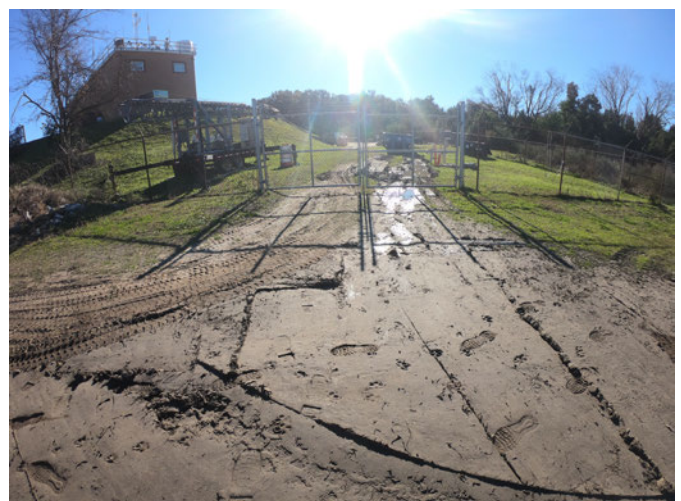
Route Condition Legend					
Poor (1)	Poor (2)	Fair (3)	Good (4)	Excellent (5)	Not Rated
See Appendix for definitions and formulas					
Inspection Date: 2/3/2021		Unpaved Length (Miles): 0.10		Surface Type: GR

Begin MP	End MP	Section Length	# of Lanes	Lane Width	Road Width	Treatment Recommendation	Treatment Cost	Unpaved Rating (Paser +)	Crown Severity	Drainage Severity	Rutting, Washboard Severity	Potholes / Loose Aggregate Severity
0.00	0.10	0.10	1	9.0	9.0	Light Rehabilitation	\$10,000	3	Med	Med	Med	Low
<b>Route Level Data:</b>		0.10	1	9.0	9.0	Light Rehabilitation	\$10,000	3	Med	Med	Med	Low

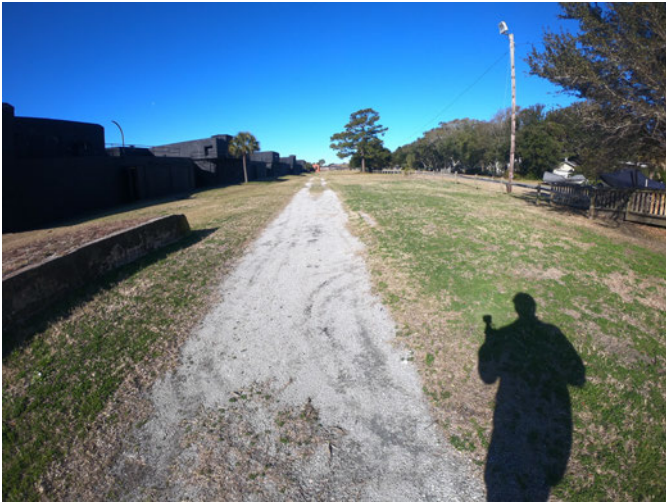
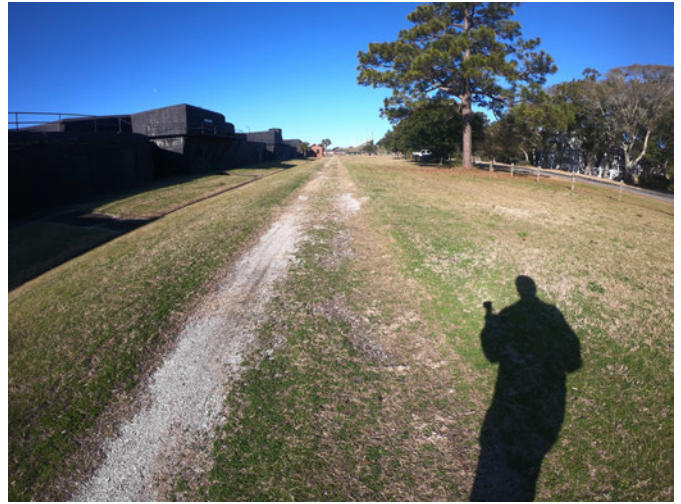
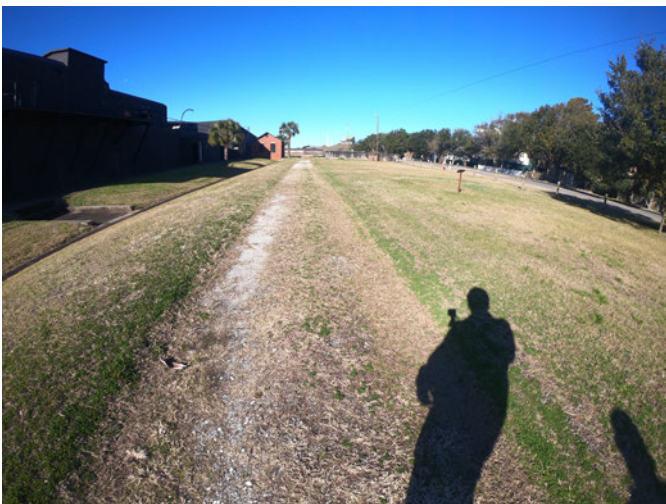
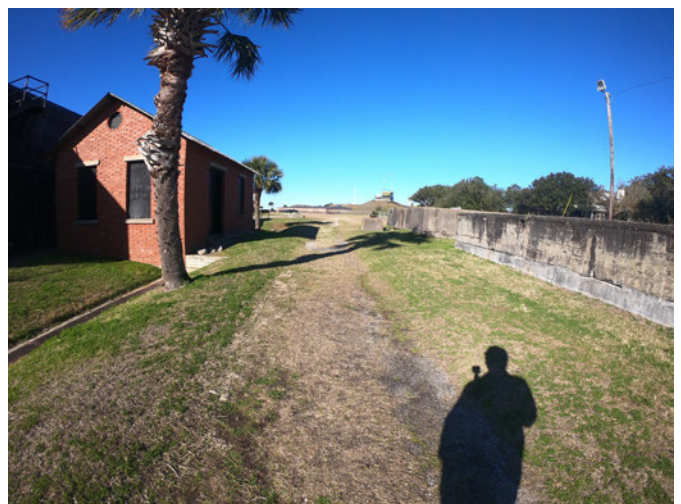
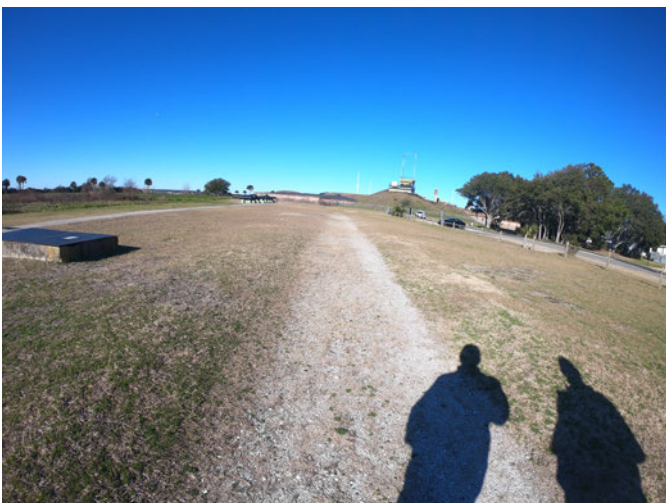
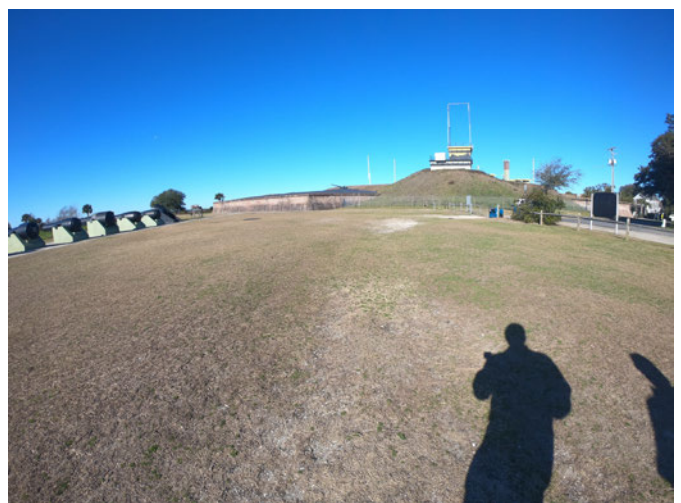
Route Condition Legend					
Poor (1)	Poor (2)	Fair (3)	Good (4)	Excellent (5)	Not Rated
See Appendix for definitions and formulas					
Inspection Date: 2/3/2021		Unpaved Length (Miles): 0.2		Surface Type: GR

Begin MP	End MP	Section Length	# of Lanes	Lane Width	Road Width	Treatment Recommendation	Treatment Cost	Unpaved Rating (Paser +)	Crown Severity	Drainage Severity	Rutting, Washboard Severity	Potholes / Loose Aggregate Severity
0.00	0.20	0.20	1	10.0	10.0	Light Rehabilitation	\$1,990	4	Low	Med	Med	Low
<b>Route Level Data:</b>		0.20	1	10.0	10.00	Light Rehabilitation	\$1,990	4	Low	Med	Med	Low

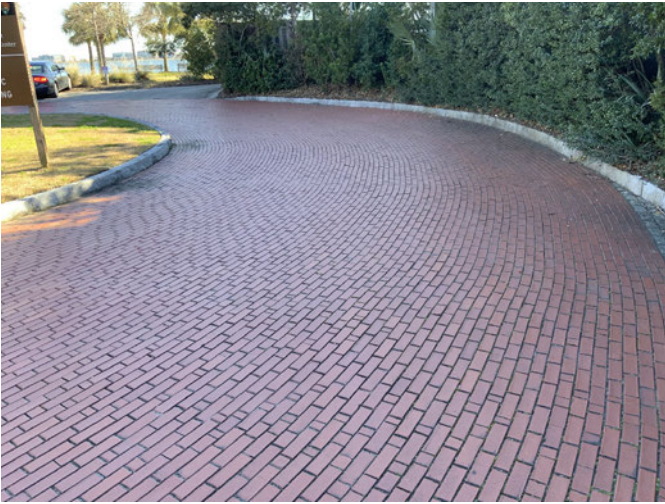
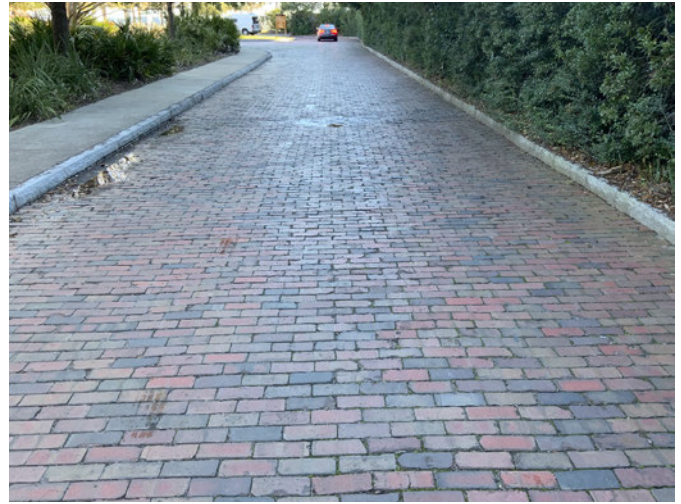
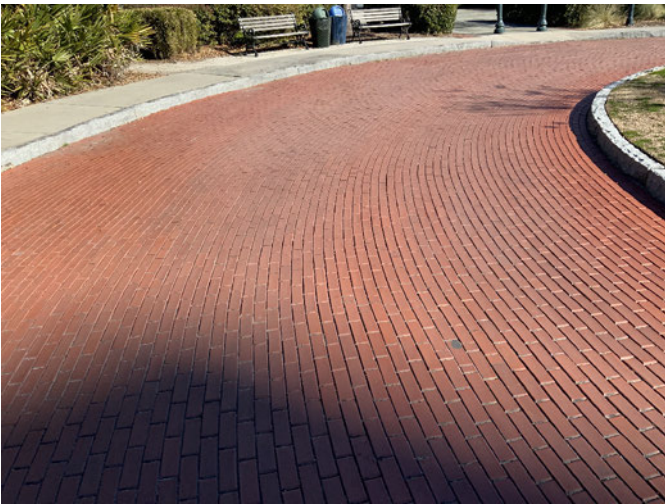
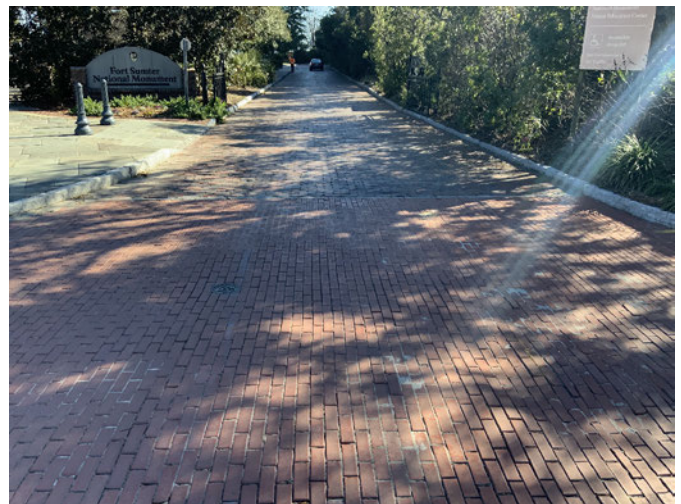
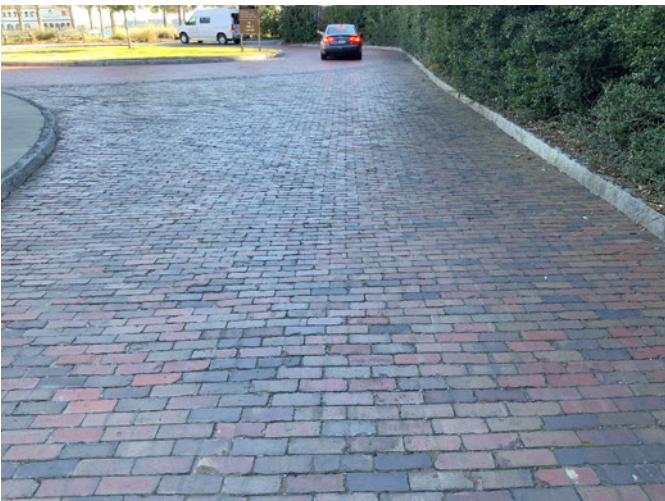
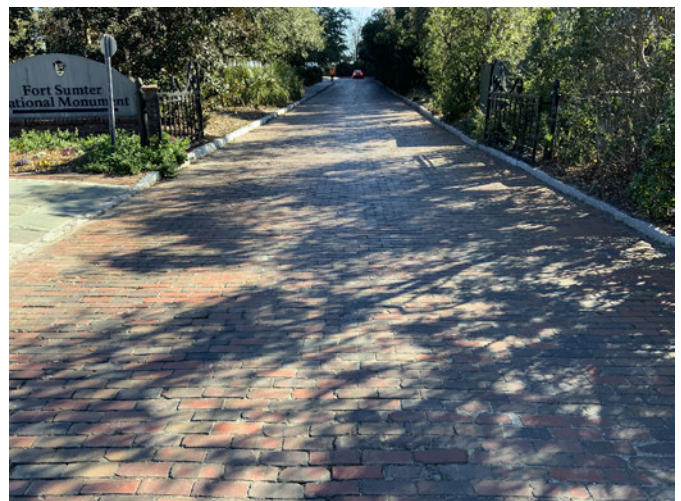
<b>Inspection Date:</b> 2/3/2021	<b>Beginning Section MP</b>	0.00				
<b>Paved Length (Miles):</b> 0.11	<b>Section Length (MI)</b>	0.11				
<b>Surface Type:</b> BRICK PAVERS	<b>Route Summary</b>					
<b>Roadway Condition Information</b>						
Pavement Condition Rating (PCR)	97	97				
Surface Condition Rating (SCR)	97	97				
Roughness Condition Index (RCI)	N/A	N/A				
<b>Distress Index Values</b>						
Structural Crack Index	N/A	N/A				
Alligator Crack Index	N/A	N/A				
Longitudinal Crack Index	N/A	N/A				
Transverse Cracking Index	N/A	N/A				
Patching Index	N/A	N/A				
Rutting Index	N/A	N/A				
International Roughness Index (IRI)	N/A	N/A				
<b>Lane &amp; Width Information</b>						
Number of Lanes	2	2				
Paved Width (ft)	18	18				
Lane Width (ft)	9	9

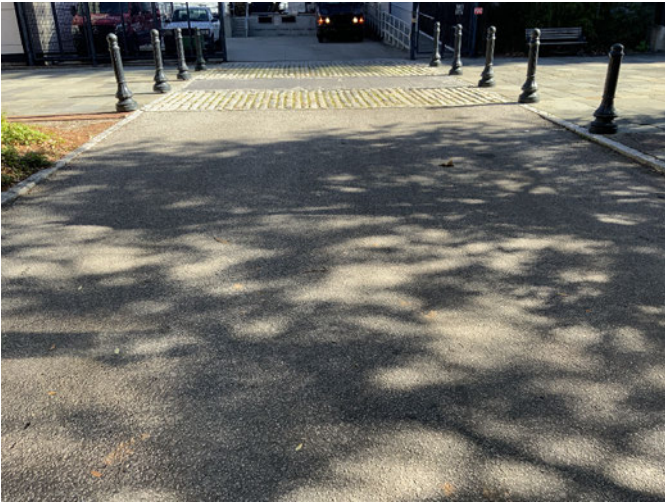
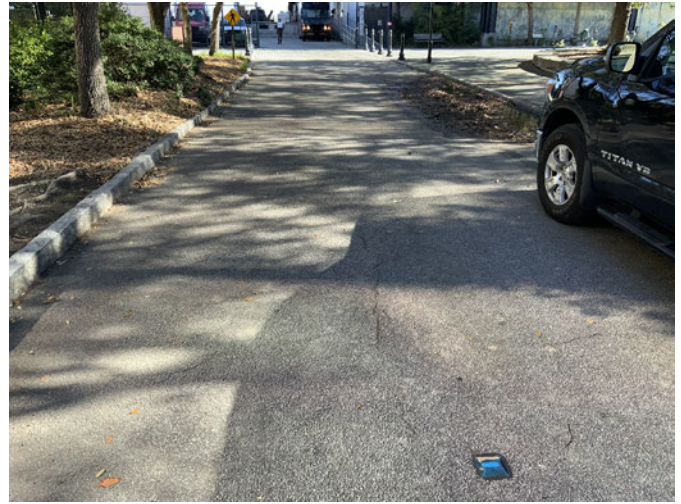
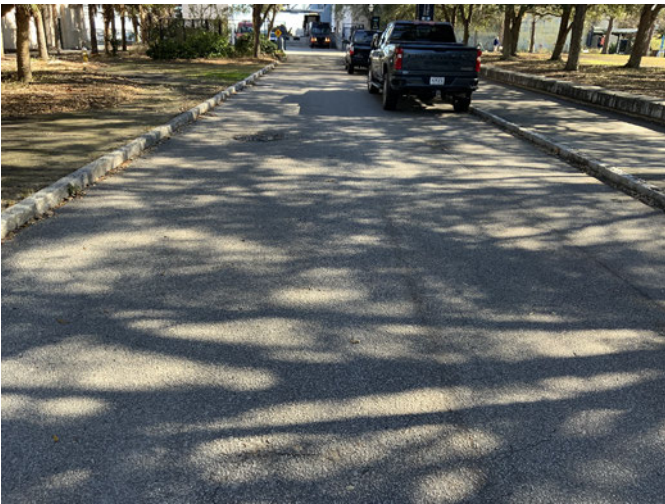
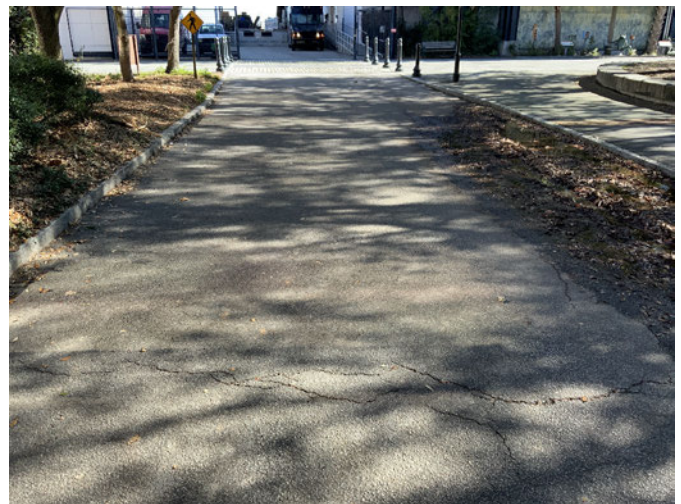
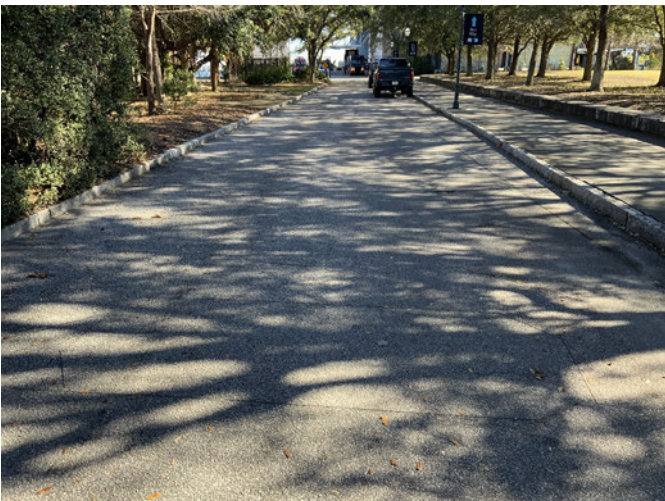
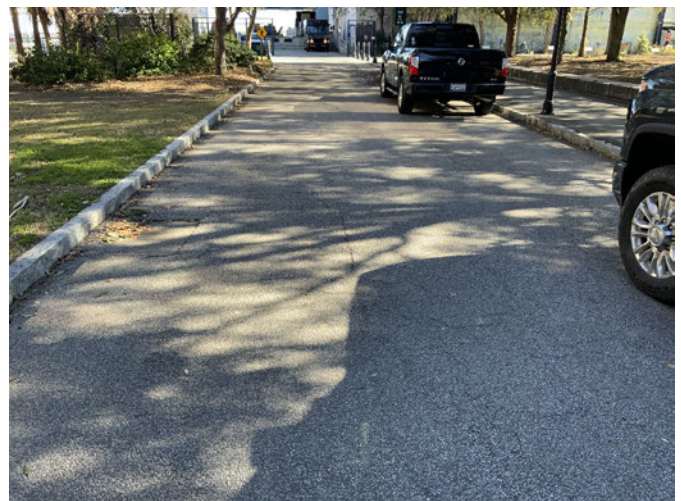
<b>Inspection Date:</b> 2/3/2021	<b>Beginning Section MP</b>	0.00				
<b>Paved Length (Miles):</b> 0.06	<b>Section Length (MI)</b>	0.06				
<b>Surface Type:</b> ASPHALT	<b>Route Summary</b>					
<b>Roadway Condition Information</b>						
Pavement Condition Rating (PCR)	90	90				
Surface Condition Rating (SCR)	90	90				
Roughness Condition Index (RCI)	N/A	N/A				
<b>Distress Index Values</b>						
Structural Crack Index	N/A	N/A				
Alligator Crack Index	90	90				
Longitudinal Crack Index	90	90				
Transverse Cracking Index	90	90				
Patching Index	90	90				
Rutting Index	90	90				
International Roughness Index (IRI)	N/A	N/A				
<b>Lane &amp; Width Information</b>						
Number of Lanes	2	2				
Paved Width (ft)	20	20				
Lane Width (ft)	10	10

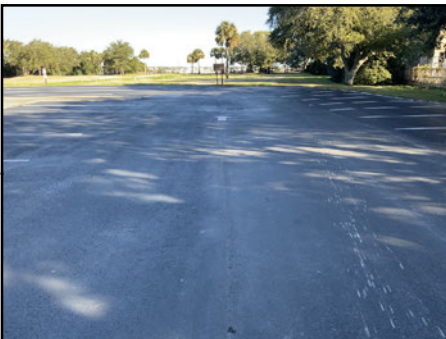
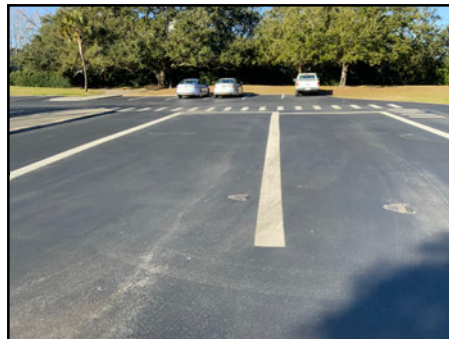
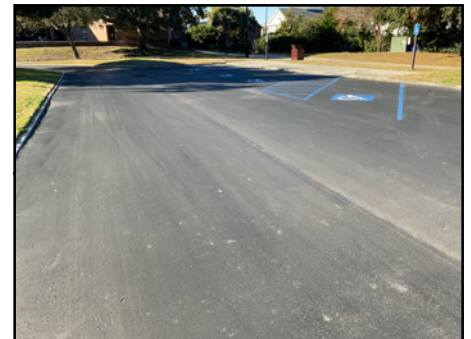
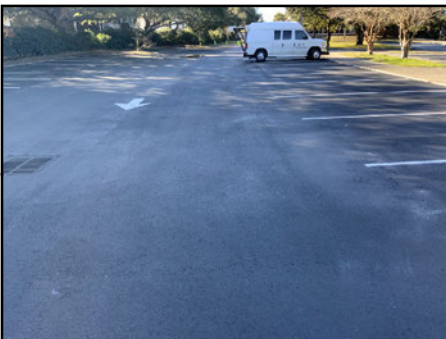
Inspection Date	FMSS Number	User Access	Surface Type
2/3/2021	58535	PUBLIC	ASPHALT
Area (Sq. Ft.)	Lane Miles (11' Widths)	Curb Reveal (Inches)	Curb Recommendation
45,872	0.79	4	LIGHT REPAIR
Curb Type		Curb & Gutter Type	
CONCRETE		NO CURB AND GUTTER	
Pavement Recommendation		Condition Rating / PCR	
PREVENTIVE MAINTENANCE		GOOD / 90

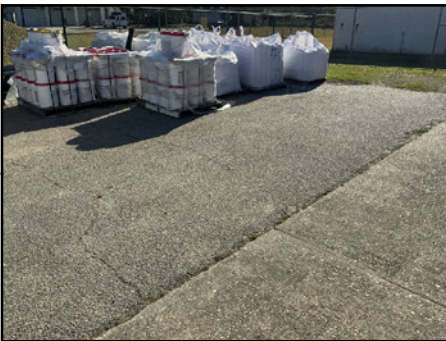
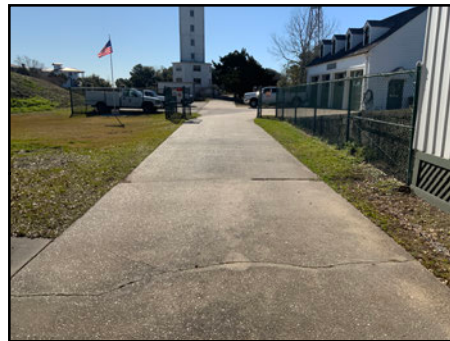
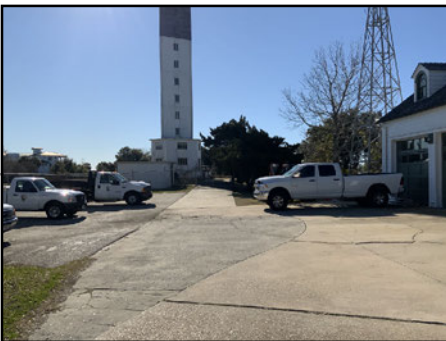
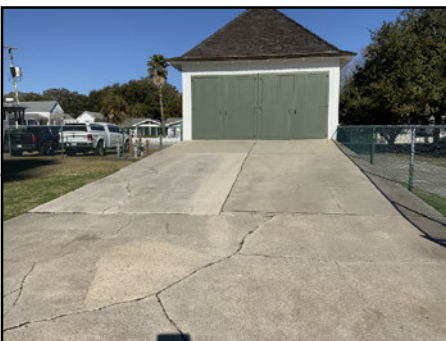
## ROUTE 0901: USCG LIFE SAVING STATION PARKING AREA

Inspection Date	FMSS Number	User Access	Surface Type
2/3/2021	58536	NONPUBLIC	CONCRETE
Area (Sq. Ft.)	Lane Miles (11' Widths)	Curb Reveal (Inches)	Curb Recommendation
9,697	0.167	NOT APPLICABLE	NOT APPLICABLE
Curb Type		Curb & Gutter Type	
NO CURB		NO CURB AND GUTTER	
Pavement Recommendation		Condition Rating / PCR	
HEAVY 3R TREATMENTS		POOR / 53

Multiple Surface types:  
 Asphalt = 2,058 SQ FT  
 Concrete = 7,639 SQ FT

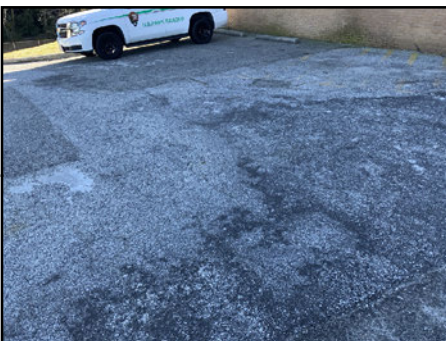
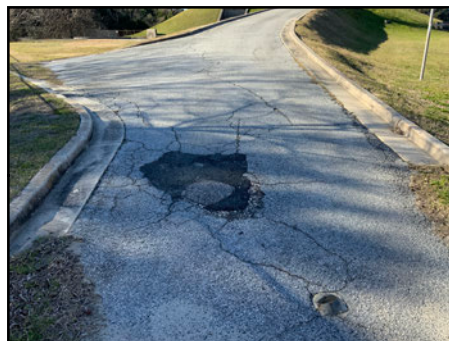
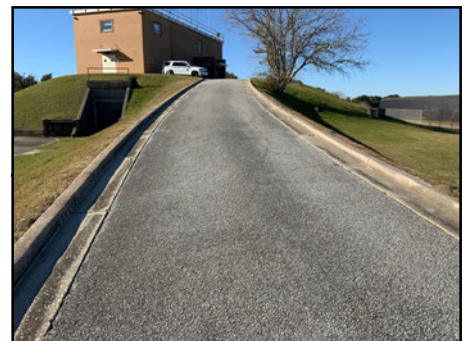
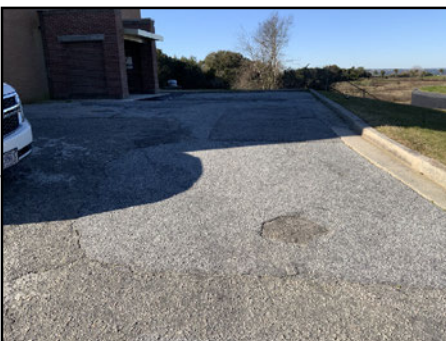
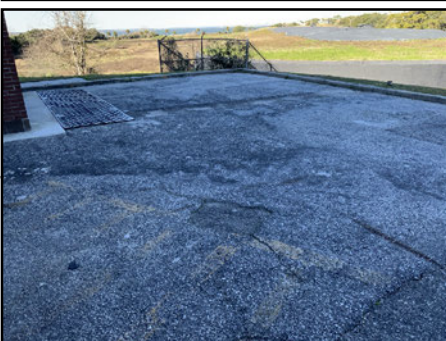
Inspection Date	FMSS Number	User Access	Surface Type
2/3/2021	58542	NONPUBLIC	ASPHALT
Area (Sq. Ft.)	Lane Miles (11' Widths)	Curb Reveal (Inches)	Curb Recommendation
4,669	0.08	4	LIGHT REPAIR
Curb Type		Curb & Gutter Type	
CONCRETE		CONCRETE	
Pavement Recommendation		Condition Rating / PCR	
LIGHT 3R TREATMENTS		FAIR / 73
