FOUN Cycle 6

Road Inventory and Condition Assessment of Paved Routes Fort Union National Monument

**Federal Lands Highway
Road Inventory Program**

Report Date: July 2017

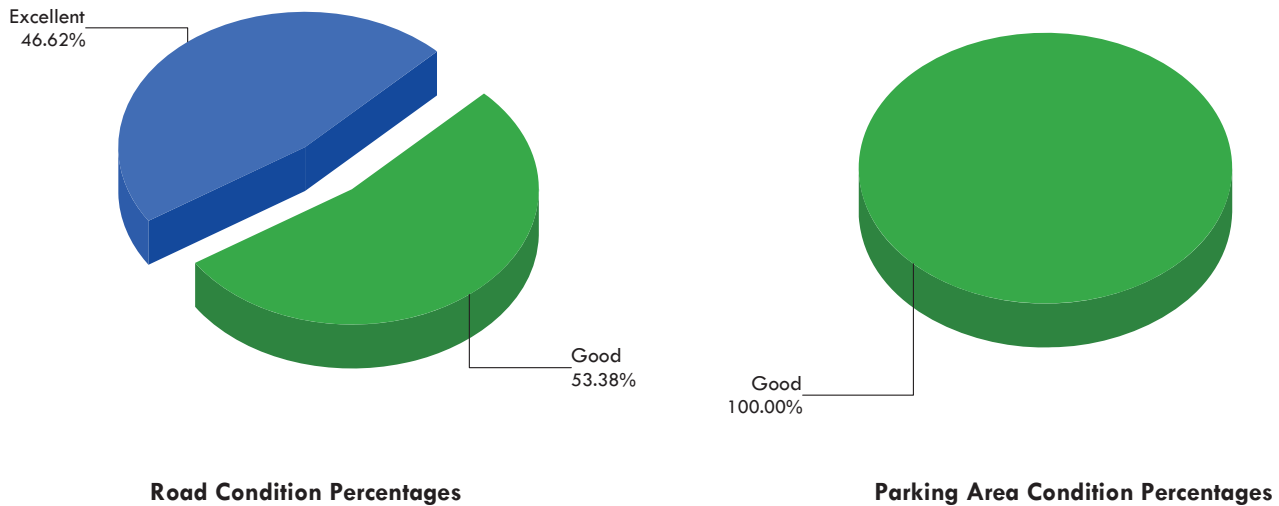
Figure 1: Pavement Condition Rating Breakdown for Paved Roads and Parking Areas

Parkwide Condition Percentages

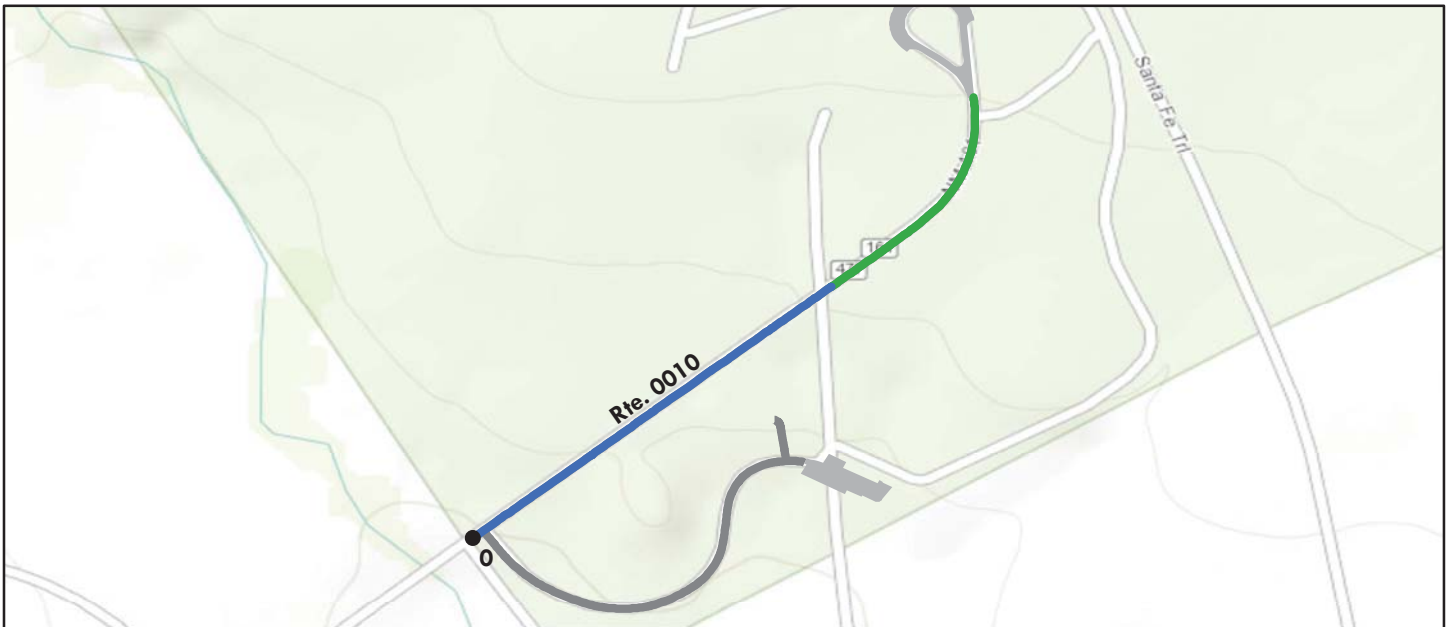
ROUTE 0010: FORT UNION PARK ACCESS ROAD

Data Collection Vehicle (DCV) Rating

Route Condition Legend – Pavement Condition Rating (PCR)						
Poor (0 - 60)	Fair (61- 84)	Good (85 - 94)	Excellent (95 - 100)	Not Rated		
See Appendix for definitions and formulas						
Inspection Date:	3/24/2017	Beginning Section MP	0			
Paved Length (Miles):	0.48	Section Length (MI)	0.48			
Surface Type:	ASPHALT	Route Summary				
Roadway Condition Information						
Pavement Condition Rating (PCR)	95	95				
Surface Condition Rating (SCR)	95	95				
Roughness Condition Index (RCI)	N/A	N/A				
Distress Index Values						
Structural Crack Index	100	100				
Alligator Crack Index	100	100				
Longitudinal Crack Index	100	100				
Transverse Cracking Index	99	99				
Patching Index	100	100				
Rutting Index	95	95				
International Roughness Index (IRI)	N/A	N/A				
Lane & Width Information						
Number of Lanes	2	2				
Paved Width (ft)	20.5	20.5				
Lane Width (ft)	10.2	10.2

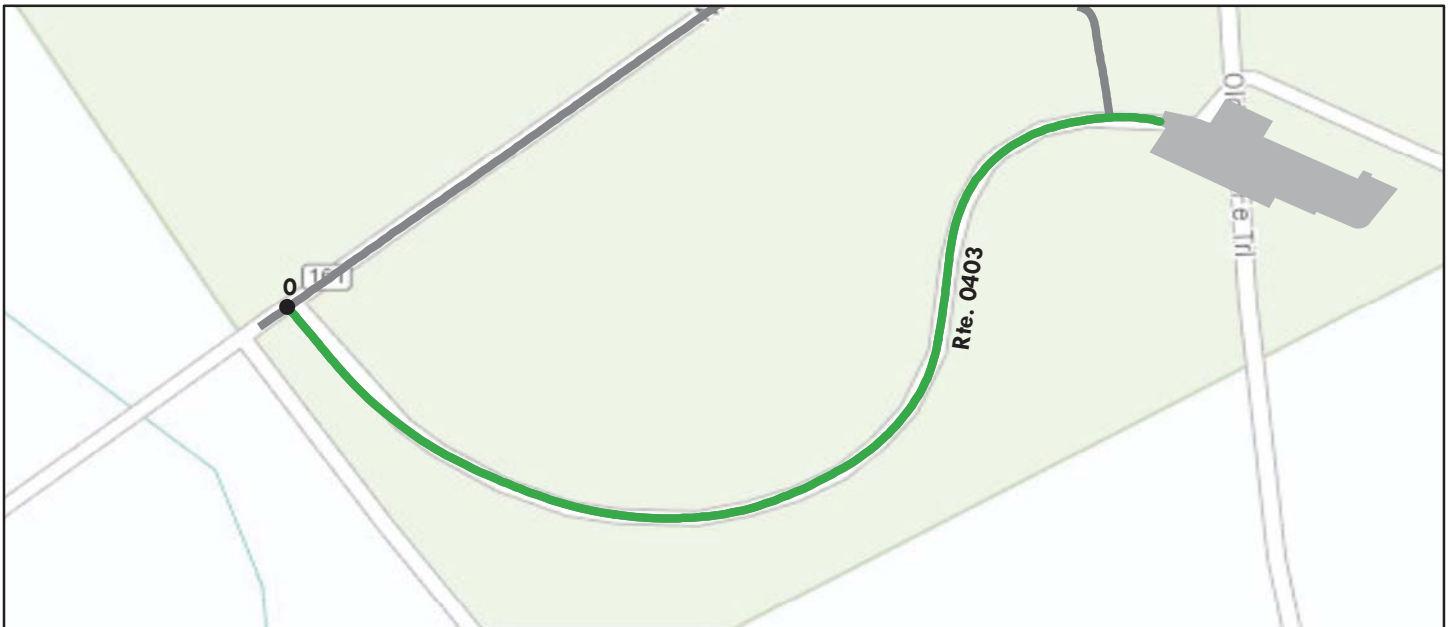
ROUTE 0403: FORT UNION MAINTENANCE AND RESIDENCE ROAD

Data Collection Vehicle (DCV) Rating

Route Condition Legend – Pavement Condition Rating (PCR)						
Poor (0 - 60)	Fair (61- 84)	Good (85 - 94)	Excellent (95 - 100)	Not Rated		
See Appendix for definitions and formulas						
Inspection Date: 3/24/2017	Beginning Section MP	0				
Paved Length (Miles): 0.3	Section Length (MI)	0.3				
Surface Type: ASPHALT	Route Summary					
Roadway Condition Information						
Pavement Condition Rating (PCR)	93	93				
Surface Condition Rating (SCR)	93	93				
Roughness Condition Index (RCI)	N/A	N/A				
Distress Index Values						
Structural Crack Index	99	99				
Alligator Crack Index	100	100				
Longitudinal Crack Index	99	99				
Transverse Cracking Index	99	99				
Patching Index	100	100				
Rutting Index	93	93				
International Roughness Index (IRI)	N/A	N/A				
Lane & Width Information						
Number of Lanes	2	2				
Paved Width (ft)	18.1	18.1				
Lane Width (ft)	8	8

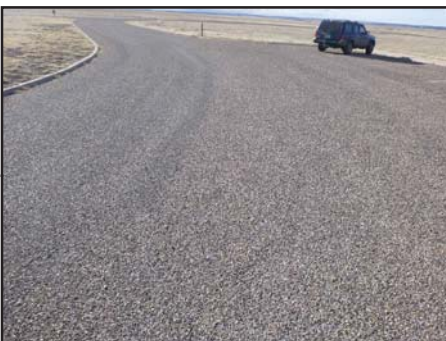
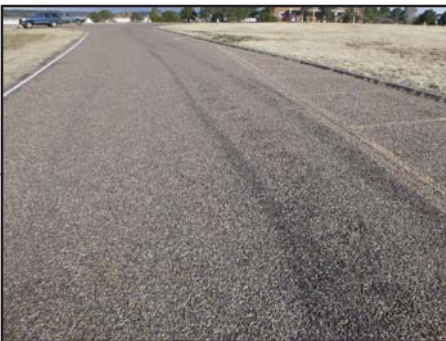
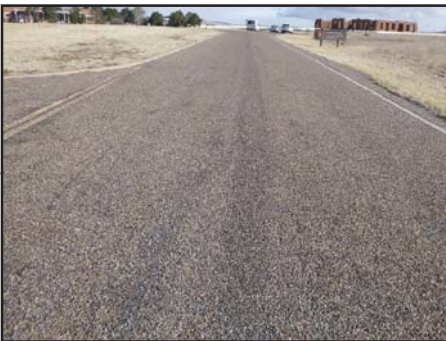
Inspection Date	FMSS Number	User Access	Surface Type
3/24/2017	54276	PUBLIC	ASPHALT
Area (Sq. Ft.)	Lane Miles (11' Widths)	Curb Reveal (Inches)	Curb Recommendation
35,541	0.612	4	DO NOTHING
Curb Type		Curb & Gutter Type	
CONCRETE		NO CURB AND GUTTER	
Pavement Recommendation		Condition Rating / PCR	
PREVENTIVE MAINTENANCE		GOOD / 90

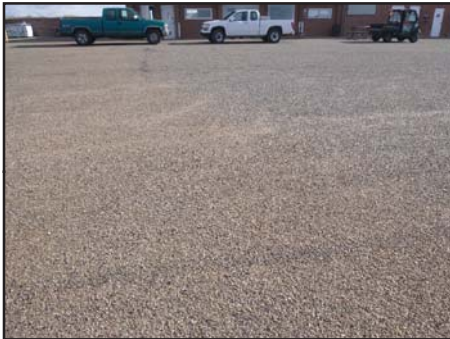
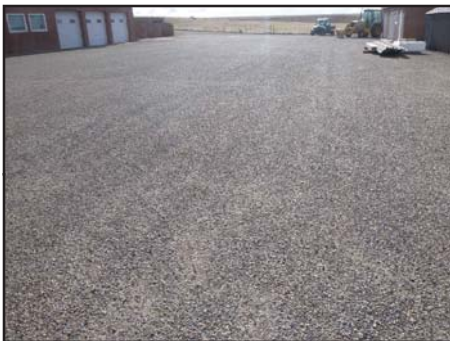
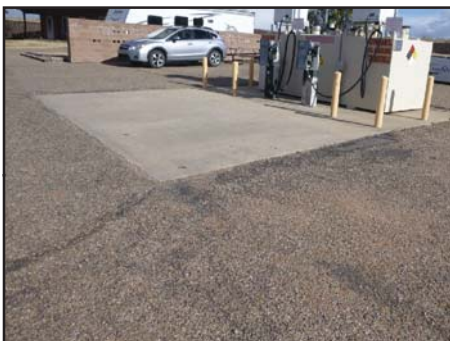
ROUTE 0901: FORT UNION MAINTENANCE AREA PARKING

Inspection Date	FMSS Number	User Access	Surface Type
3/24/2017	54277	NONPUBLIC	ASPHALT
Area (Sq. Ft.)	Lane Miles (11' Widths)	Curb Reveal (Inches)	Curb Recommendation
25,796	0.444	NOT APPLICABLE	NOT APPLICABLE
Curb Type		Curb & Gutter Type	
NO CURB		NO CURB AND GUTTER	
Pavement Recommendation		Condition Rating / PCR	
PREVENTIVE MAINTENANCE		GOOD / 90

Note: Parking area consists of multiple surface types: 1 part Asphalt at 25,340 square feet; 1 part Concrete at 456 square feet.
