GERO Cycle 6

Final Report

Road Inventory and Condition Assessment of Paved Routes George Rogers Clark National Historical Park

George Rogers Clark National Historical Park in Indiana

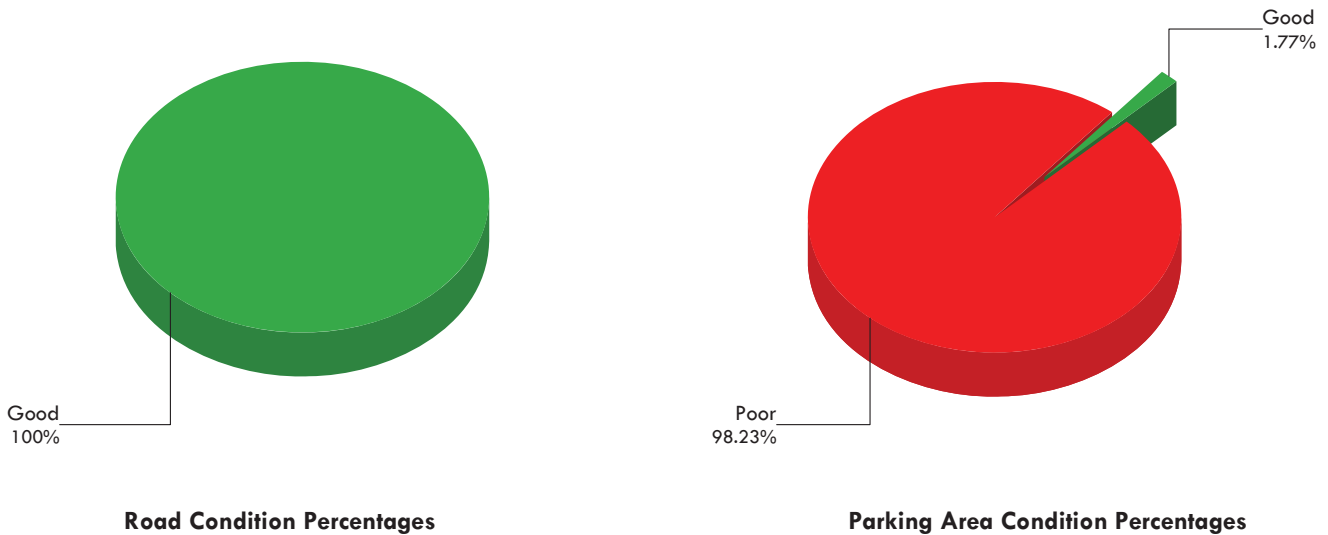
Figure 1: Pavement Condition Rating Breakdown for Paved Roads and Parking Areas

Parkwide Condition Percentages

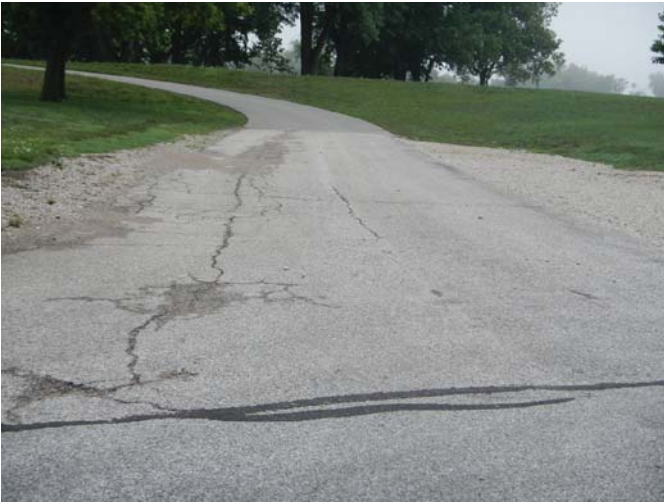
GERO_0100_3865.JPG

ROUTE 0100: PEARL DRIVE

Route Condition Legend – Pavement Condition Rating (PCR)						
Poor (0 - 60)	Fair (61- 84)	Good (85 - 94)	Excellent (95 - 100)	Not Rated		
See Appendix for definitions and formulas						
Inspection Date: 6/13/2018	Beginning Section MP	0.00				
Paved Length (Miles): 0.07	Section Length (MI)	0.07				
Surface Type: ASPHALT	Route Summary					
Roadway Condition Information						
Pavement Condition Rating (PCR)	90	90				
Surface Condition Rating (SCR)	90	90				
Roughness Condition Index (RCI)	N/A	N/A				
Distress Index Values						
Structural Crack Index	N/A	N/A				
Alligator Crack Index	90	90				
Longitudinal Crack Index	90	90				
Transverse Cracking Index	90	90				
Patching Index	97	97				
Rutting Index	90	90				
International Roughness Index (IRI)	N/A	N/A				
Lane & Width Information						
Number of Lanes	2	2				
Paved Width (ft)	16.5	16.5				
Lane Width (ft)	8.3	8.3

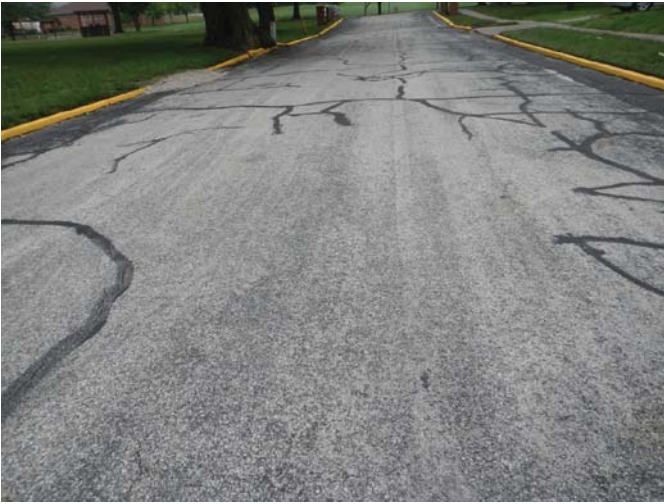
GERO_0900_3872.JPG

Inspection Date	FMSS Number	User Access	Surface Type
6/13/2018	64206	PUBLIC	ASPHALT
Area (Sq. Ft.)	Lane Miles (11' Widths)	Curb Reveal (Inches)	Curb Recommendation
39,234	0.676	3	DO NOTHING
Curb Type		Curb & Gutter Type	
CONCRETE		NO CURB AND GUTTER	
Pavement Recommendation		Condition Rating / PCR	
HEAVY 3R TREATMENTS		POOR / 53

ROUTE 0900: GERO PARKING AREA

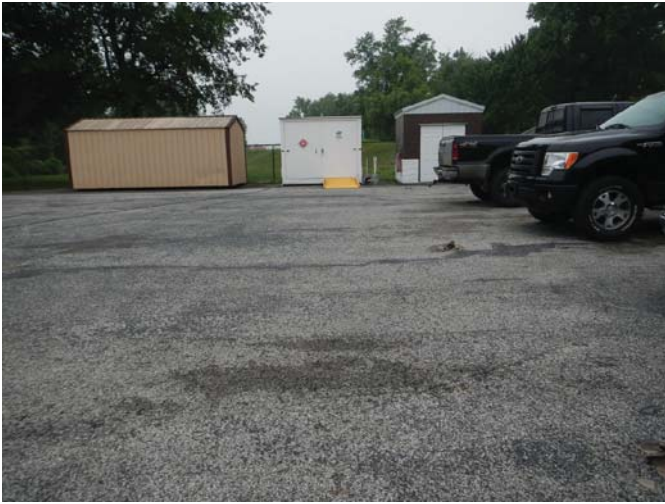
GERO_0901_3857.JPG

Inspection Date	FMSS Number	User Access	Surface Type
6/13/2018	81143	NONPUBLIC	ASPHALT
Area (Sq. Ft.)	Lane Miles (11' Widths)	Curb Reveal (Inches)	Curb Recommendation
12,508	0.215	NOT APPLICABLE	NOT APPLICABLE
Curb Type		Curb & Gutter Type	
NO CURB		NO CURB AND GUTTER	
Pavement Recommendation		Condition Rating / PCR	
HEAVY 3R TREATMENTS		POOR / 53

ROUTE 0901: MAINTENANCE PARKING LOT

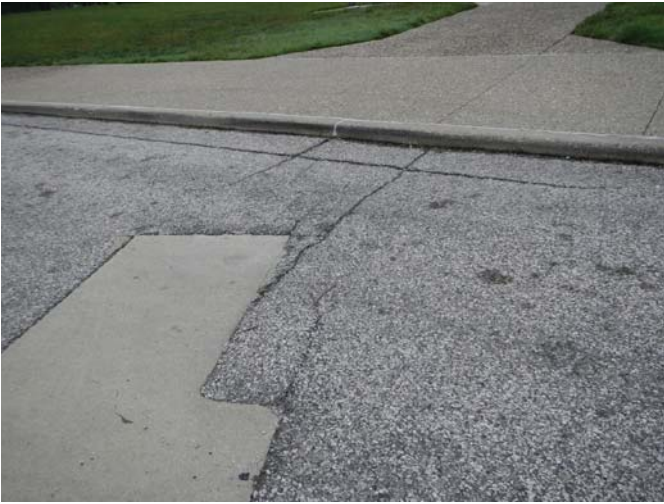
GERO_0902_3883.JPG

Inspection Date	FMSS Number	User Access	Surface Type
6/13/2018	64204	PUBLIC	ASPHALT
Area (Sq. Ft.)	Lane Miles (11' Widths)	Curb Reveal (Inches)	Curb Recommendation
933	0.016	4	DO NOTHING
Curb Type		Curb & Gutter Type	
CONCRETE		CONCRETE	
Pavement Recommendation		Condition Rating / PCR	
PREVENTIVE MAINTENANCE		GOOD / 90

ROUTE 0902: VISITOR CENTER PULL-OFF
