GLDE Cycle 6

Final Report

Road Inventory and Condition Assessment of Paved Routes Gloria Dei (Old Swedes') Church National Historic Site

Report Date: October 2020

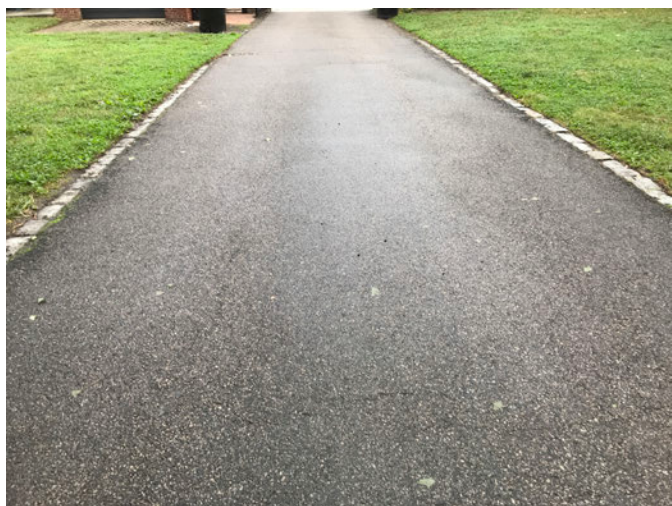
GLDE_0900_4.jpg

Inspection Date	FMSS Number	User Access	Surface Type
9/28/2020	N/A	PUBLIC	ASPHALT
Area (Sq. Ft.)	Lane Miles (11' Widths)	Curb Reveal (Inches)	Curb Recommendation
1,389	0.024	0	DO NOTHING
Curb Type		Curb & Gutter Type	
STONE		NO CURB AND GUTTER	
Pavement Recommendation		Condition Rating / PCR	
PREVENTIVE MAINTENANCE		GOOD / 90
