GOIS Cycle 6

Final Report

Road Inventory and Condition Assessment of Paved Routes Governors Island National Monument

Report Date: February 2021

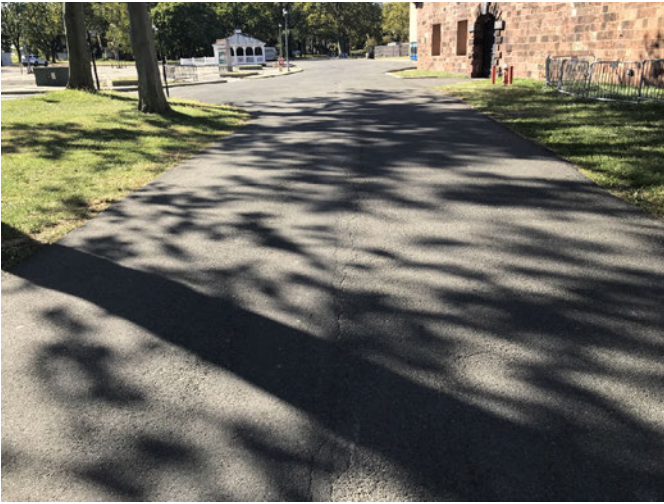
GOIS_0402_1.jpg

Inspection Date:	10/8/2020	Beginning Section MP	0.00				
Paved Length (Miles):	0.12	Section Length (MI)	0.12				
Surface Type:	ASPHALT	Route Summary					
Roadway Condition Information							
Pavement Condition Rating (PCR)	30	30					
Surface Condition Rating (SCR)	30	30					
Roughness Condition Index (RCI)	N/A	N/A					
Distress Index Values							
Structural Crack Index	N/A	N/A					
Alligator Crack Index	30	30					
Longitudinal Crack Index	30	30					
Transverse Cracking Index	73	73					
Patching Index	73	73					
Rutting Index	53	53					
International Roughness Index (IRI)	N/A	N/A					
Lane & Width Information							
Number of Lanes	2	2					
Paved Width (ft)	17.6	17.6					
Lane Width (ft)	8.8	8.8

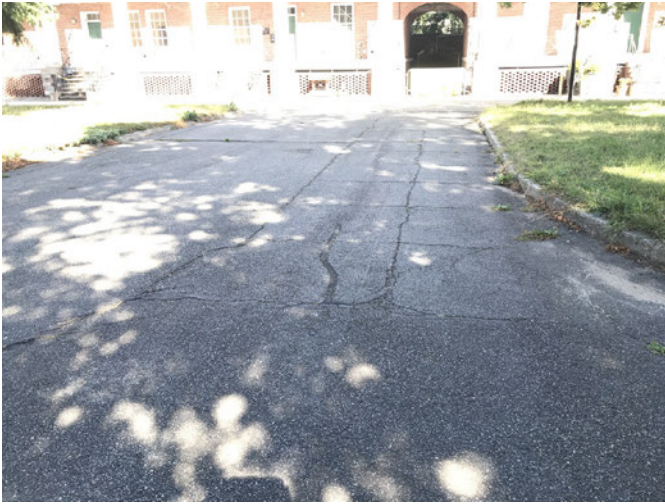
GOIS_0900_1.jpg

Inspection Date	FMSS Number	User Access	Surface Type
10/8/2020	70175	PUBLIC	ASPHALT
Area (Sq. Ft.)	Lane Miles (11' Widths)	Curb Reveal (Inches)	Curb Recommendation
26,128	0.45	5	MODERATE REPAIR
Curb Type		Curb & Gutter Type	
ASPHALT AND CONCRETE		NO CURB AND GUTTER	
Pavement Recommendation		Condition Rating / PCR	
HEAVY 3R TREATMENTS		POOR / 53

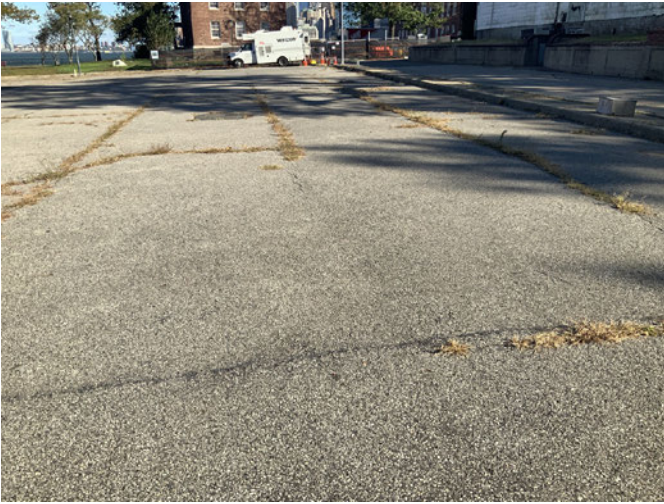
GOIS_0901_2.jpg

Inspection Date	FMSS Number	User Access	Surface Type
10/8/2020	70173	PUBLIC	ASPHALT
Area (Sq. Ft.)	Lane Miles (11' Widths)	Curb Reveal (Inches)	Curb Recommendation
26,478	0.456	5	LIGHT REPAIR
Curb Type		Curb & Gutter Type	
CONCRETE		NO CURB AND GUTTER	
Pavement Recommendation		Condition Rating / PCR	
HEAVY 3R TREATMENTS		POOR / 53

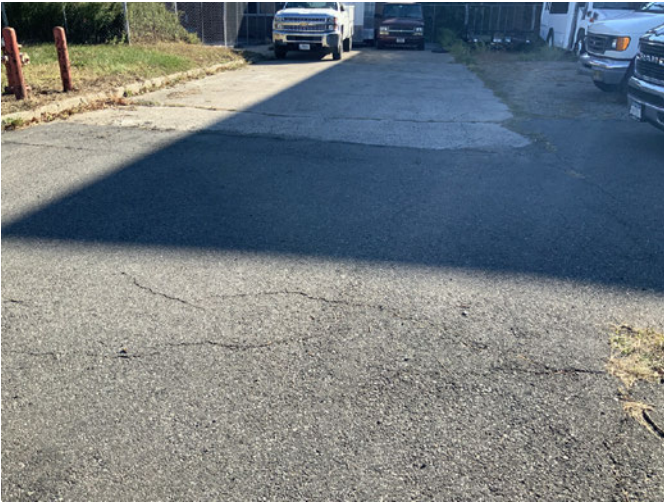
GOIS_0902_2.jpg

Inspection Date	FMSS Number	User Access	Surface Type
10/8/2020	240775	NONPUBLIC	ASPHALT
Area (Sq. Ft.)	Lane Miles (11' Widths)	Curb Reveal (Inches)	Curb Recommendation
6,938	0.119	5	DO NOTHING
Curb Type		Curb & Gutter Type	
CONCRETE		NO CURB AND GUTTER	
Pavement Recommendation		Condition Rating / PCR	
LIGHT 3R TREATMENTS		FAIR / 73
