GOSP Cycle 6

Final Report

Road Inventory and Condition Assessment of Paved Routes Golden Spike National Historic Site

Report Date: August 2017

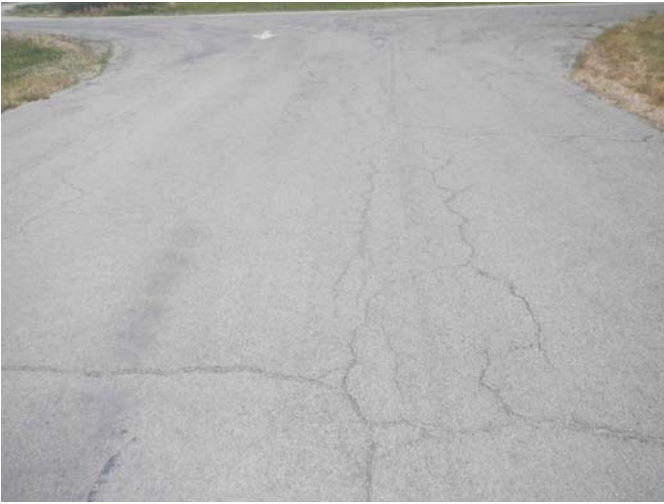
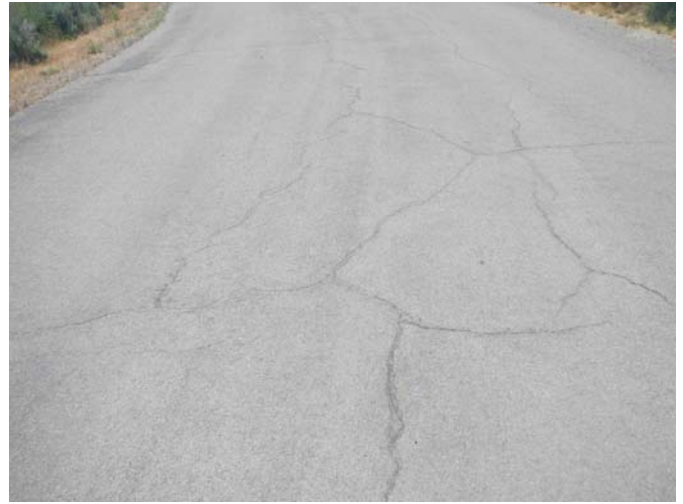
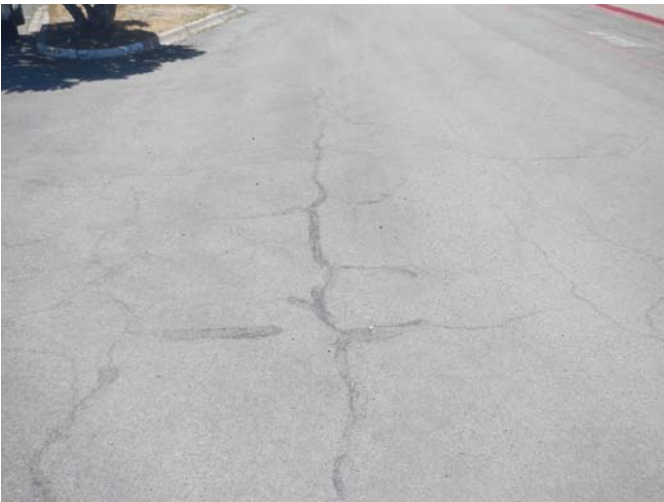
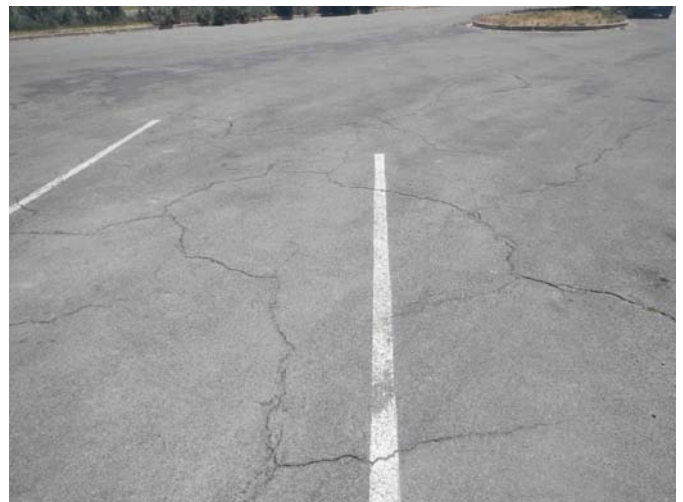
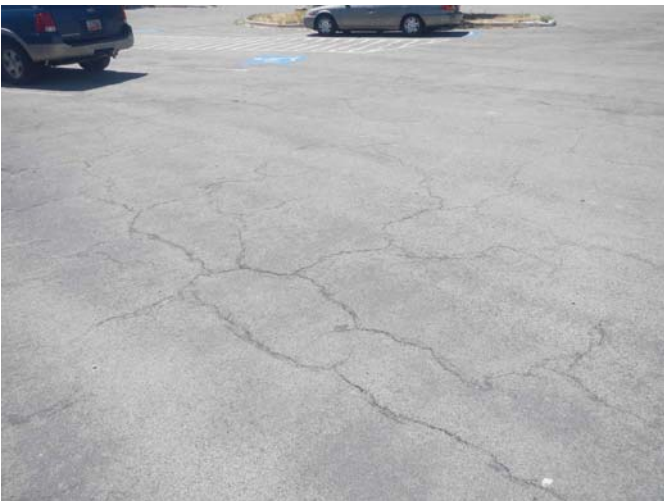
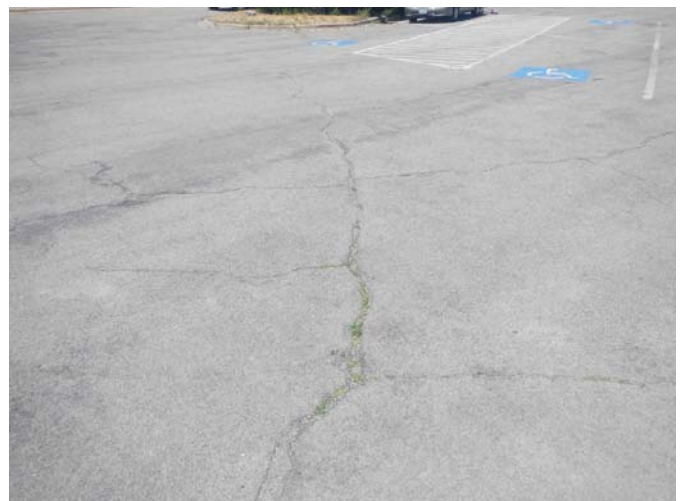
ROUTE 0900: VISITOR PARKING

Inspection Date	FMSS Number	User Access	Surface Type
6/24/2017	32398	PUBLIC	ASPHALT
Area (Sq. Ft.)	Lane Miles (11' Widths)	Curb Reveal (Inches)	Curb Recommendation
58,201	1.002	NOT APPLICABLE	MODERATE REPAIR
Curb Type		Curb & Gutter Type	
NO CURB		CONCRETE	
Pavement Recommendation		Condition Rating / PCR	
HEAVY 3R TREATMENTS		POOR / 53

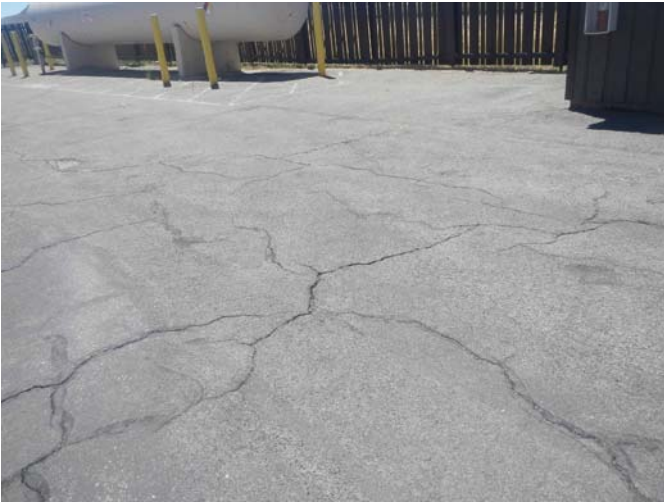
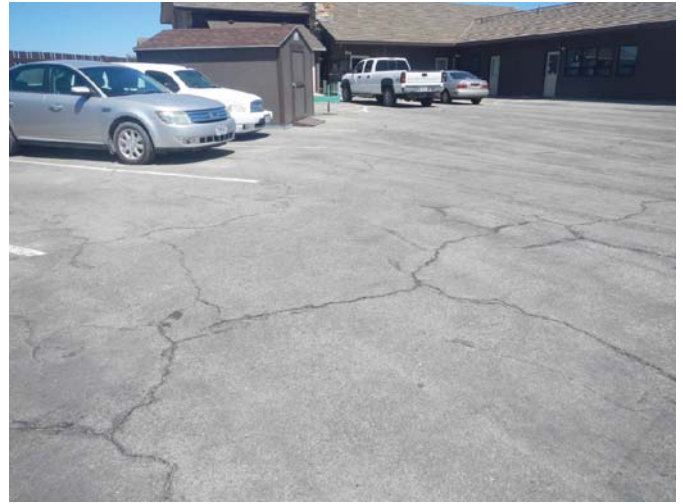
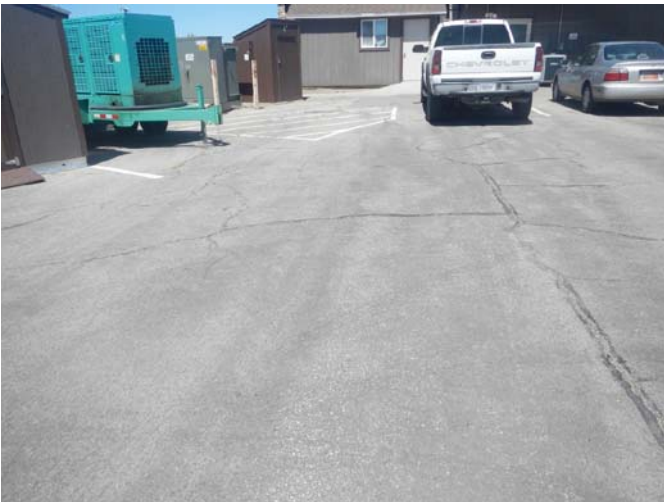
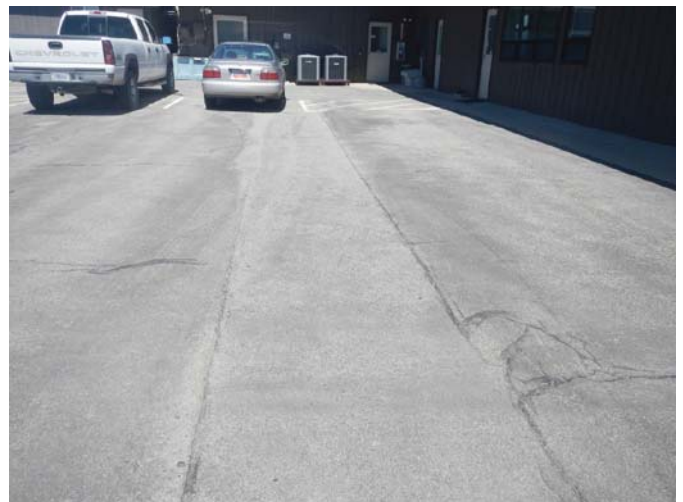
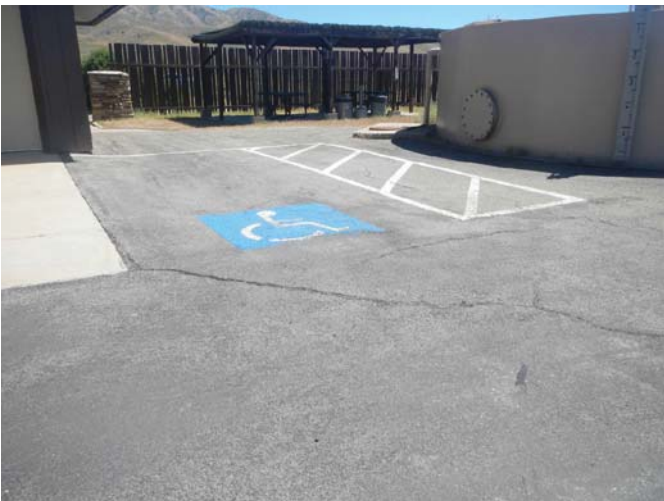
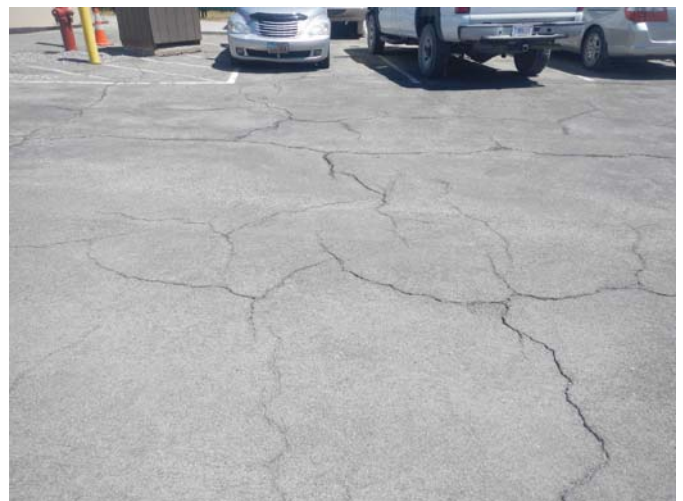
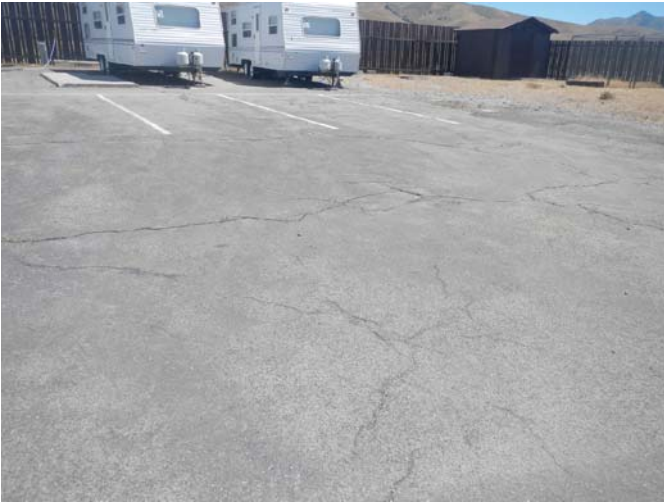
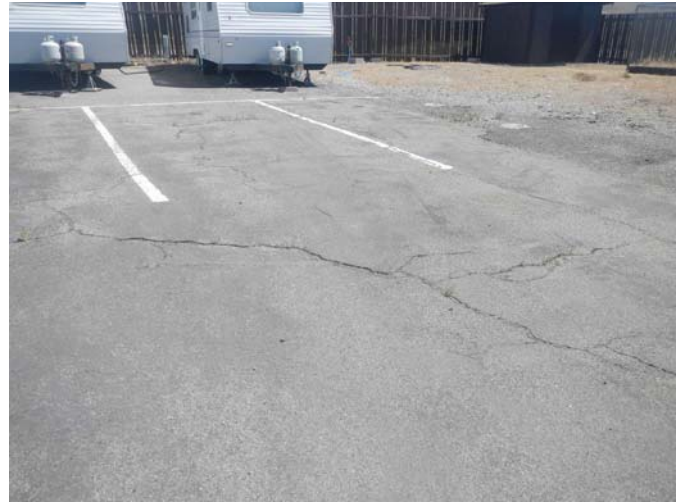
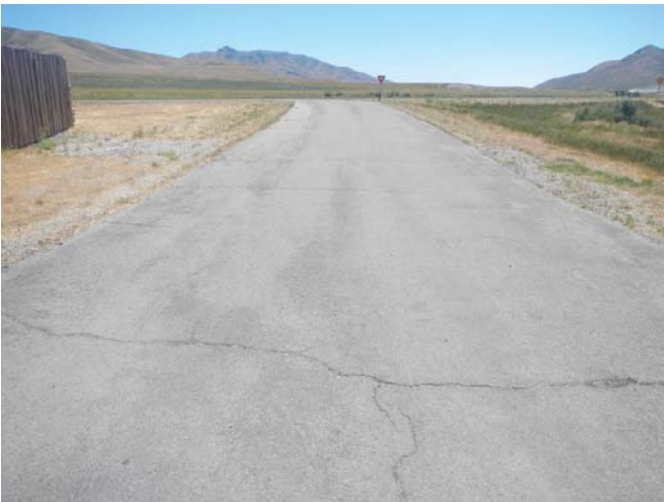
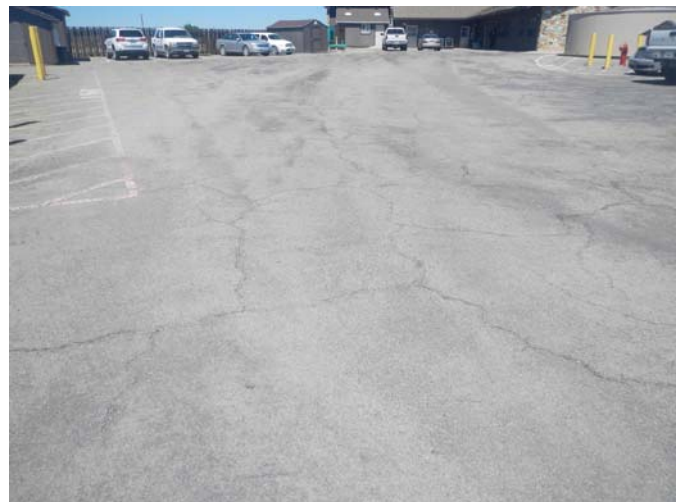
ROUTE 0901: ADMINISTRATIVE PARKING

Inspection Date	FMSS Number	User Access	Surface Type
6/24/2017	32400	NONPUBLIC	ASPHALT
Area (Sq. Ft.)	Lane Miles (11' Widths)	Curb Reveal (Inches)	Curb Recommendation
21,061	0.363	NOT APPLICABLE	NOT APPLICABLE
Curb Type		Curb & Gutter Type	
NO CURB		NO CURB AND GUTTER	
Pavement Recommendation		Condition Rating / PCR	
HEAVY 3R TREATMENTS		POOR / 53

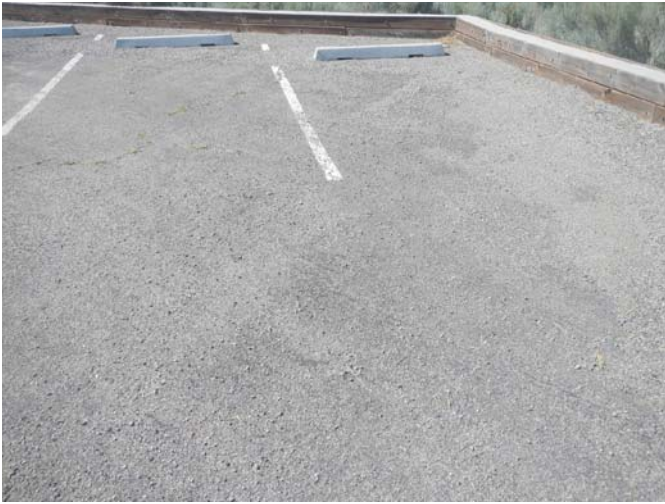
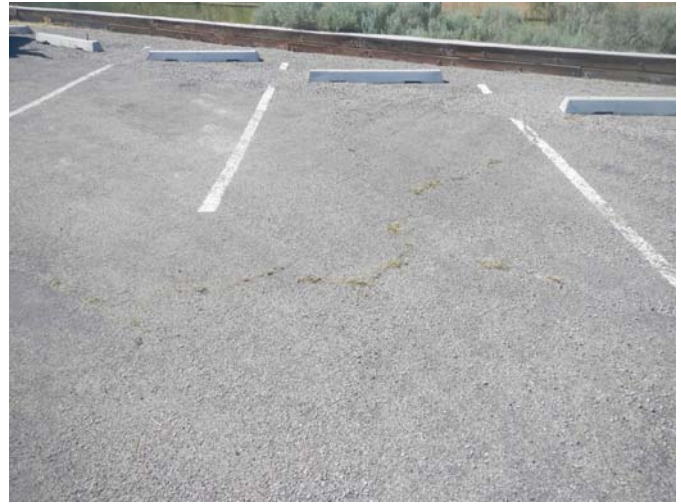
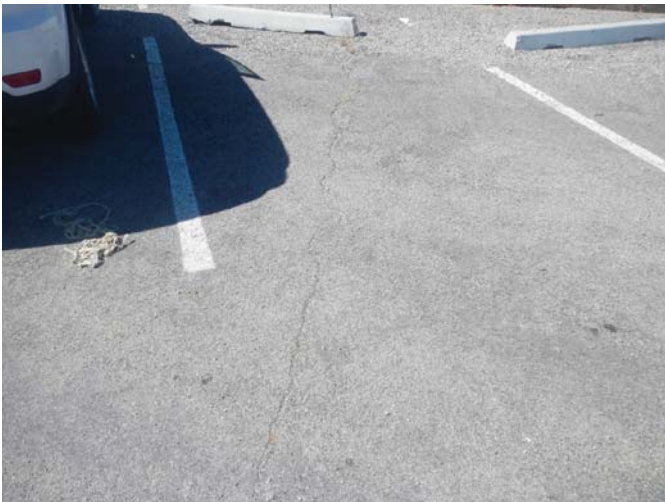
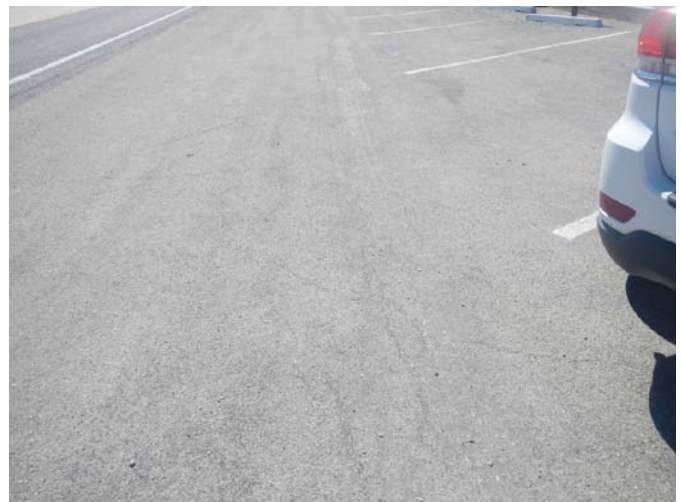
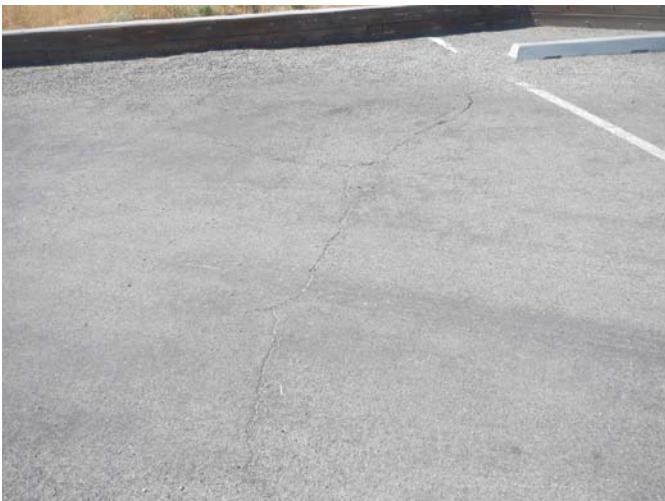
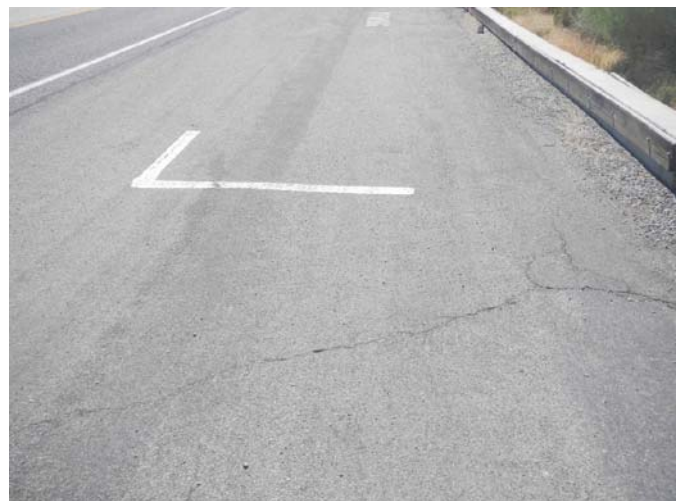
Golden Spike National Historic Site
ROUTE 0903: BIG FILL EXHIBIT LOWER PARKING AREA

Inspection Date	FMSS Number	User Access	Surface Type
6/24/2017	32577	PUBLIC	ASPHALT
Area (Sq. Ft.)	Lane Miles (11' Widths)	Curb Reveal (Inches)	Curb Recommendation
4,826	0.083	NOT APPLICABLE	NOT APPLICABLE
Curb Type		Curb & Gutter Type	
NO CURB		NO CURB AND GUTTER	
Pavement Recommendation		Condition Rating / PCR	
LIGHT 3R TREATMENTS		FAIR / 73
