# GRPO Cycle 6

## Final Report

# Road Inventory and Condition Assessment of Paved Routes Grand Portage National Monument

Report Date: October 2018

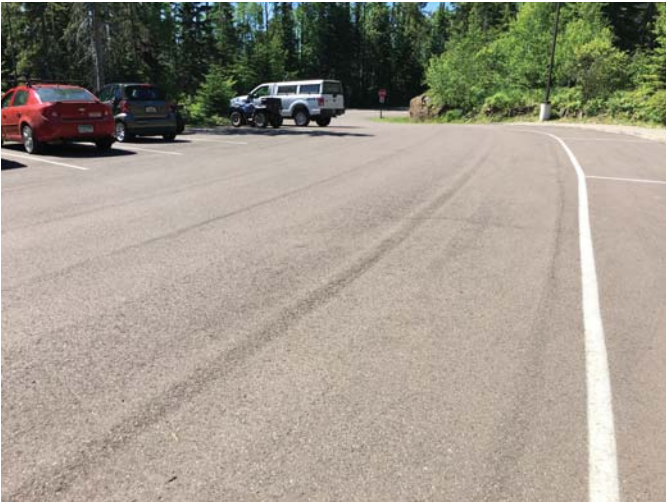
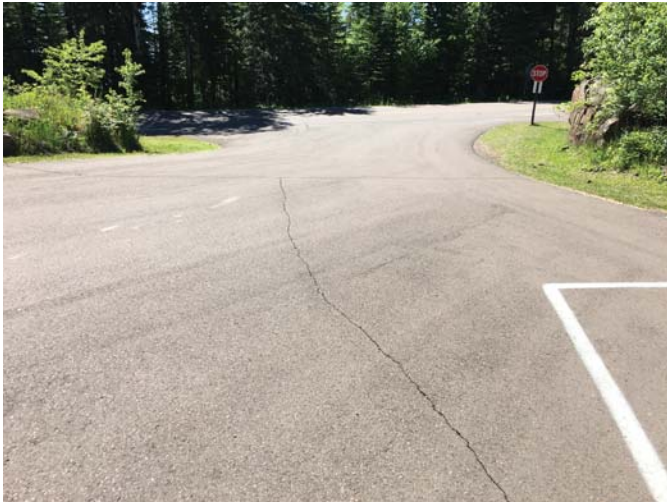
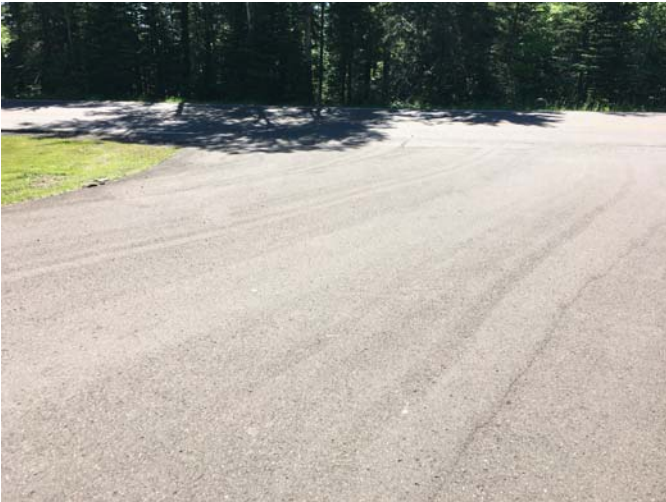
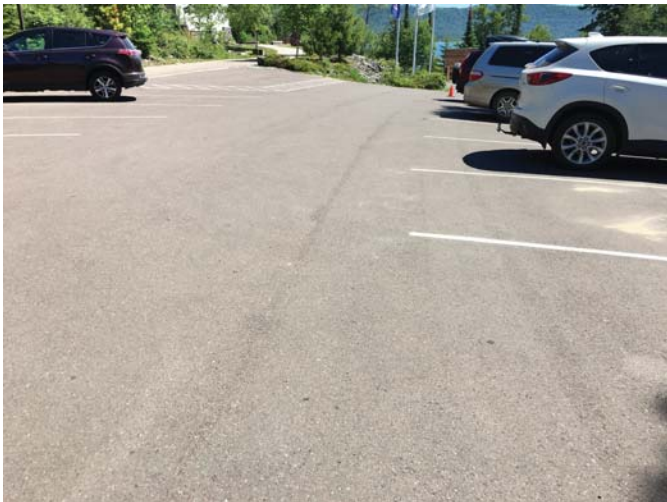
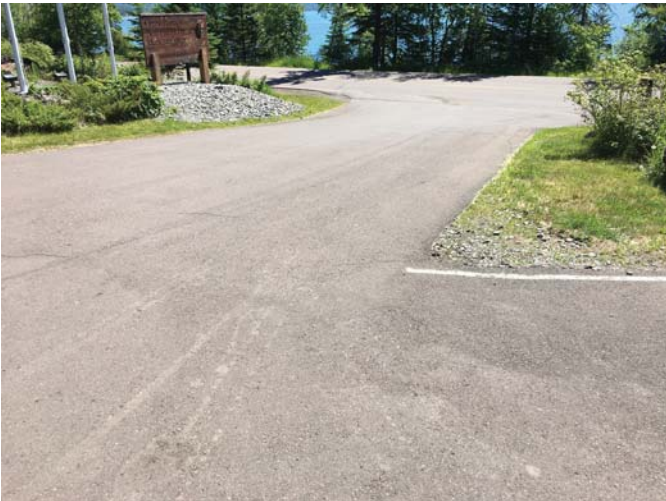
## ROUTE 0906: HERITAGE CENTER PARKING LOT

Inspection Date	FMSS Number	User Access	Surface Type
6/28/2018	106717	PUBLIC	ASPHALT
Area (Sq. Ft.)	Lane Miles (11' Widths)	Curb Reveal (Inches)	Curb Recommendation
22,615	0.389	NOT APPLICABLE	NOT APPLICABLE
Curb Type		Curb & Gutter Type	
NO CURB		NO CURB AND GUTTER	
Pavement Recommendation		Condition Rating / PCR	
PREVENTIVE MAINTENANCE		GOOD / 90

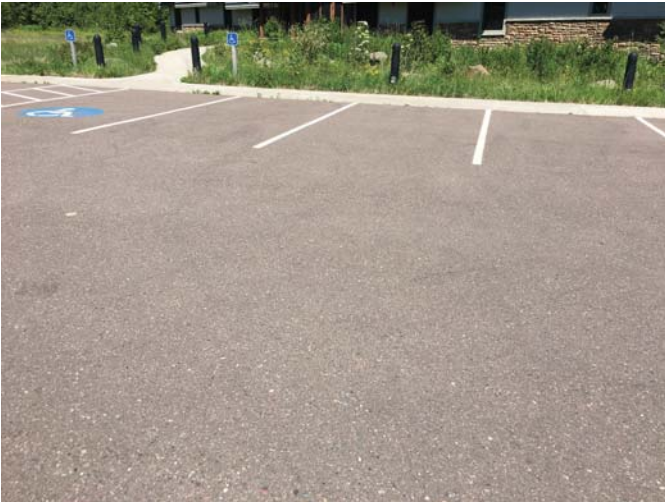
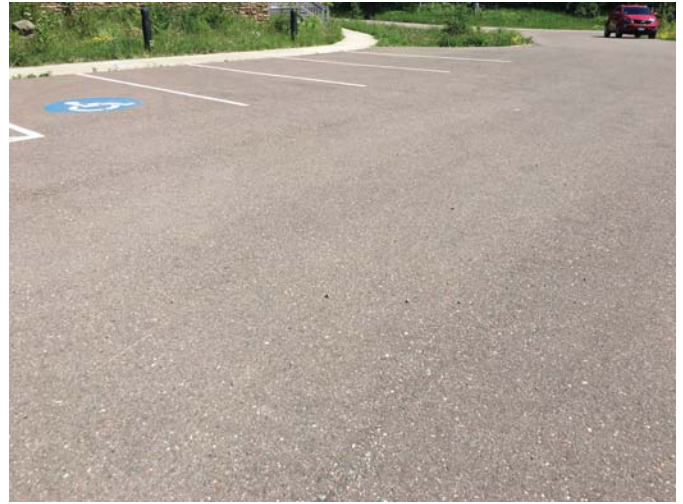
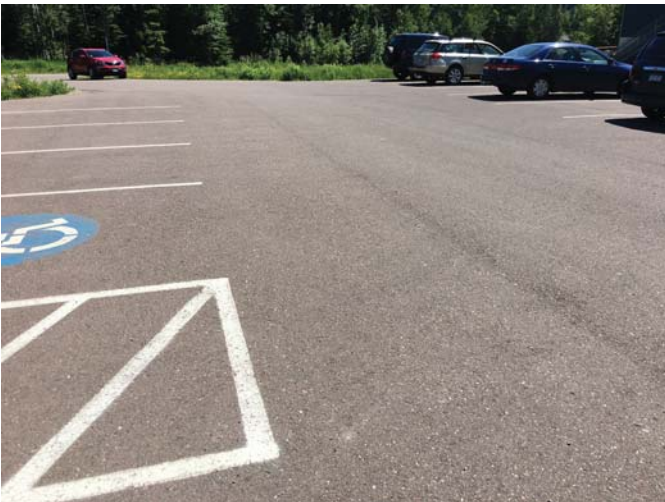
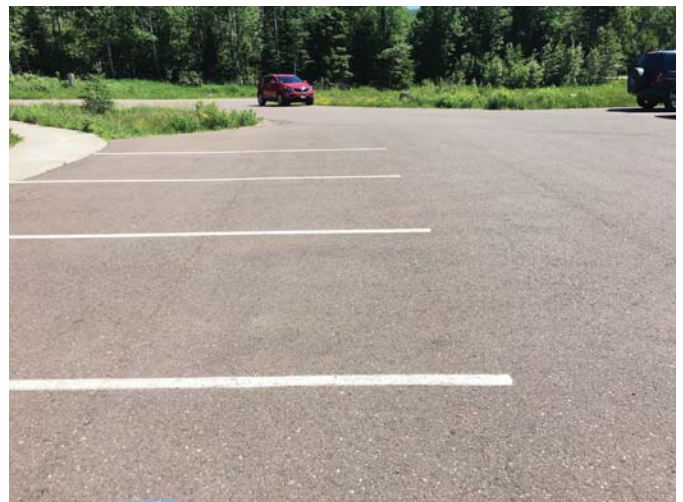
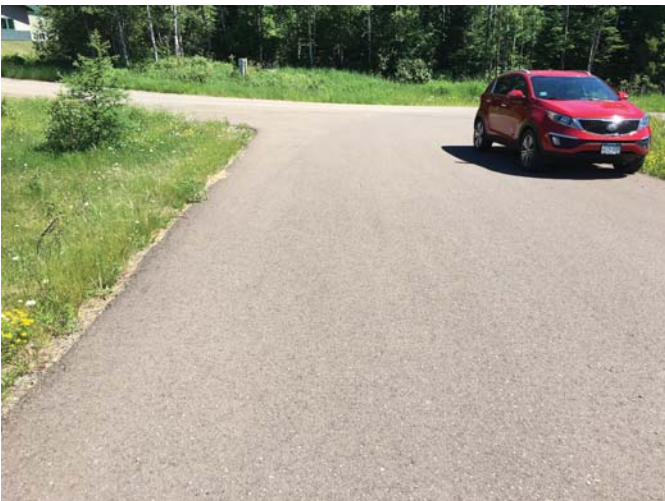
## ROUTE 0907: SEASONAL HOUSING COMPLEX P ARKING LOT

Inspection Date	FMSS Number	User Access	Surface Type
6/28/2018	238009	NONPUBLIC	ASPHALT
Area (Sq. Ft.)	Lane Miles (11' Widths)	Curb Reveal (Inches)	Curb Recommendation
6,937	0.119	NOT APPLICABLE	NOT APPLICABLE
Curb Type		Curb & Gutter Type	
NO CURB		NO CURB AND GUTTER	
Pavement Recommendation		Condition Rating / PCR	
PREVENTIVE MAINTENANCE		GOOD / 90
