HOAL Cycle 6

Final Report

Road Inventory and Condition Assessment of Paved Routes Horace M. Albright Training Center

Report Date: November 2016

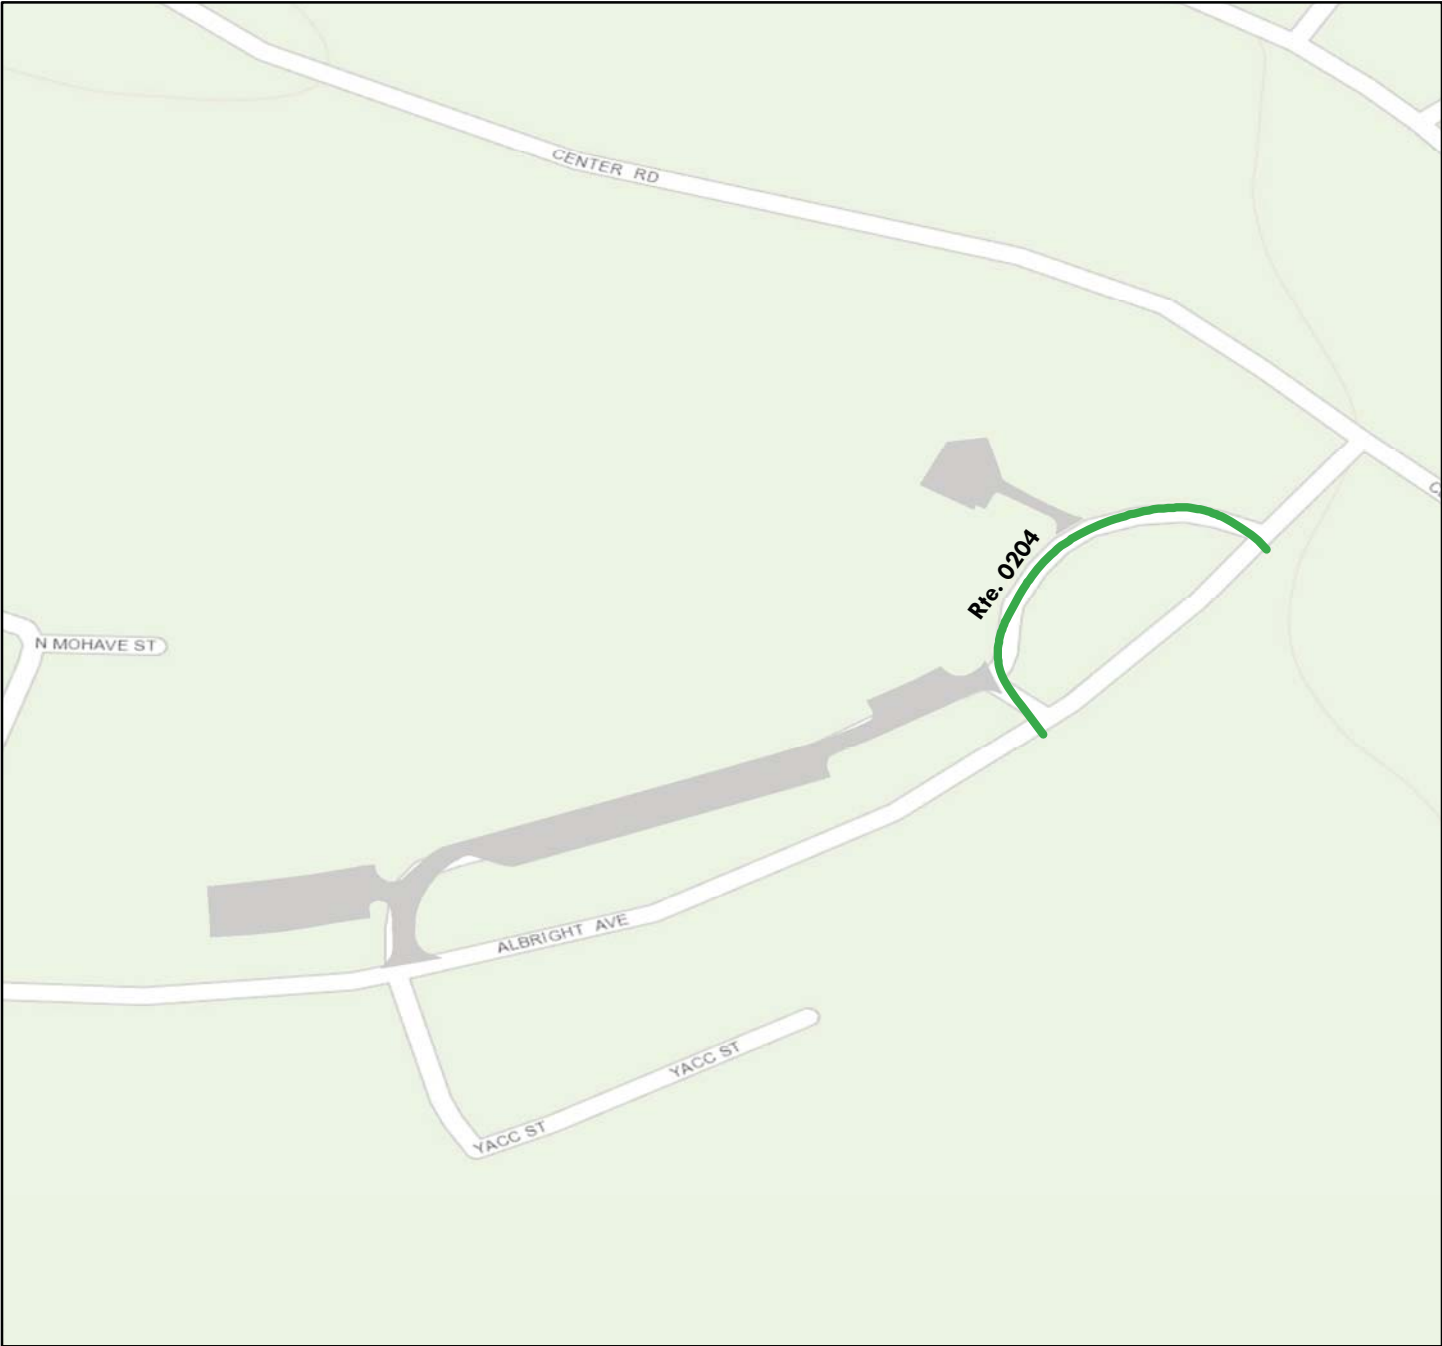
Area Map 1

ROUTE CONDITION MAP

PCR - MILE BY MILE

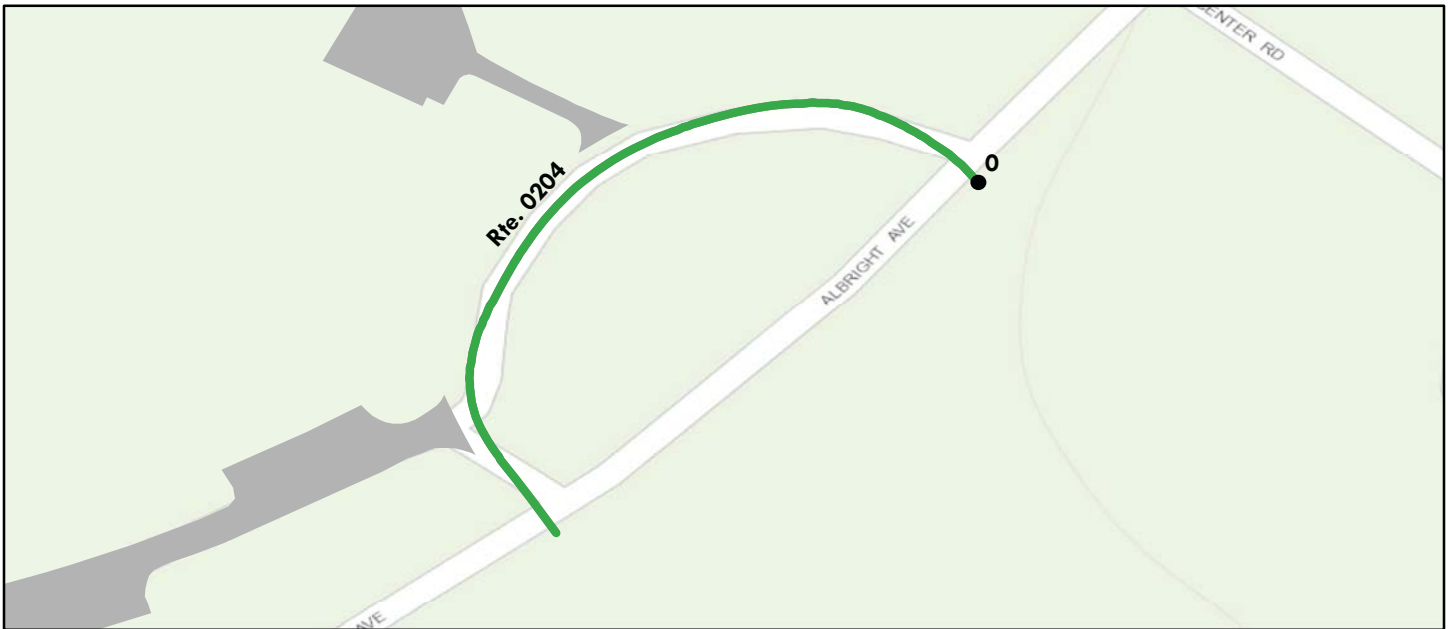
ROUTE 0204: NPS ACADEMY LOOP ROAD

Data Collection Vehicle (DCV) Rating

Route Condition Legend – Pavement Condition Rating (PCR)						
Poor (0 - 60)	Fair (61- 84)	Good (85 - 94)	Excellent (95 - 100)	Not Rated		
See Appendix for definitions and formulas						
Inspection Date: 7/8/2016	Beginning Section MP	0				
Paved Length (Miles): 0.09	Section Length (MI)	0.09				
Surface Type: ASPHALT	Route Summary					
Roadway Condition Information						
Pavement Condition Rating (PCR)	87	87				
Surface Condition Rating (SCR)	87	87				
Roughness Condition Index (RCI)	N/A	N/A				
Distress Index Values						
Structural Crack Index	96	96				
Alligator Crack Index	100	100				
Longitudinal Crack Index	96	96				
Transverse Cracking Index	87	87				
Patching Index	100	100				
Rutting Index	99	99				
International Roughness Index (IRI)	N/A	N/A				
Lane & Width Information						
Number of Lanes	2	2				
Paved Width (ft)	26.8	26.8				
Lane Width (ft)	13.4	13.4

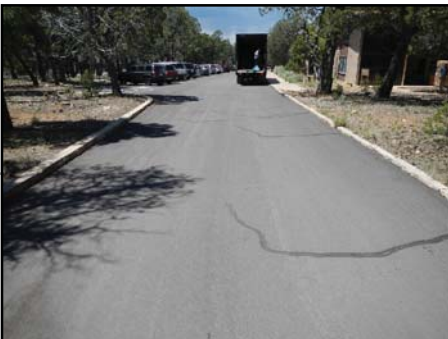
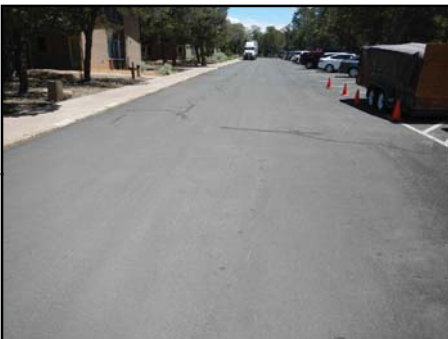
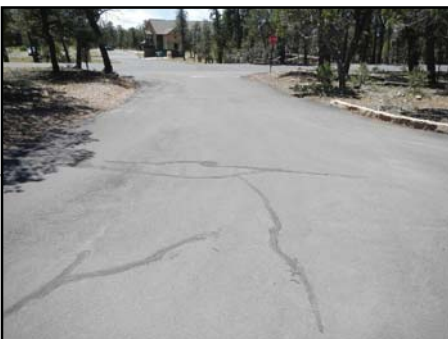
Inspection Date	FMSS Number	User Access	Surface Type
5/17/2016	58398	PUBLIC	ASPHALT
Area (Sq. Ft.)	Lane Miles (11' Widths)	Curb Reveal (Inches)	Curb Recommendation
37,140	0.639	5	DO NOTHING
Curb Type		Curb & Gutter Type	
STONE		NO CURB AND GUTTER	
Pavement Recommendation		Condition Rating / PCR	
PREVENTIVE MAINTENANCE		GOOD / 90

Parking area consists of multiple surface types: 1 part Asphalt at 36,542 square feet; 1 part Concrete at 598 square feet.

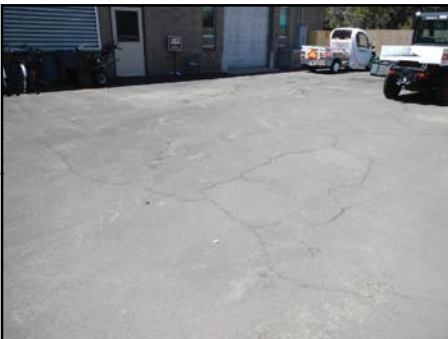
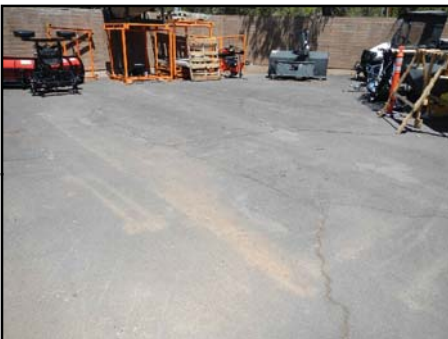
ROUTE 0988: ALBRIGHT TRAINING GARAGE PARKING

Inspection Date	FMSS Number	User Access	Surface Type
5/17/2016	90499	PUBLIC	ASPHALT
Area (Sq. Ft.)	Lane Miles (11' Widths)	Curb Reveal (Inches)	Curb Recommendation
5,838	0.101	NOT APPLICABLE	NOT APPLICABLE
Curb Type		Curb & Gutter Type	
NO CURB		NO CURB AND GUTTER	
Pavement Recommendation		Condition Rating / PCR	
HEAVY 3R TREATMENTS		POOR / 53
