HOVE Cycle 6

Final Report

Road Inventory and Condition Assessment of Paved Routes Hovenweep National Monument

Report Date: November 2017

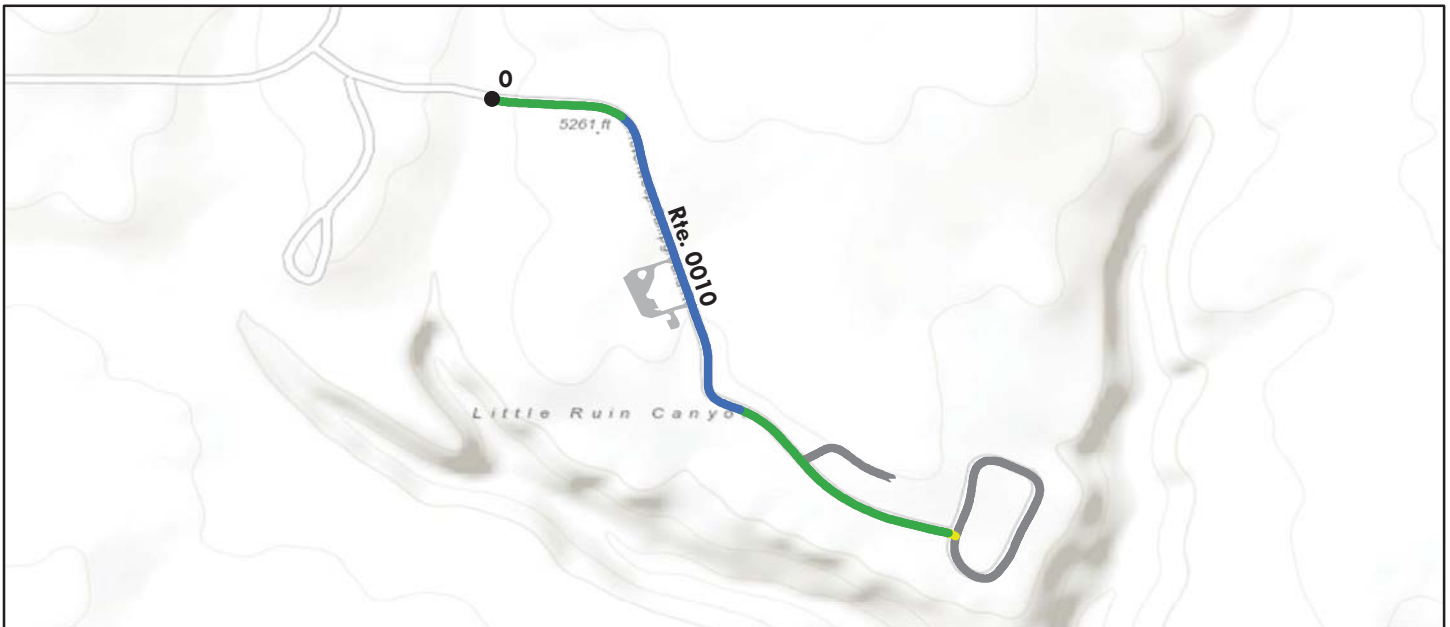
ROUTE 0010: ENTRANCE ROAD

Inspection Date: 6/4/2017	Beginning Section MP	0				
Paved Length (Miles): 0.60	Section Length (MI)	0.60				
Surface Type: ASPHALT	Route Summary					
Roadway Condition Information						
Pavement Condition Rating (PCR)	94	94				
Surface Condition Rating (SCR)	94	94				
Roughness Condition Index (RCI)	N/A	N/A				
Distress Index Values						
Structural Crack Index	99	99				
Alligator Crack Index	100	100				
Longitudinal Crack Index	99	99				
Transverse Cracking Index	94	94				
Patching Index	100	100				
Rutting Index	96	96				
International Roughness Index (IRI)	N/A	N/A				
Lane & Width Information						
Number of Lanes	2	2				
Paved Width (ft)	19.2	19.2				
Lane Width (ft)	9	9

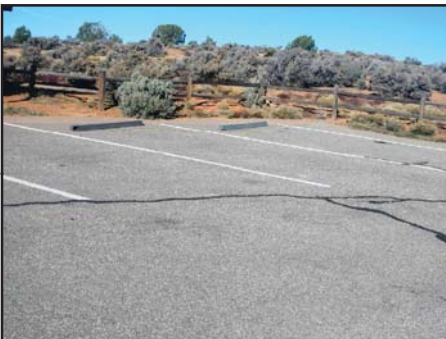
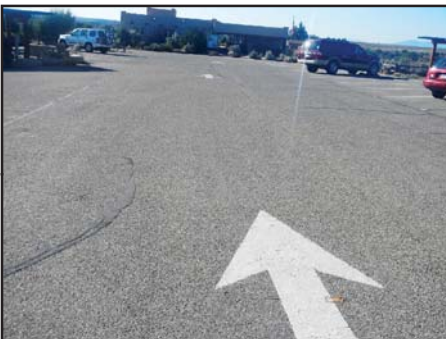
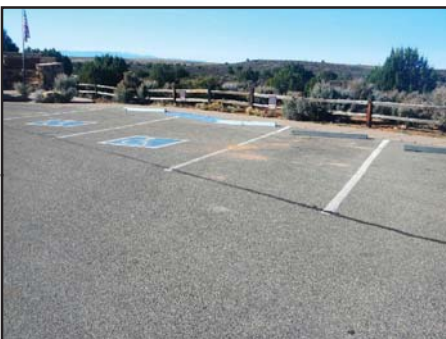
Inspection Date	FMSS Number	User Access	Surface Type
3/20/2016	61493	PUBLIC	ASPHALT
Area (Sq. Ft.)	Lane Miles (11' Widths)	Curb Reveal (Inches)	Curb Recommendation
24,925	0.429	NOT APPLICABLE	NOT APPLICABLE
Curb Type		Curb & Gutter Type	
NO CURB		NO CURB AND GUTTER	
Pavement Recommendation		Condition Rating / PCR	
PREVENTIVE MAINTENANCE		GOOD / 90

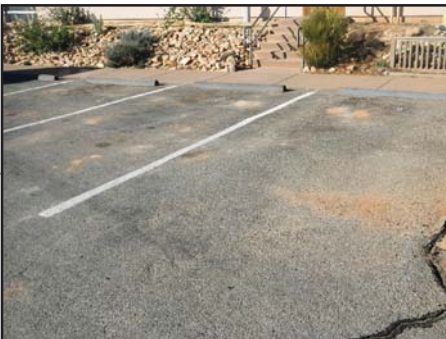
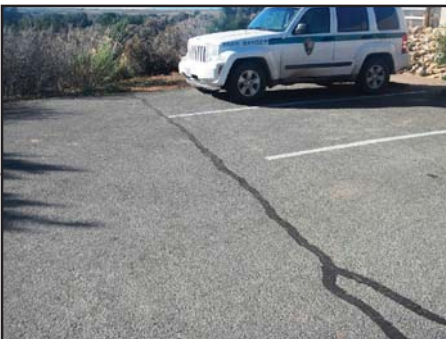
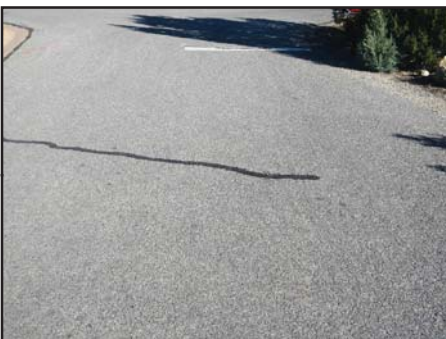
ROUTE 0901: EMPLOYEE PARKING

Inspection Date	FMSS Number	User Access	Surface Type
3/20/2016	98185	NONPUBLIC	ASPHALT
Area (Sq. Ft.)	Lane Miles (11' Widths)	Curb Reveal (Inches)	Curb Recommendation
2,846	0.049	NOT APPLICABLE	NOT APPLICABLE
Curb Type		Curb & Gutter Type	
NO CURB		NO CURB AND GUTTER	
Pavement Recommendation		Condition Rating / PCR	
PREVENTIVE MAINTENANCE		GOOD / 90
