HSTR Cycle 6

Final Report

Road Inventory and Condition Assessment of Paved Routes Harry S Truman National Historic Site

Report Date: December 2017

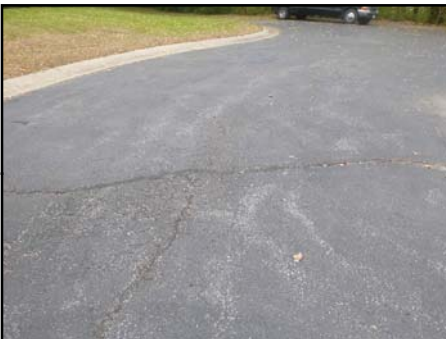
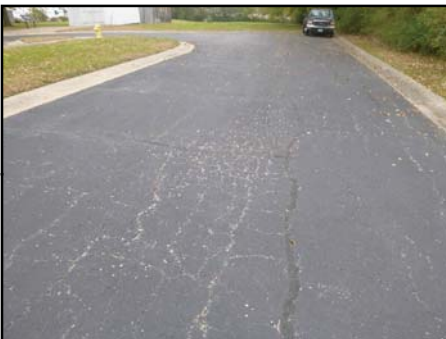
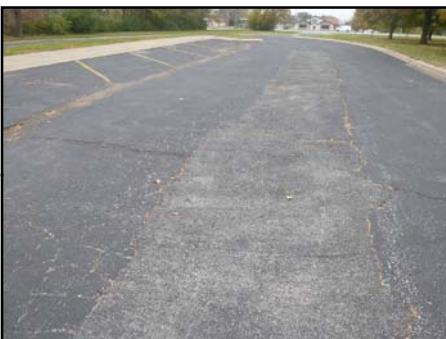
ROUTE 0900: TRUMAN FARM PARKING LOT

Inspection Date	FMSS Number	User Access	Surface Type
11/1/2017	81699	PUBLIC	ASPHALT
Area (Sq. Ft.)	Lane Miles (11' Widths)	Curb Reveal (Inches)	Curb Recommendation
18,040	0.311	NOT APPLICABLE	LIGHT REPAIR
Curb Type		Curb & Gutter Type	
NO CURB		CONCRETE	
Pavement Recommendation		Condition Rating / PCR	
HEAVY 3R TREATMENTS		POOR / 53

Note: Parking Area consists of multiple surface types: 1 part asphalt at 17,576 square feet; 1 part concrete at 464 square feet.

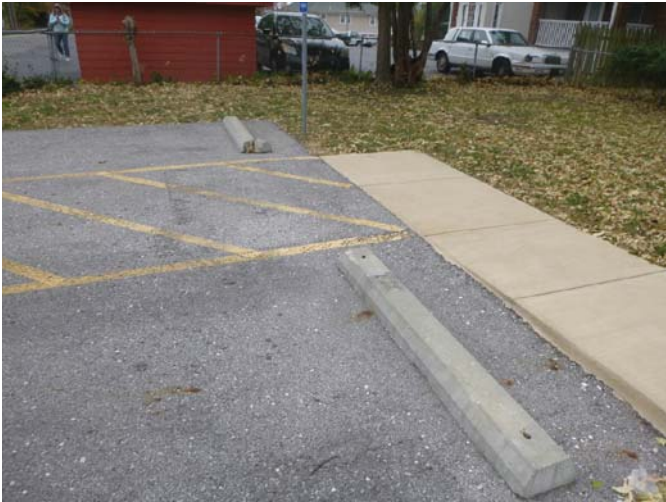
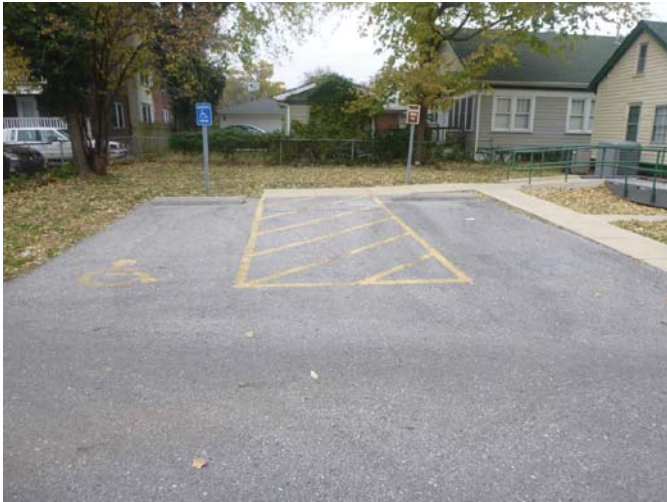
ROUTE 0901: NOLAND HOME PARKING LOT

Inspection Date	FMSS Number	User Access	Surface Type
11/1/2017	237854	PUBLIC	ASPHALT
Area (Sq. Ft.)	Lane Miles (11' Widths)	Curb Reveal (Inches)	Curb Recommendation
574	0.01	NOT APPLICABLE	NOT APPLICABLE
Curb Type		Curb & Gutter Type	
NO CURB		NO CURB AND GUTTER	
Pavement Recommendation		Condition Rating / PCR	
PREVENTIVE MAINTENANCE		GOOD / 90
