INDE Cycle 6

Final Report

Road Inventory and Condition Assessment of Paved Routes Independence National Historical Park

Report Date: October 2020

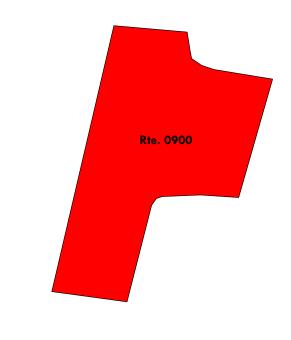
ROUTE 0900: QUARTERS PARKING AREA

Inspection Date	FMSS Number	User Access	Surface Type	
9/28/2020	61101	NONPUBLIC	ASPHALT	
Area (Sq. Ft.)	Lane Miles (11' Widths)	Curb Reveal (Inches)	Curb Recommendation	
2,257	0.039	4	LIGHT REPAIR	
Curb Type		Curb & Gutter Type		
CONCRETE NO CURI		NO CURB A	AND GUTTER	
Pavement Recommendation		Condition Rating / PCR		
HEAVY 3R TREATMENTS		POOR	2 / 53	
Route Condition Legend – Pavement Condition Rating (PCR)

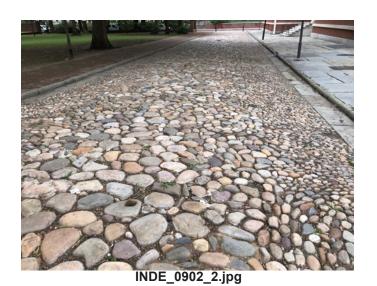
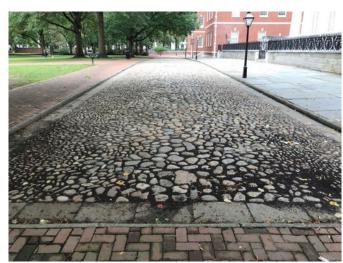
INDE_0902_5.jpg

Inspection Date	FMSS Number	User Access	Surface Type
9/28/2020	61103	NONPUBLIC	COBBLESTONE
Area (Sq. Ft.)	Lane Miles (11' Widths)	Curb Reveal (Inches)	Curb Recommendation
6,809	0.117	NOT APPLICABLE	LIGHT REPAIR
Curb Type		Curb & Gutter Type	
NO CURB		STONE	
Pavement Recommendation		Condition Rating / PCR	
DO NOTHING		EXCELLENT / 97	
Route Condition Legend – Pavement Condition Rating (PCR)			
Poor (0 - 60)	Fair (61- 84) Good	(85 - 94) Excellent (95 - 10	0) Not Rated
See Appendix for definitions and formulas

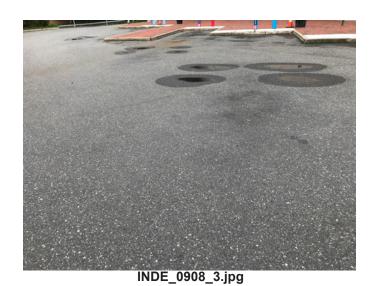
ROUTE 0908: NATIONAL CONSTITUTION CENTER BUS PARKING

Inspection Date	FMSS Number	User Access	Surface Type
9/28/2020		PUBLIC	ASPHALT
Area (Sq. Ft.)	Lane Miles (11' Widths)	Curb Reveal (Inches)	Curb Recommendation
16,737	0.288	4	MODERATE REPAIR
Curb Type		Curb & Gutter Type	
CONCRETE		ICRETE NO CURB AND GUTTER	
Pavement Recommendation		Condition Rating / PCR	
LIGHT 3R TREATMENTS		FAIR / 73	
Route Condition Legend – Payement Condition Rating (PCR)
