JECA Cycle 6

Final Report

Road Inventory and Condition Assessment of Paved Routes Jewel Cave National Monument

Report Date: April 2018

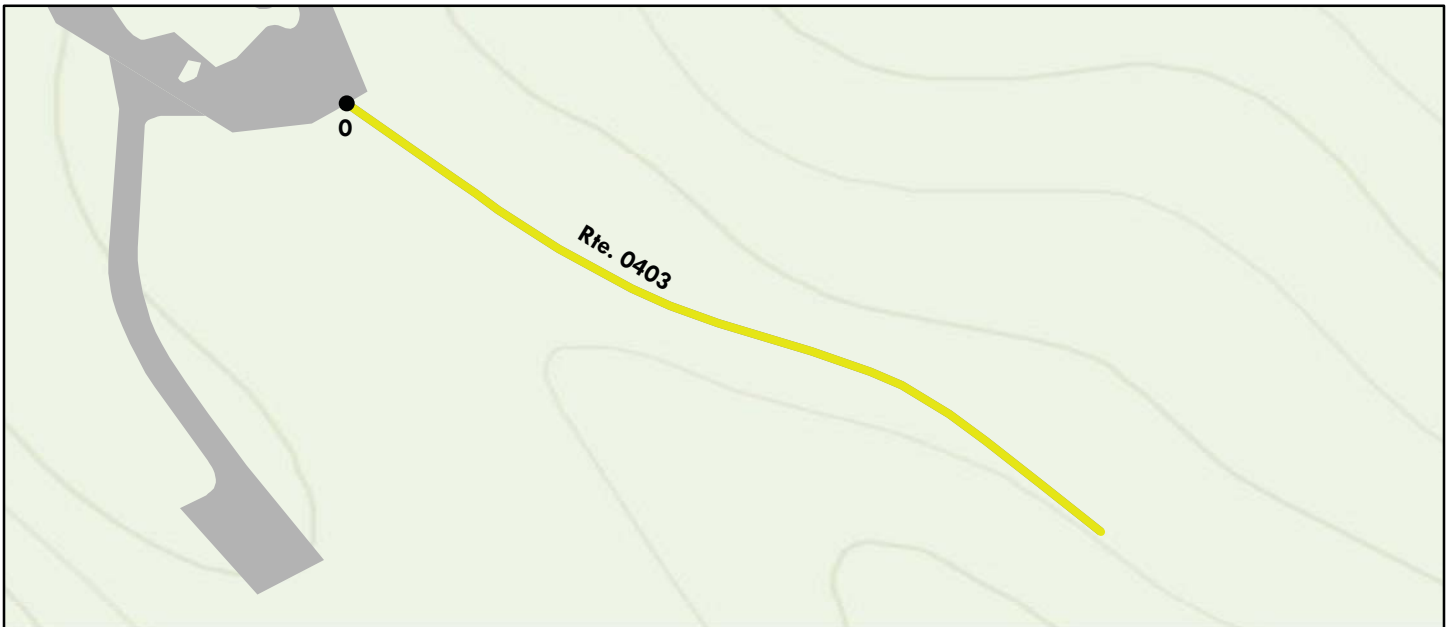
ROUTE 0403: WELL HOUSE ROAD

Inspection Date: 7/19/2017	Beginning Section MP	0				
Paved Length (Miles): 0.09	Section Length (MI)	0.09				
Surface Type: ASPHALT	Route Summary					
Roadway Condition Information						
Pavement Condition Rating (PCR)	74	74				
Surface Condition Rating (SCR)	74	74				
Roughness Condition Index (RCI)	N/A	N/A				
Distress Index Values						
Structural Crack Index	95	95				
Alligator Crack Index	97	97				
Longitudinal Crack Index	98	98				
Transverse Cracking Index	100	100				
Patching Index	91	91				
Rutting Index	74	74				
International Roughness Index (IRI)	N/A	N/A				
Lane & Width Information						
Number of Lanes	1	1				
Paved Width (ft)	13.7	13.7				
Lane Width (ft)	13.7	13.7

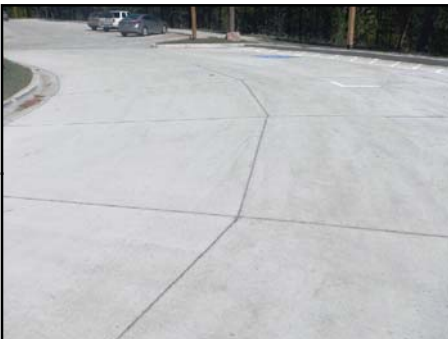
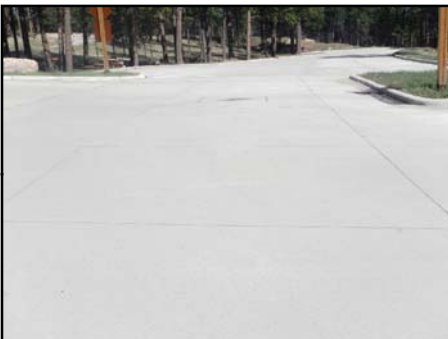
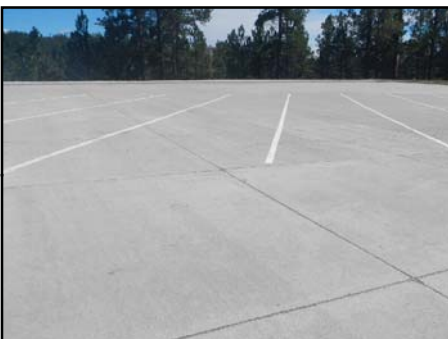
Inspection Date	FMSS Number	User Access	Surface Type
4/26/2017	245152	PUBLIC	CONCRETE
Area (Sq. Ft.)	Lane Miles (11' Widths)	Curb Reveal (Inches)	Curb Recommendation
83,252	1.433	NOT APPLICABLE	DO NOTHING
Curb Type		Curb & Gutter Type	
NO CURB		CONCRETE	
Pavement Recommendation		Condition Rating / PCR	
PREVENTIVE MAINTENANCE		GOOD / 90

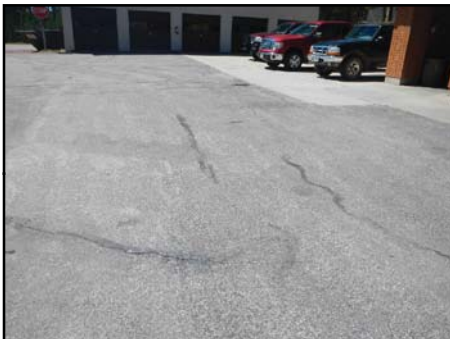
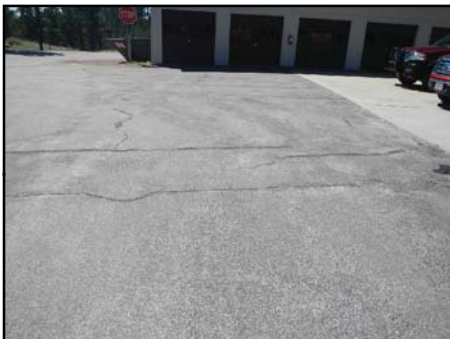
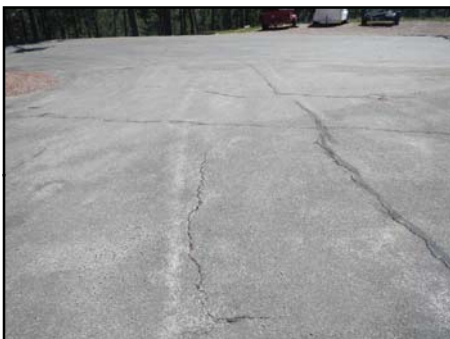
ROUTE 0901: BUILDING 9 (MAINTENANCE) PARKING

Inspection Date	FMSS Number	User Access	Surface Type
4/26/2017	104488	NONPUBLIC	ASPHALT
Area (Sq. Ft.)	Lane Miles (11' Widths)	Curb Reveal (Inches)	Curb Recommendation
10,613	0.183	NOT APPLICABLE	NOT APPLICABLE
Curb Type		Curb & Gutter Type	
NO CURB		NO CURB AND GUTTER	
Pavement Recommendation		Condition Rating / PCR	
LIGHT 3R TREATMENTS		FAIR / 73

Note: Parking area consists of multiple surface types: 1 part Asphalt at 7,742 square feet; 1 part Concrete at 2,871 square feet.

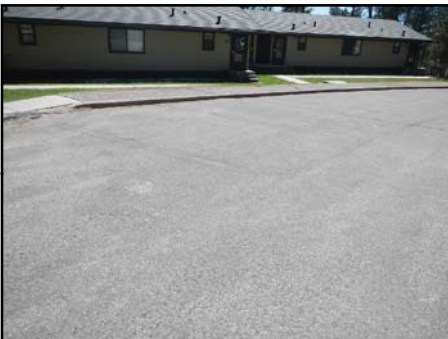
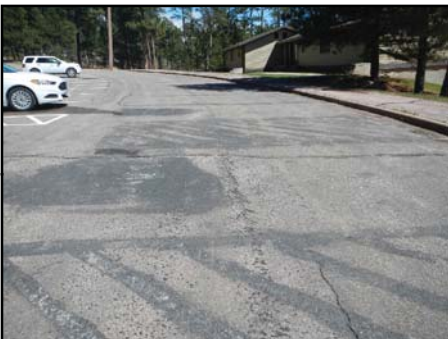
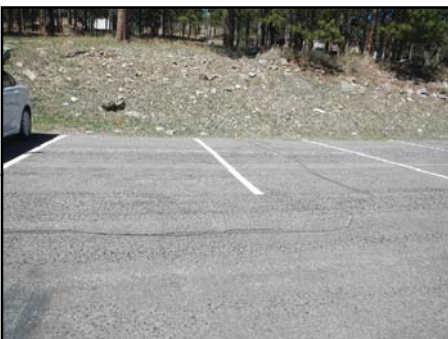
ROUTE 0902: EMPLOYEE HOUSING PARKING

Inspection Date	FMSS Number	User Access	Surface Type
4/26/2017	104456	NONPUBLIC	ASPHALT
Area (Sq. Ft.)	Lane Miles (11' Widths)	Curb Reveal (Inches)	Curb Recommendation
11,658	0.201	NOT APPLICABLE	DO NOTHING
Curb Type		Curb & Gutter Type	
NO CURB		CONCRETE	
Pavement Recommendation		Condition Rating / PCR	
PREVENTIVE MAINTENANCE		GOOD / 90

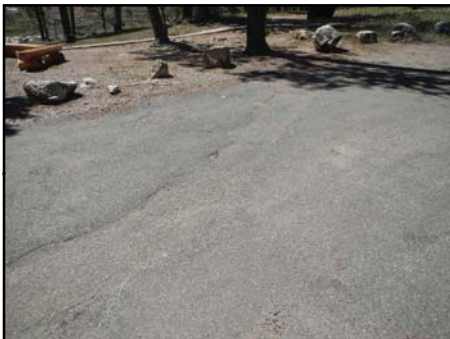
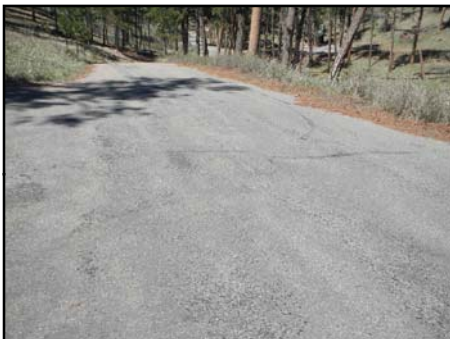
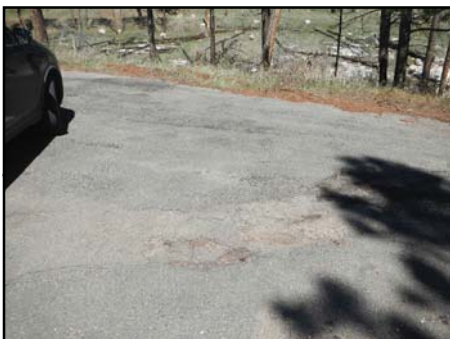
ROUTE 0905: OLD AREA PARKING

Inspection Date	FMSS Number	User Access	Surface Type
4/26/2017	233668	PUBLIC	ASPHALT
Area (Sq. Ft.)	Lane Miles (11' Widths)	Curb Reveal (Inches)	Curb Recommendation
6,966	0.12	NOT APPLICABLE	NOT APPLICABLE
Curb Type		Curb & Gutter Type	
NO CURB		NO CURB AND GUTTER	
Pavement Recommendation		Condition Rating / PCR	
LIGHT 3R TREATMENTS		FAIR / 73

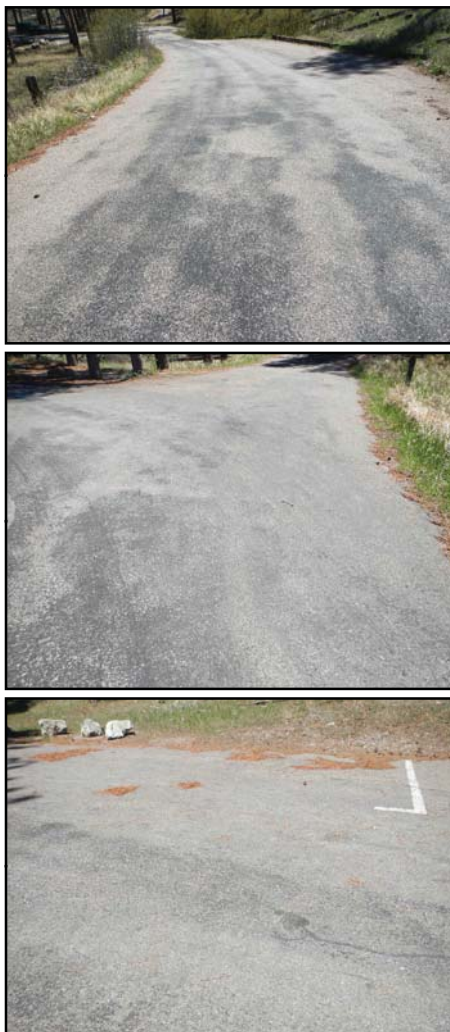
ROUTE 0906: HISTORIC AREA ROADS AND PARKING

Inspection Date	FMSS Number	User Access	Surface Type
4/26/2017	40940	PUBLIC	ASPHALT
Area (Sq. Ft.)	Lane Miles (11' Widths)	Curb Reveal (Inches)	Curb Recommendation
28,777	0.495	NOT APPLICABLE	NOT APPLICABLE
Curb Type		Curb & Gutter Type	
NO CURB		NO CURB AND GUTTER	
Pavement Recommendation		Condition Rating / PCR	
LIGHT 3R TREATMENTS		FAIR / 73
