### Road Inventory and Condition Assessment of Paved Routes Jimmy Carter National Historical Park

**Federal Lands Highway  
Road Inventory Program**

**Federal Highway Administration  
Eastern Federal Lands Highway Division  
Road Inventory Program (RIP)**

**Report Date: February 2021**

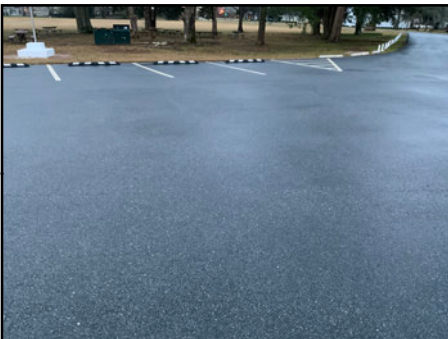
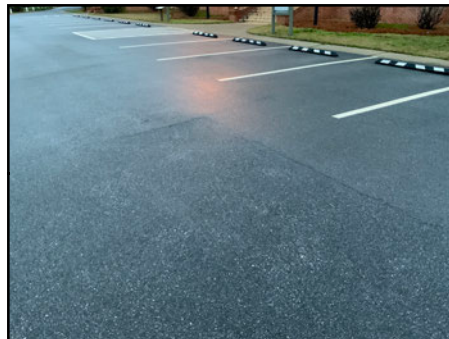
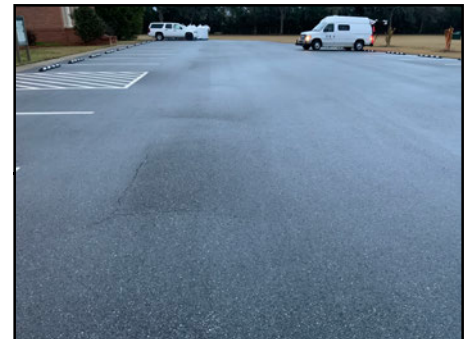
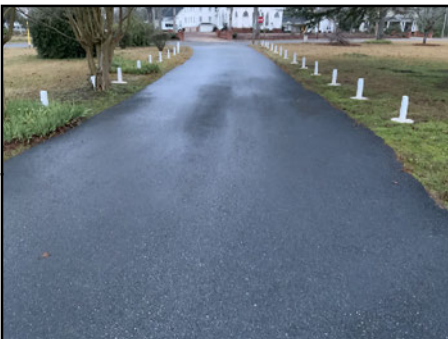
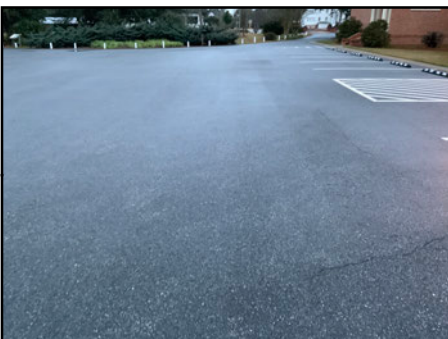
Inspection Date	FMSS Number	User Access	Surface Type
2/6/2021	80327	PUBLIC	ASPHALT
Area (Sq. Ft.)	Lane Miles (11' Widths)	Curb Reveal (Inches)	Curb Recommendation
21,602	0.372	NOT APPLICABLE	NOT APPLICABLE
Curb Type		Curb & Gutter Type	
NO CURB		NO CURB AND GUTTER	
Pavement Recommendation		Condition Rating / PCR	
PREVENTIVE MAINTENANCE		GOOD / 90

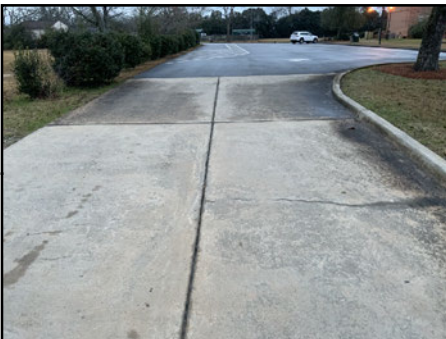
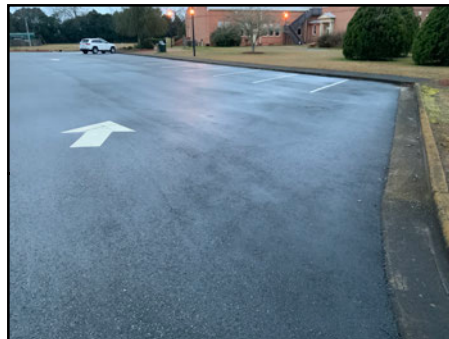
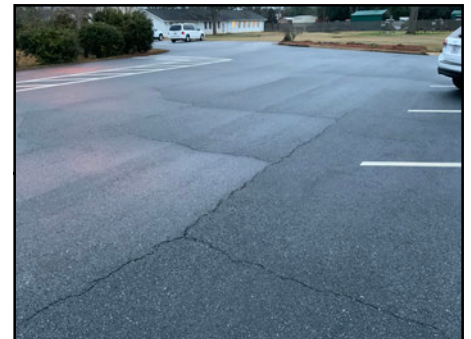
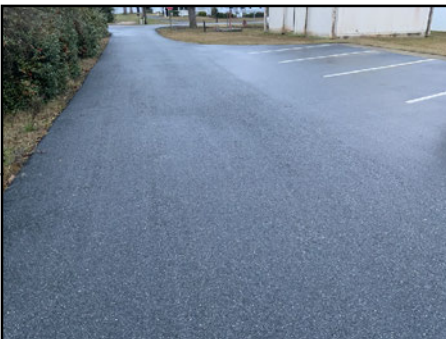
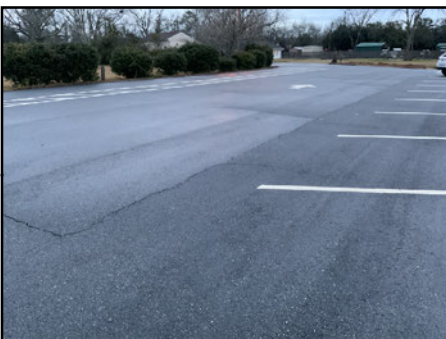
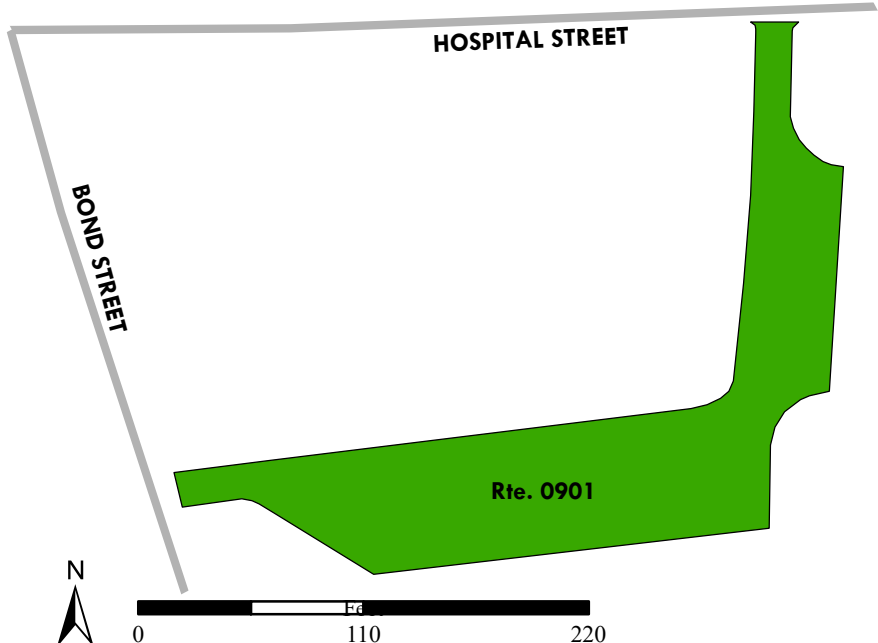
## ROUTE 0901: REAR HIGH SCHOOL PARKING

Inspection Date	FMSS Number	User Access	Surface Type
2/6/2021	80328	PUBLIC	ASPHALT
Area (Sq. Ft.)	Lane Miles (11' Widths)	Curb Reveal (Inches)	Curb Recommendation
18,554	0.319	0	LIGHT REPAIR
Curb Type		Curb & Gutter Type	
CONCRETE		CONCRETE	
Pavement Recommendation		Condition Rating / PCR	
PREVENTIVE MAINTENANCE		GOOD / 90

MULTIPLE SURFACE TYPES: ASPHALT IS 17,847 SQFT, CONCRETE IS 707 SQFT.

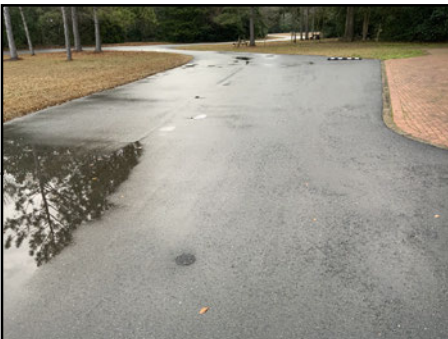
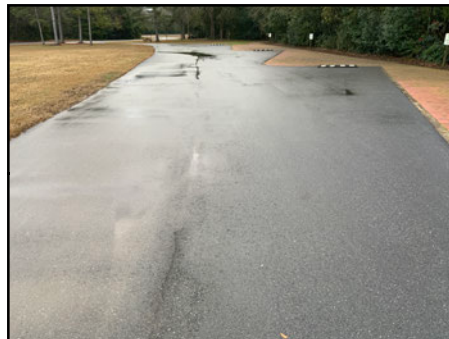
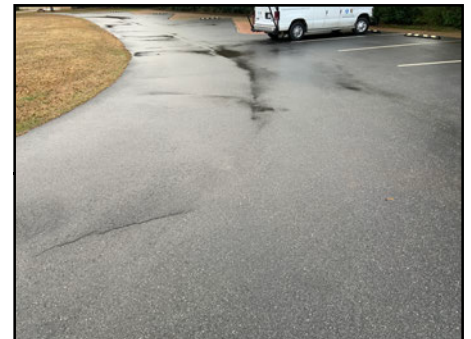
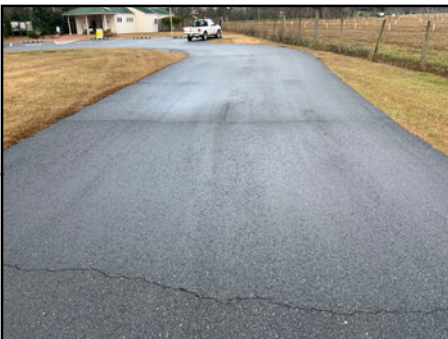
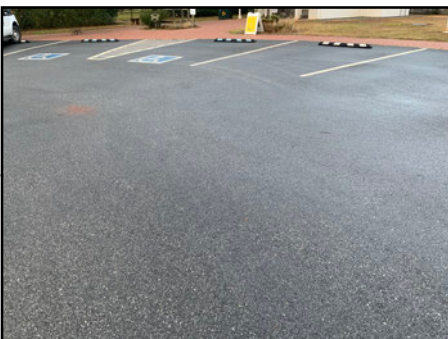
## ROUTE 0903: COMFORT STATION PARKING

Inspection Date	FMSS Number	User Access	Surface Type
2/6/2021	80330	PUBLIC	ASPHALT
Area (Sq. Ft.)	Lane Miles (11' Widths)	Curb Reveal (Inches)	Curb Recommendation
37,106	0.639	0	LIGHT REPAIR
Curb Type		Curb & Gutter Type	
CONCRETE		NO CURB AND GUTTER	
Pavement Recommendation		Condition Rating / PCR	
PREVENTIVE MAINTENANCE		GOOD / 90

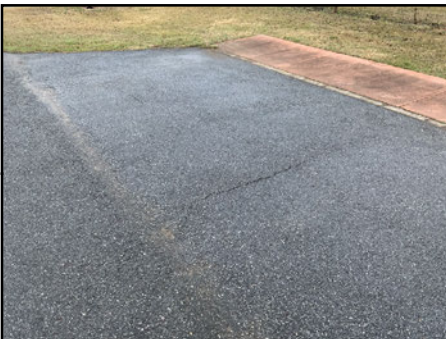
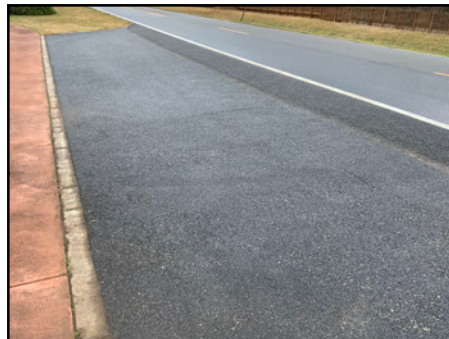
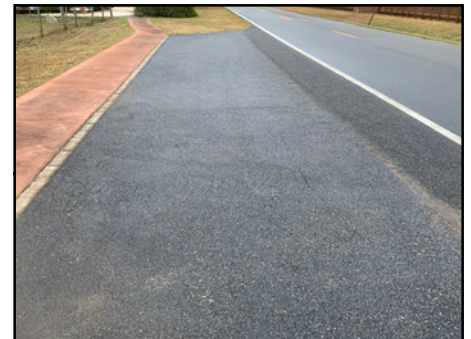
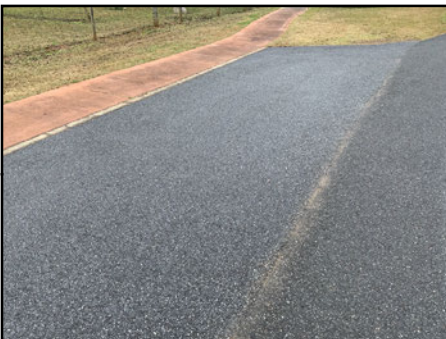
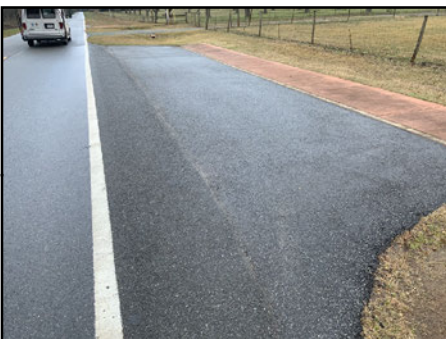
## ROUTE 0904: HANDICAP PARKING

Inspection Date	FMSS Number	User Access	Surface Type
2/6/2021	80331	PUBLIC	ASPHALT
Area (Sq. Ft.)	Lane Miles (11' Widths)	Curb Reveal (Inches)	Curb Recommendation
799	0.014	0	LIGHT REPAIR
Curb Type		Curb & Gutter Type	
CONCRETE		NO CURB AND GUTTER	
Pavement Recommendation		Condition Rating / PCR	
DO NOTHING		EXCELLENT / 97

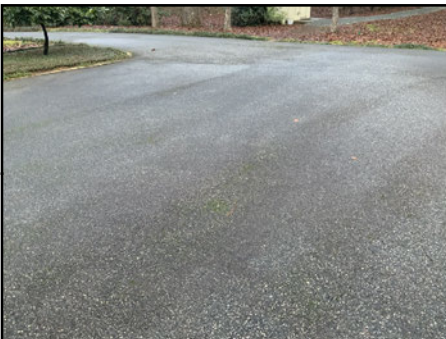
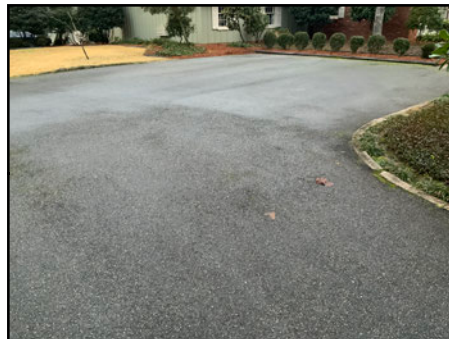
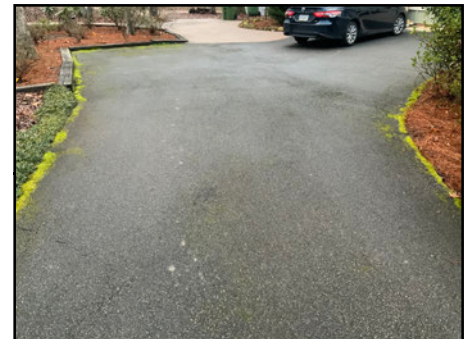
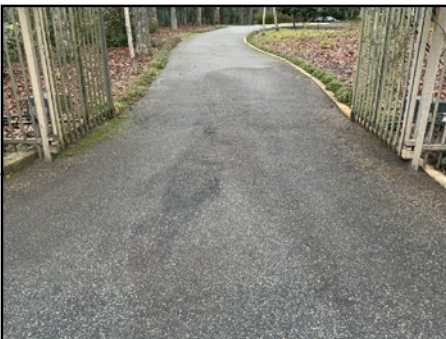
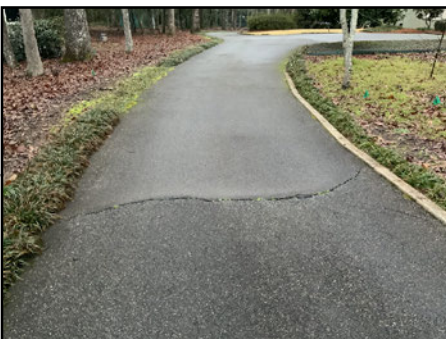
## ROUTE 0905: CARTER RESIDENCE PARKING

Inspection Date	FMSS Number	User Access	Surface Type
2/6/2021	80332	NONPUBLIC	ASPHALT
Area (Sq. Ft.)	Lane Miles (11' Widths)	Curb Reveal (Inches)	Curb Recommendation
4,208	0.072	2	DO NOTHING
Curb Type		Curb & Gutter Type	
CONCRETE AND WOOD		NO CURB AND GUTTER	
Pavement Recommendation		Condition Rating / PCR	
PREVENTIVE MAINTENANCE		GOOD / 90

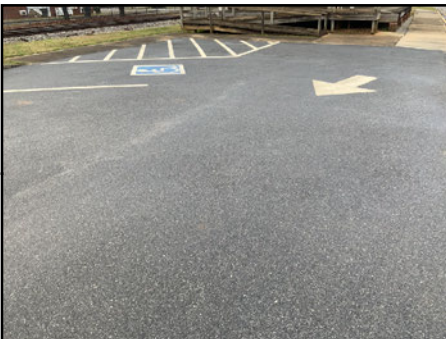
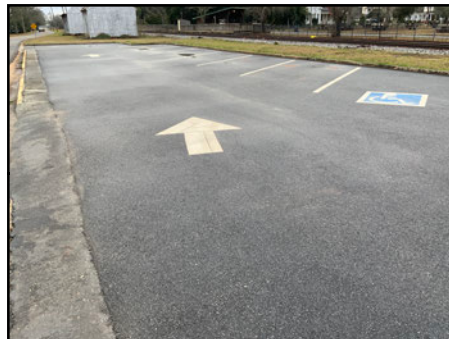
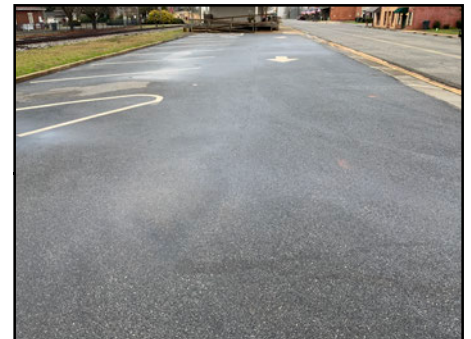
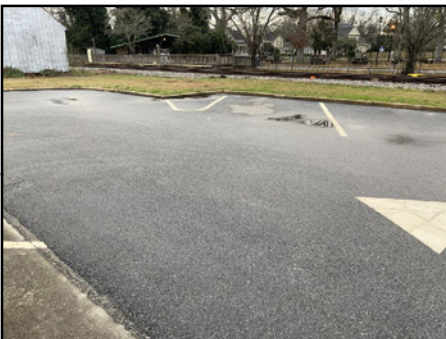
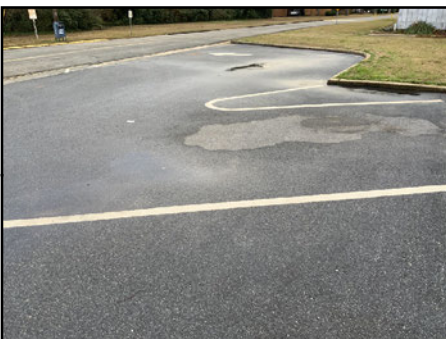
## ROUTE 0906: PLAINS DEPOT PARKING

Inspection Date	FMSS Number	User Access	Surface Type
2/6/2021	89444	PUBLIC	ASPHALT
Area (Sq. Ft.)	Lane Miles (11' Widths)	Curb Reveal (Inches)	Curb Recommendation
4,788	0.082	4	LIGHT REPAIR
Curb Type		Curb & Gutter Type	
CONCRETE		NO CURB AND GUTTER	
Pavement Recommendation		Condition Rating / PCR	
PREVENTIVE MAINTENANCE		GOOD / 90
