KAHO Cycle 6

Final Report

Road Inventory and Condition Assessment of Paved Routes Kaloko-Honokohau National Historical Park

Report Date: July 2022

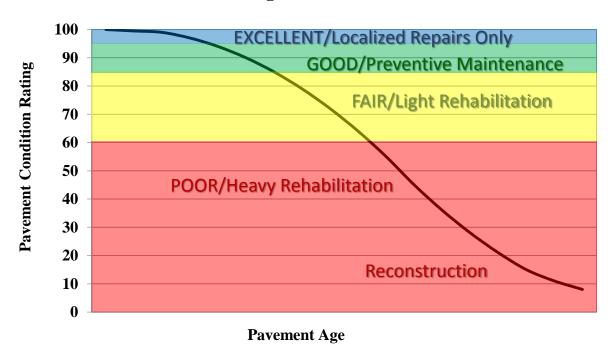
Condition Categories and Treatments

- Excellent/New: PCR of 95-100. Pavements in this range will require only spot repairs
- Good: PCR of 85-94. Pavements in this range will likely be candidates for preventive maintenance. Examples include Chip and Slurry Seals, Micro Surfacing and Thin Overlays.
- Fair: PCR of 61-84. Pavements in this range will likely be candidates of Light Rehabilitation (L3R). Examples include single-lift overlays up to 2.5 inches in total thickness, milling and overlays.
- Poor: PCR of 60 or below. Pavements in this range will likely be candidates of Heavy Rehabilitation or Reconstruction (H3R or 4R). Examples include Pulverization, Multiple Lift Overlays, and Reconstruction.
