# KATM Cycle 6

## Final Report

### Road Inventory and Condition Assessments for Katmai National Park & Preserve

**Federal Highway Administration  
Eastern Federal Lands Highway Division  
Road Inventory Program (RIP)**

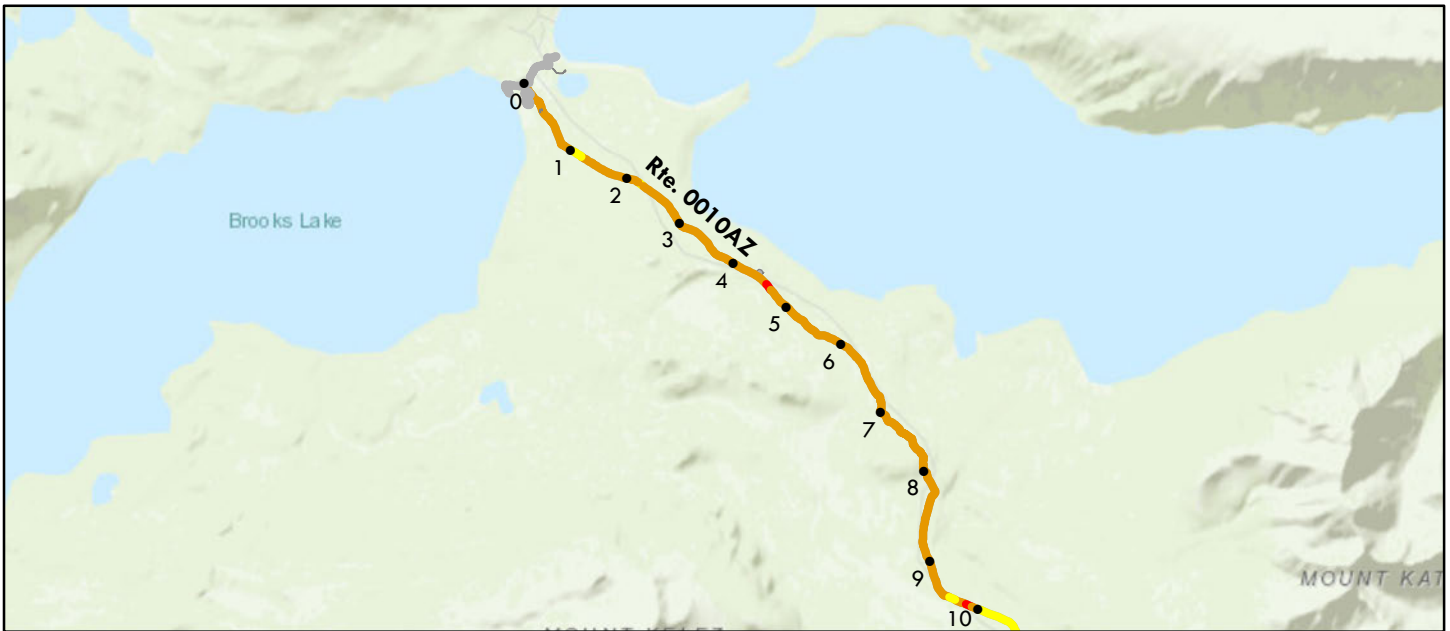
Route Condition Legend					
Poor (1)	Poor (2)	Fair (3)	Good (4)	Excellent (5)	Not Rated
See Appendix for definitions and formulas					
Inspection Date: 6/26/2019		Unpaved Length (Miles): 22.3		Surface Type: GRAVEL

Begin MP	End MP	Section Length	# of Lanes	Lane Width	Road Width	Treatment Recommendation	Treatment Cost	Unpaved Rating (Paser +)	Crown Severity	Drainage Severity	Rutting, Washboard Severity	Potholes / Loose Aggregate Severity

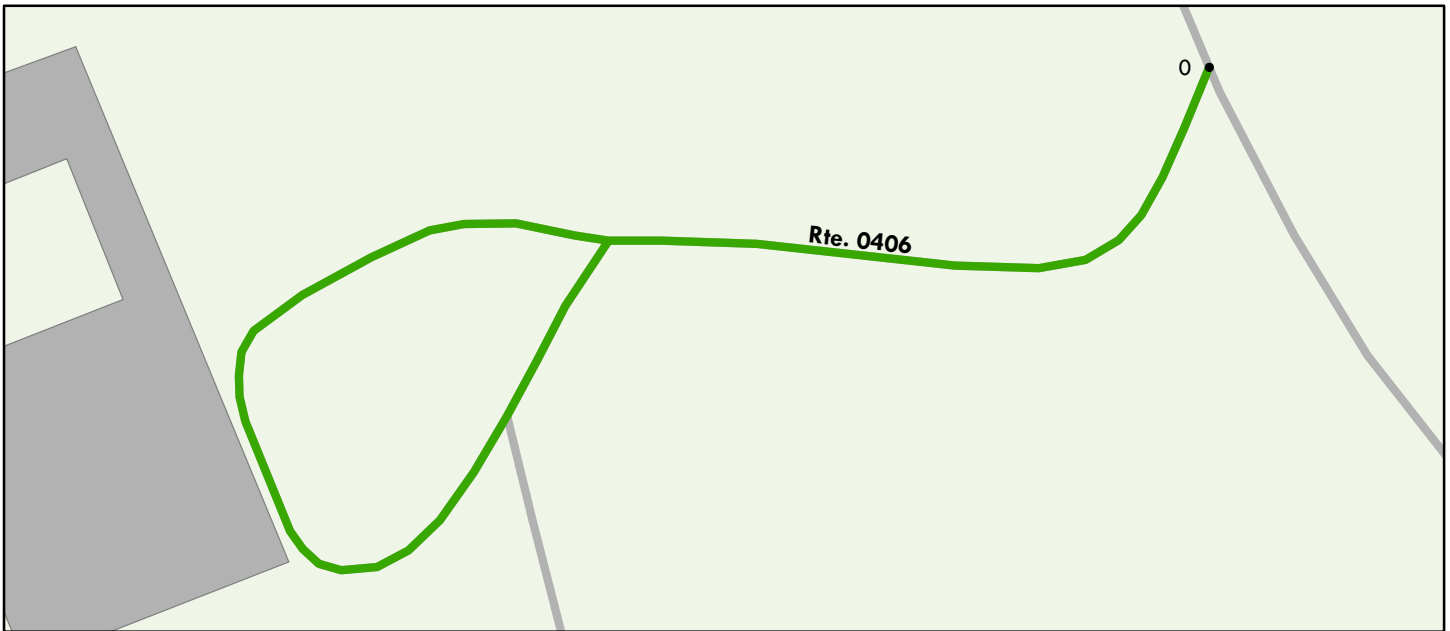
### Condition Summary Table for KATM-0406

Route Condition Legend					
Poor (1)	Poor (2)	Fair (3)	Good (4)	Excellent (5)	Not Rated
See Appendix for definitions and formulas					
Inspection Date: 6/25/2019		Unpaved Length (Miles): 0.13		Surface Type: GRAVEL

Begin MP	End MP	Section Length	# of Lanes	Lane Width	Road Width	Treatment Recommendation	Treatment Cost	Unpaved Rating (Paser +)	Crown Severity	Drainage Severity	Rutting, Washboard Severity	Potholes / Loose Aggregate Severity
0.00	0.13	0.13	1	13.0	13.0	Routine Maintenance	\$1,270	4	Low	Med	Low	Med
<b>Route Level Data:</b>		0.13	1	13.0	13.0	Routine Maintenance	\$1,270	4	Low	Med	Low	Med

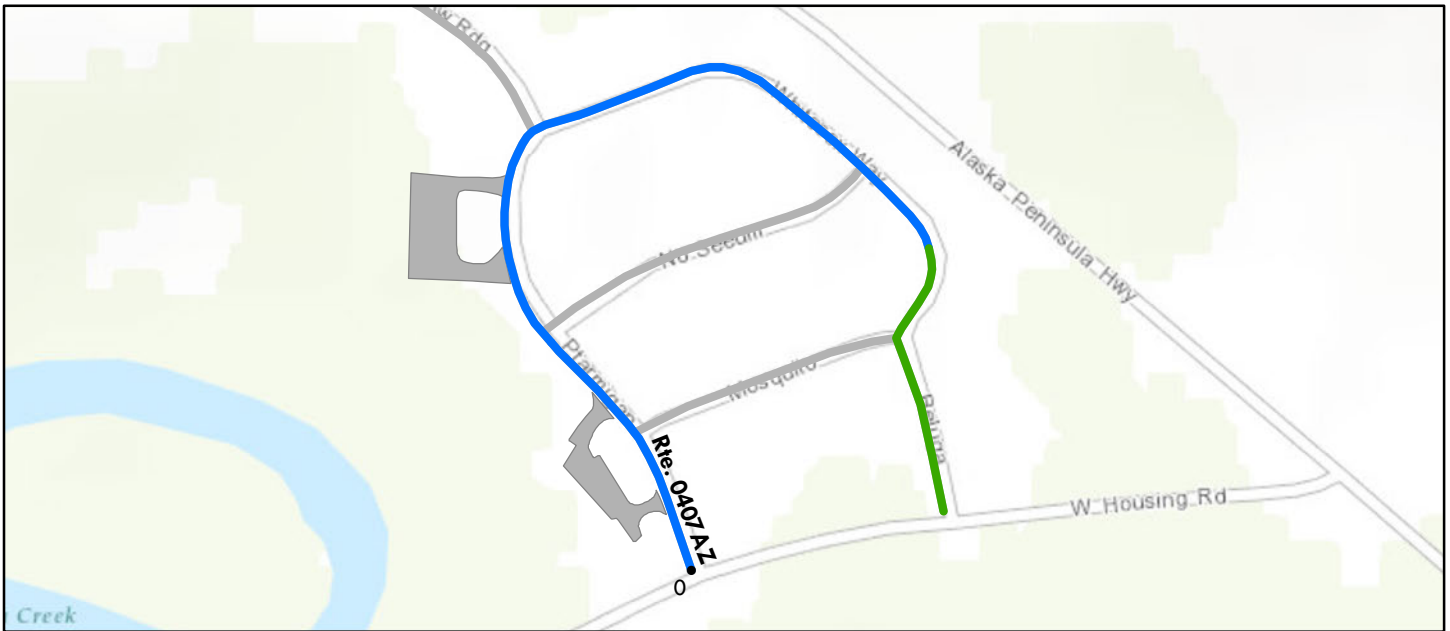
### Condition Summary Table for KATM-0407AZ

Begin MP	End MP	Section Length	# of Lanes	Lane Width	Road Width	Treatment Recommendation	Treatment Cost	Unpaved Rating (Paser +)	Crown Severity	Drainage Severity	Rutting, Washboard Severity	Potholes / Loose Aggregate Severity
0.00	0.49	0.49	2	10.0	20.0	Limited Local Maintenance	\$0	5	Low	Low	Low	Med
<b>Route Level Data:</b>		0.49	2	10.0	20.0	Limited Local Maintenance	\$0	5	Low	Low	Low	Med

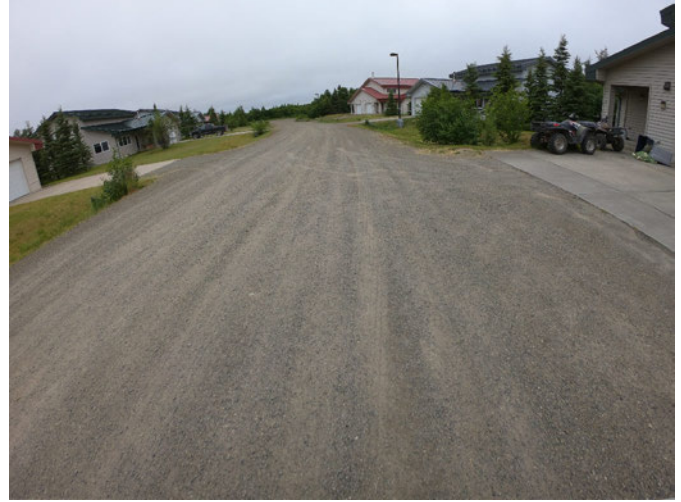
KATM\_0407DZ\_0.041

Begin MP	End MP	Section Length	# of Lanes	Lane Width	Road Width	Treatment Recommendation	Treatment Cost	Unpaved Rating (Paser +)	Crown Severity	Drainage Severity	Rutting, Washboard Severity	Potholes / Loose Aggregate Severity
0.00	0.14	0.14	2	8.0	16.0	Routine Maintenance	\$1,410	4	Med	Low	Low	Med
<b>Route Level Data:</b>		0.14	2	8.0	16.0	Routine Maintenance	\$1,410	4	Med	Low	Low	Med

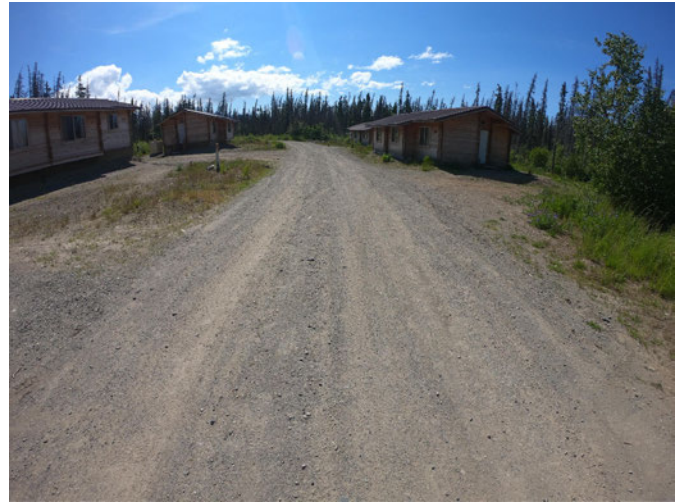
KATM\_0408\_0.108

Begin MP	End MP	Section Length	# of Lanes	Lane Width	Road Width	Treatment Recommendation	Treatment Cost	Unpaved Rating (Paser +)	Crown Severity	Drainage Severity	Rutting, Washboard Severity	Potholes / Loose Aggregate Severity
0.00	0.40	0.40	1	13.0	13.0	Routine Maintenance	\$4,030	4	Low	Med	Med	Med
<b>Route Level Data:</b>		0.40	1	13.0	13.0	Routine Maintenance	\$4,030	4	Low	Med	Med	Med

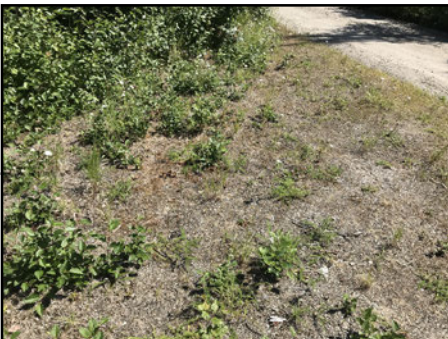
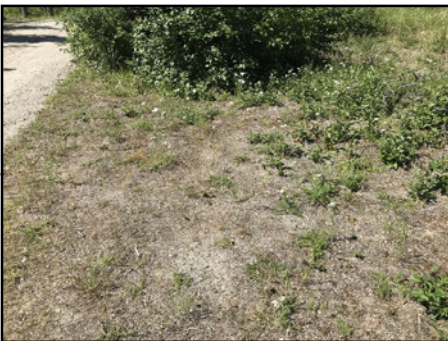
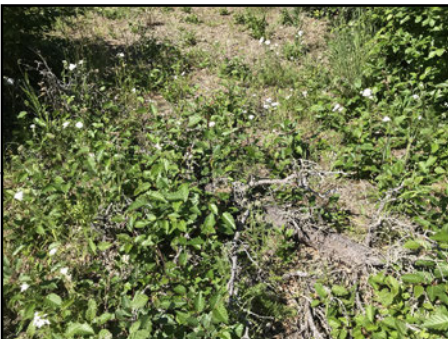
## ROUTE 0901: BC - CONCESSION PARKING

Inspection Date	FMSS Number	User Access	Surface Type
6/25/2019	39543	NONPUBLIC	GRAVEL
Area (Sq. Ft.)	Lane Miles (11' Widths)	Curb Reveal (Inches)	Curb Recommendation
580	0.01	NOT APPLICABLE	NOT APPLICABLE
Curb Type		Curb & Gutter Type	
NO CURB		NO CURB AND GUTTER	
Treatment Recommendation		Condition Rating	
HEAVY REHABILITATION		2

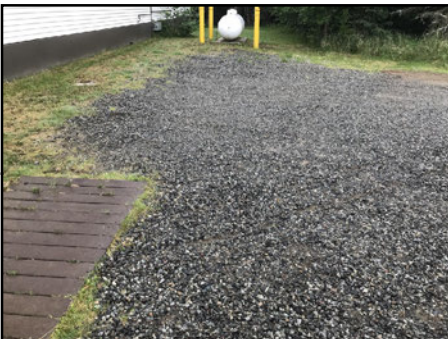
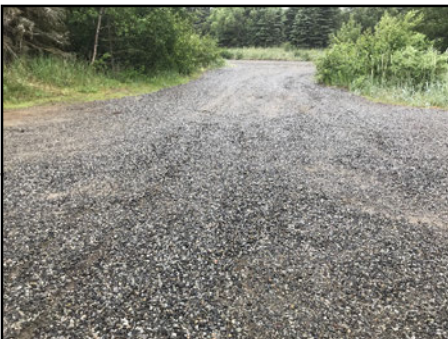
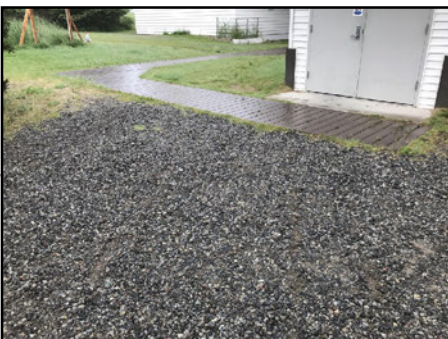
ROUTE 0902AZ: KS - RESIDENCE PARKING A

Inspection Date	FMSS Number	User Access	Surface Type
6/24/2019	39544	NONPUBLIC	GRAVEL
Area (Sq. Ft.)	Lane Miles (11' Widths)	Curb Reveal (Inches)	Curb Recommendation
3,352	0.058	NOT APPLICABLE	NOT APPLICABLE
Curb Type		Curb & Gutter Type	
NO CURB		NO CURB AND GUTTER	
Treatment Recommendation		Condition Rating	
ROUTINE MAINTENANCE		4

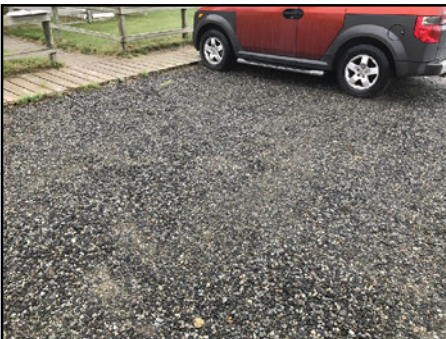
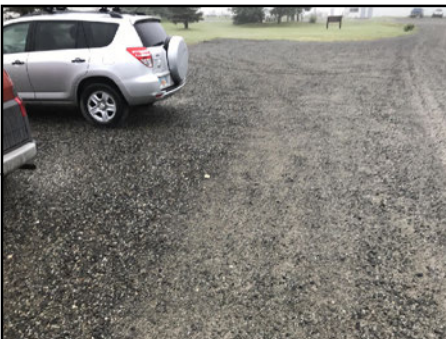
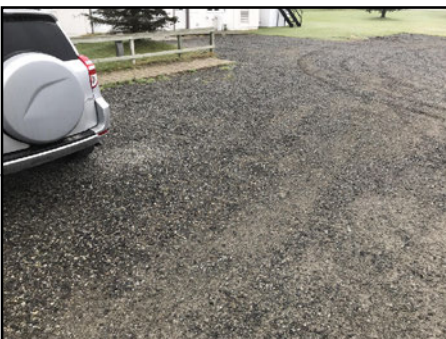
## ROUTE 0902BZ: KS - RESIDENCE PARKING B

Inspection Date	FMSS Number	User Access	Surface Type
6/24/2019	39544	NONPUBLIC	GRAVEL
Area (Sq. Ft.)	Lane Miles (11' Widths)	Curb Reveal (Inches)	Curb Recommendation
4,559	0.078	NOT APPLICABLE	NOT APPLICABLE
Curb Type		Curb & Gutter Type	
NO CURB		NO CURB AND GUTTER	
Treatment Recommendation		Condition Rating	
ROUTINE MAINTENANCE		4

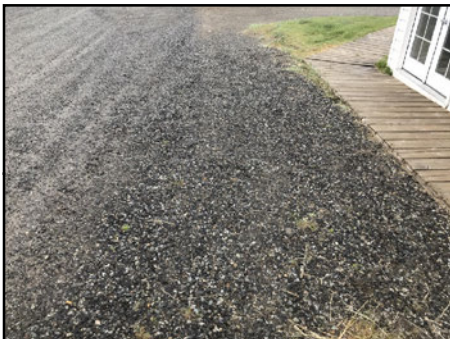
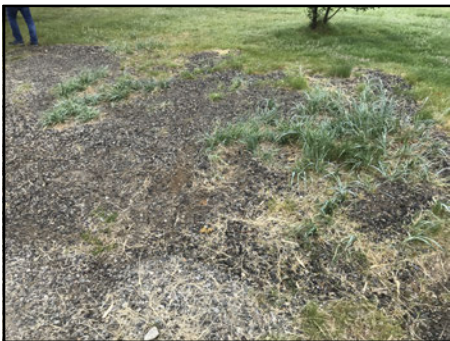
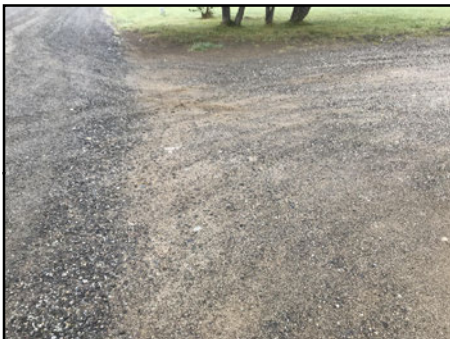
## ROUTE 0902CZ: KS - RESIDENCE PARKING C

Inspection Date	FMSS Number	User Access	Surface Type
6/24/2019	39544	NONPUBLIC	GRAVEL
Area (Sq. Ft.)	Lane Miles (11' Widths)	Curb Reveal (Inches)	Curb Recommendation
2,276	0.039	NOT APPLICABLE	NOT APPLICABLE
Curb Type		Curb & Gutter Type	
NO CURB		NO CURB AND GUTTER	
Treatment Recommendation		Condition Rating	
HEAVY REHABILITATION		2

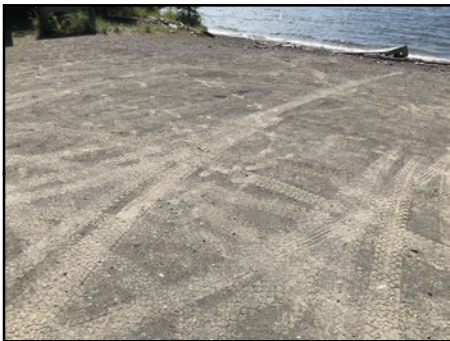
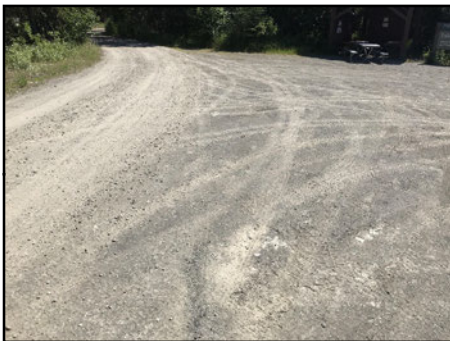
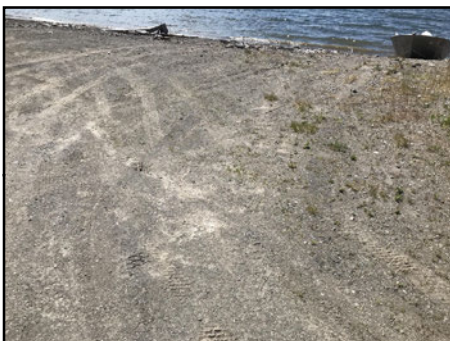
## ROUTE 0903: BC - BROOKS LAKE FLOAT PLANE GATHERING AREA

Inspection Date	FMSS Number	User Access	Surface Type
6/25/2019	39545	PUBLIC	GRAVEL
Area (Sq. Ft.)	Lane Miles (11' Widths)	Curb Reveal (Inches)	Curb Recommendation
2,829	0.049	NOT APPLICABLE	NOT APPLICABLE
Curb Type		Curb & Gutter Type	
NO CURB		NO CURB AND GUTTER	
Treatment Recommendation		Condition Rating	
ROUTINE MAINTENANCE		4

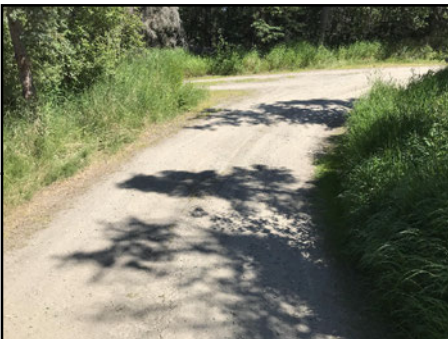
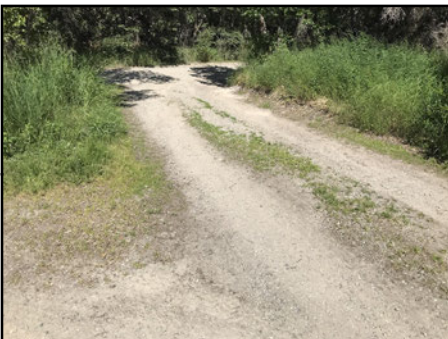
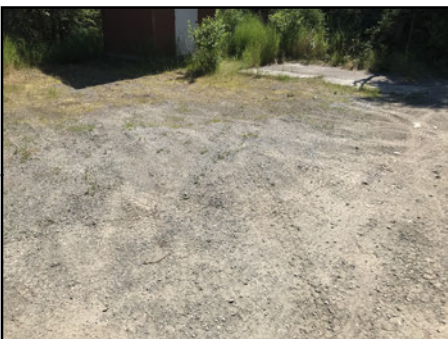
## ROUTE 0905: BC - BROOKS FALLS TRAIL PARKING

Inspection Date	FMSS Number	User Access	Surface Type
6/25/2019	39547	NONPUBLIC	GRAVEL
Area (Sq. Ft.)	Lane Miles (11' Widths)	Curb Reveal (Inches)	Curb Recommendation
6,730	0.116	NOT APPLICABLE	NOT APPLICABLE
Curb Type		Curb & Gutter Type	
NO CURB		NO CURB AND GUTTER	
Treatment Recommendation		Condition Rating	
HEAVY REHABILITATION		2

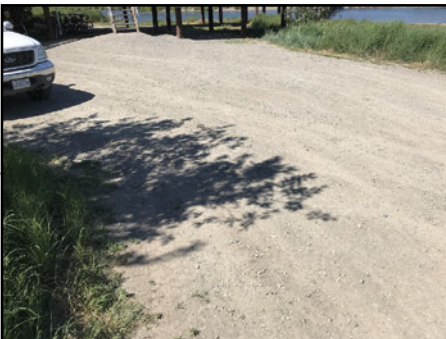
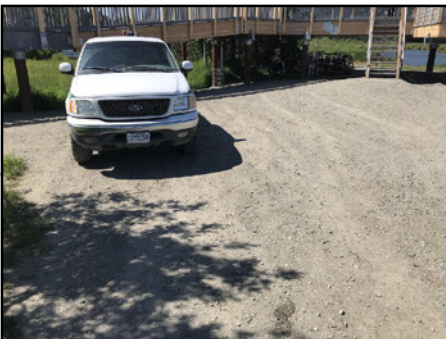
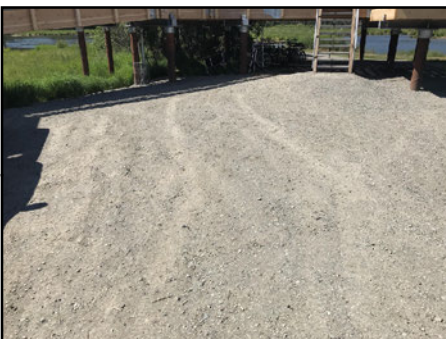
## ROUTE 0906: BC - LOWER PLATFORM PARKING AND TURNAROUND

Inspection Date	FMSS Number	User Access	Surface Type
6/25/2019	39548	PUBLIC	GRAVEL
Area (Sq. Ft.)	Lane Miles (11' Widths)	Curb Reveal (Inches)	Curb Recommendation
3,168	0.055	NOT APPLICABLE	NOT APPLICABLE
Curb Type		Curb & Gutter Type	
NO CURB		NO CURB AND GUTTER	
Treatment Recommendation		Condition Rating	
ROUTINE MAINTENANCE		4

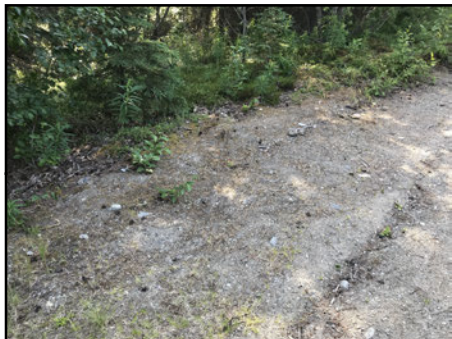
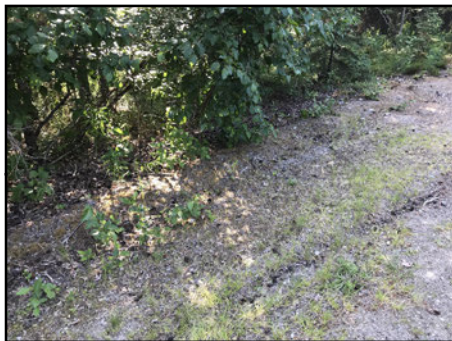
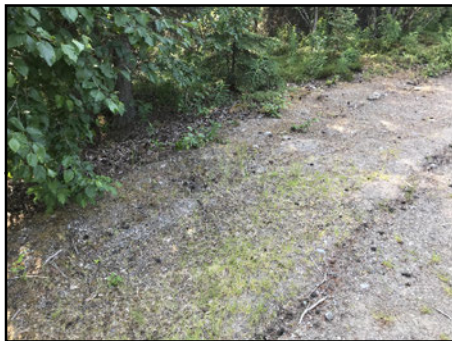
## ROUTE 0907: BC - RESEARCH BAY OVERLOOK PARKING

Inspection Date	FMSS Number	User Access	Surface Type
6/25/2019	95832	PUBLIC	GRAVEL
Area (Sq. Ft.)	Lane Miles (11' Widths)	Curb Reveal (Inches)	Curb Recommendation
364	0.006	NOT APPLICABLE	NOT APPLICABLE
Curb Type		Curb & Gutter Type	
NO CURB		NO CURB AND GUTTER	
Treatment Recommendation		Condition Rating	
HEAVY REHABILITATION		2

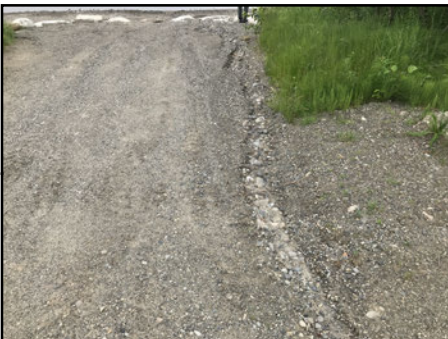
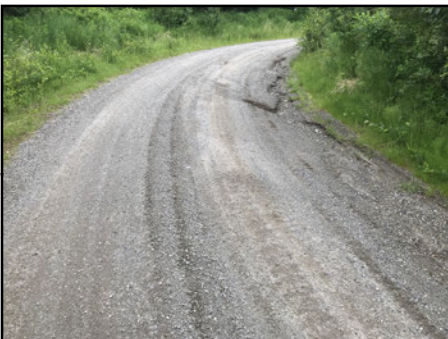
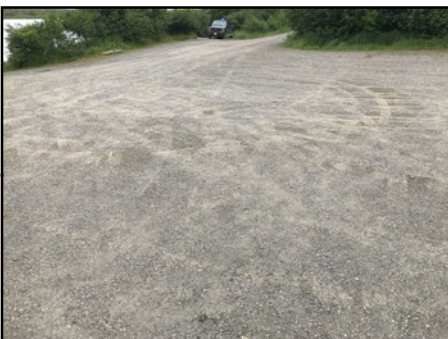
Inspection Date	FMSS Number	User Access	Surface Type
6/24/2019	91353	PUBLIC	GRAVEL
Area (Sq. Ft.)	Lane Miles (11' Widths)	Curb Reveal (Inches)	Curb Recommendation
57,509	0.99	NOT APPLICABLE	NOT APPLICABLE
Curb Type		Curb & Gutter Type	
NO CURB		NO CURB AND GUTTER	
Treatment Recommendation		Condition Rating	
HEAVY REHABILITATION		2

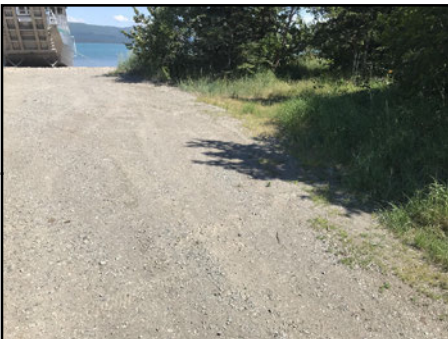
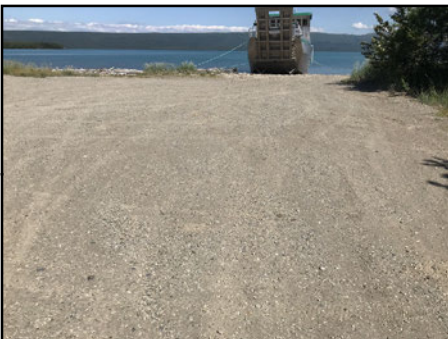
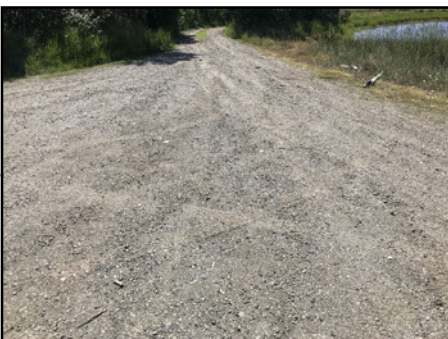
Inspection Date	FMSS Number	User Access	Surface Type
6/25/2019	236392	NONPUBLIC	GRAVEL
Area (Sq. Ft.)	Lane Miles (11' Widths)	Curb Reveal (Inches)	Curb Recommendation
16,029	0.276	NOT APPLICABLE	NOT APPLICABLE
Curb Type		Curb & Gutter Type	
NO CURB		NO CURB AND GUTTER	
Treatment Recommendation		Condition Rating	
ROUTINE MAINTENANCE		4

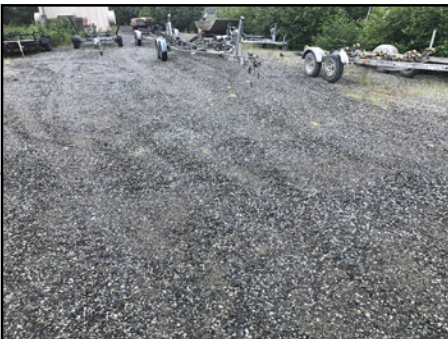
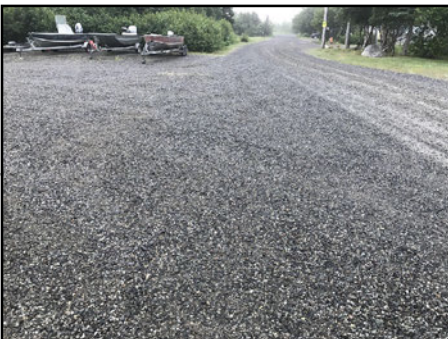
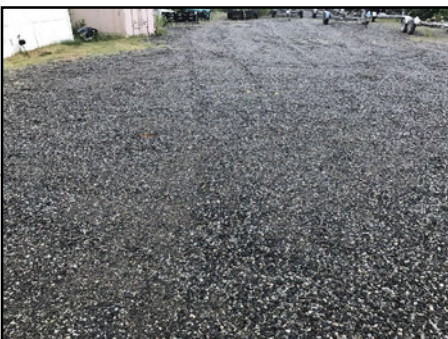
Inspection Date	FMSS Number	User Access	Surface Type
6/24/2019	108366	NONPUBLIC	GRAVEL
Area (Sq. Ft.)	Lane Miles (11' Widths)	Curb Reveal (Inches)	Curb Recommendation
15,050	0.259	NOT APPLICABLE	NOT APPLICABLE
Curb Type		Curb & Gutter Type	
NO CURB		NO CURB AND GUTTER	
Treatment Recommendation		Condition Rating	
ROUTINE MAINTENANCE		4

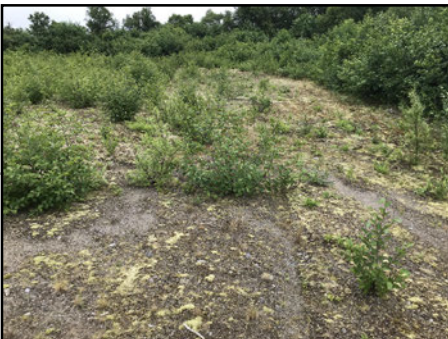
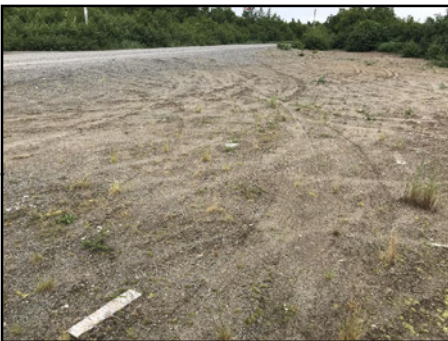
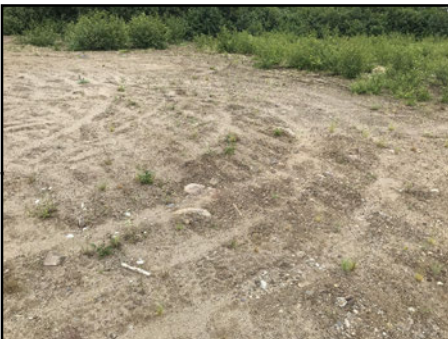
Inspection Date	FMSS Number	User Access	Surface Type
6/24/2019	86507	PUBLIC	GRAVEL
Area (Sq. Ft.)	Lane Miles (11' Widths)	Curb Reveal (Inches)	Curb Recommendation
21,528	0.371	NOT APPLICABLE	NOT APPLICABLE
Curb Type		Curb & Gutter Type	
NO CURB		NO CURB AND GUTTER	
Treatment Recommendation		Condition Rating	
RECONSTRUCTION		1

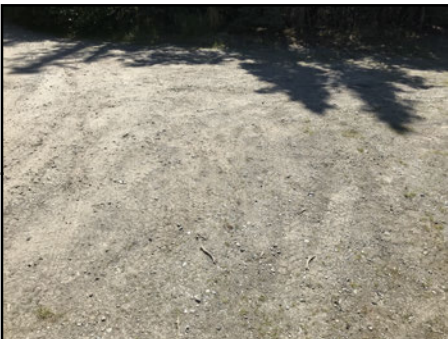
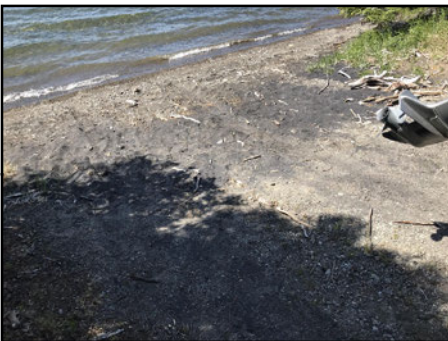
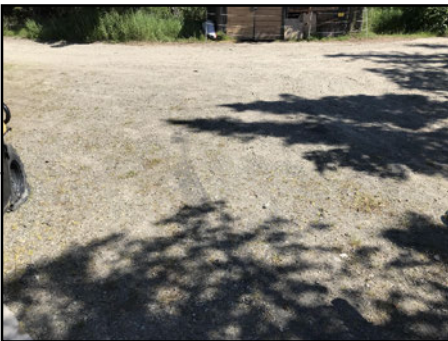
Inspection Date	FMSS Number	User Access	Surface Type
6/25/2019	39546	PUBLIC	GRAVEL
Area (Sq. Ft.)	Lane Miles (11' Widths)	Curb Reveal (Inches)	Curb Recommendation
3,191	0.055	NOT APPLICABLE	NOT APPLICABLE
Curb Type		Curb & Gutter Type	
NO CURB		NO CURB AND GUTTER	
Treatment Recommendation		Condition Rating	
HEAVY REHABILITATION		2

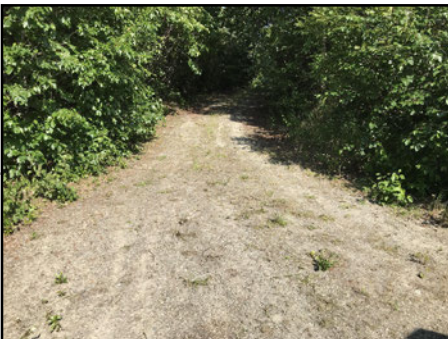
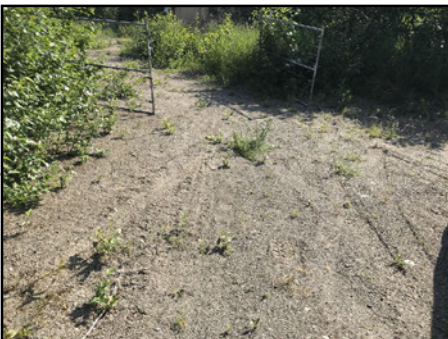
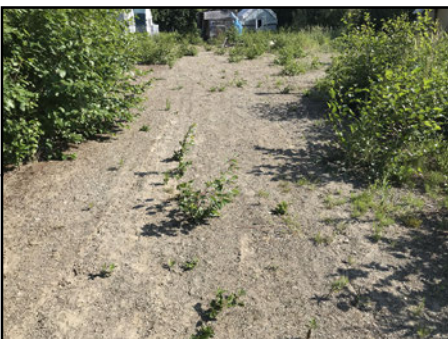
Inspection Date	FMSS Number	User Access	Surface Type
6/25/2019	95831	PUBLIC	GRAVEL
Area (Sq. Ft.)	Lane Miles (11' Widths)	Curb Reveal (Inches)	Curb Recommendation
13,849	0.238	NOT APPLICABLE	NOT APPLICABLE
Curb Type		Curb & Gutter Type	
NO CURB		NO CURB AND GUTTER	
Treatment Recommendation		Condition Rating	
HEAVY REHABILITATION		2

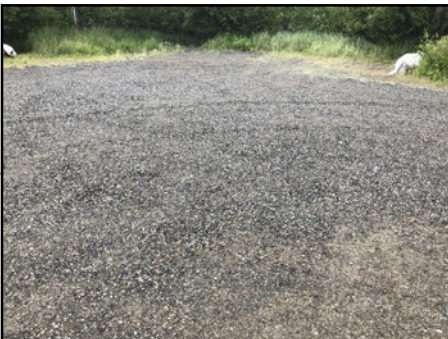
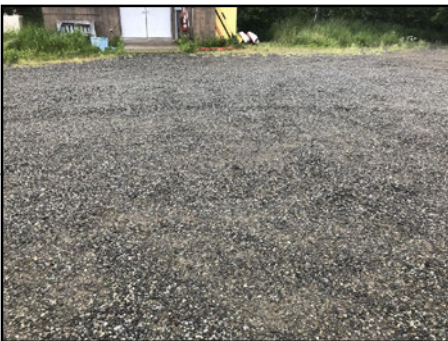
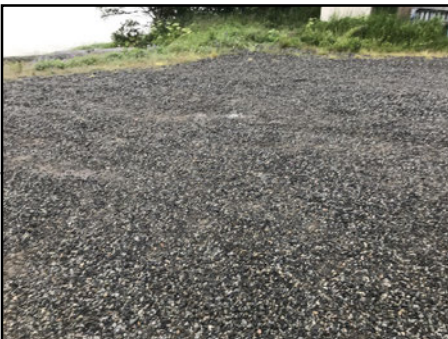
Inspection Date	FMSS Number	User Access	Surface Type
6/24/2019	N/A	PUBLIC	GRAVEL
Area (Sq. Ft.)	Lane Miles (11' Widths)	Curb Reveal (Inches)	Curb Recommendation
4,178	0.072	NOT APPLICABLE	NOT APPLICABLE
Curb Type		Curb & Gutter Type	
NO CURB		NO CURB AND GUTTER	
Treatment Recommendation		Condition Rating	
ROUTINE MAINTENANCE		4

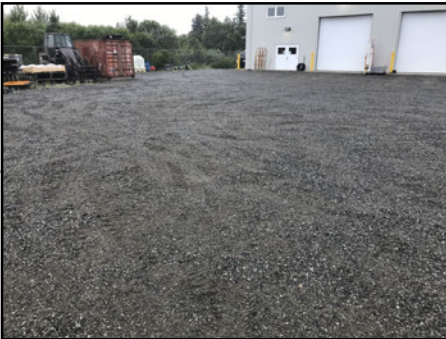
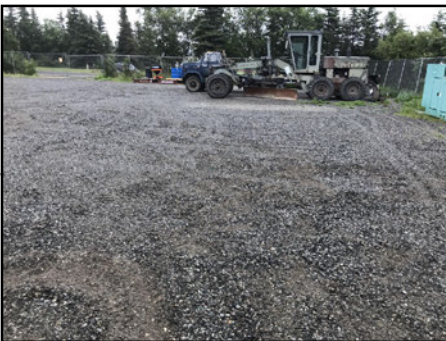
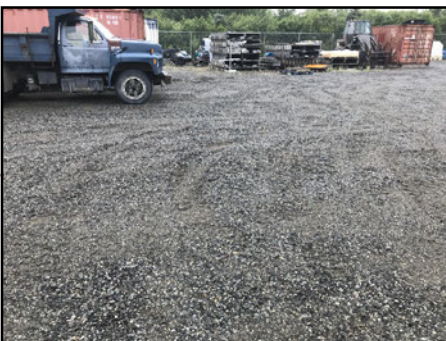
Inspection Date	FMSS Number	User Access	Surface Type
6/24/2019	N/A	NONPUBLIC	GRAVEL
Area (Sq. Ft.)	Lane Miles (11' Widths)	Curb Reveal (Inches)	Curb Recommendation
44,171	0.761	NOT APPLICABLE	NOT APPLICABLE
Curb Type		Curb & Gutter Type	
NO CURB		NO CURB AND GUTTER	
Treatment Recommendation		Condition Rating	
ROUTINE MAINTENANCE		4

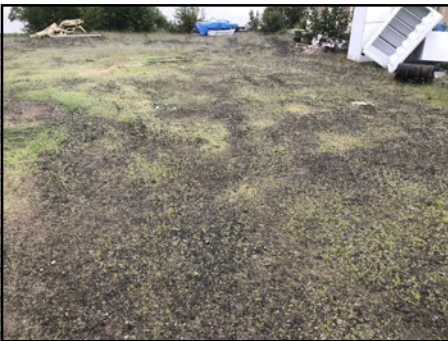
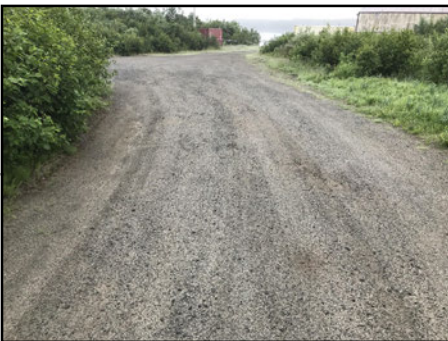
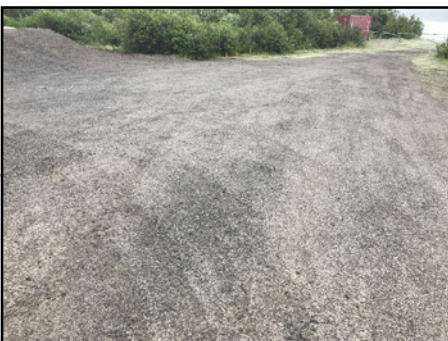
Inspection Date	FMSS Number	User Access	Surface Type
6/24/2019	N/A	NONPUBLIC	GRAVEL
Area (Sq. Ft.)	Lane Miles (11' Widths)	Curb Reveal (Inches)	Curb Recommendation
9,424	0.162	NOT APPLICABLE	NOT APPLICABLE
Curb Type		Curb & Gutter Type	
NO CURB		NO CURB AND GUTTER	
Treatment Recommendation		Condition Rating	
ROUTINE MAINTENANCE		4

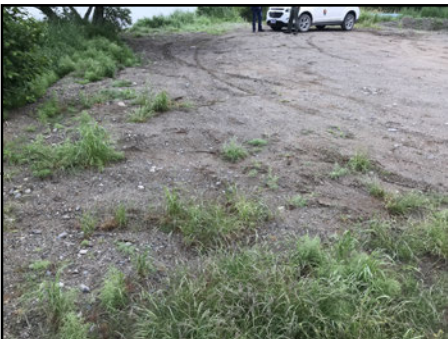
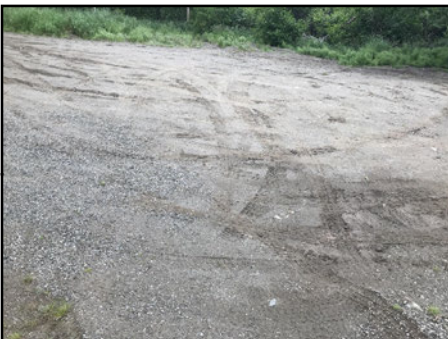
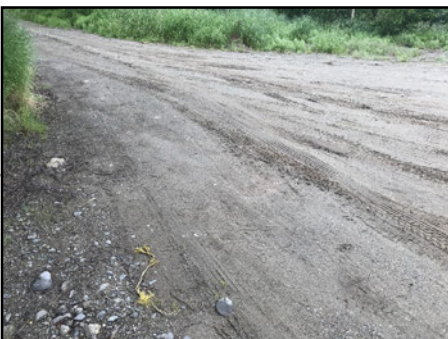
Inspection Date	FMSS Number	User Access	Surface Type
6/24/2019	N/A	PUBLIC	GRAVEL
Area (Sq. Ft.)	Lane Miles (11' Widths)	Curb Reveal (Inches)	Curb Recommendation
2,956	0.051	NOT APPLICABLE	NOT APPLICABLE
Curb Type		Curb & Gutter Type	
NO CURB		NO CURB AND GUTTER	
Treatment Recommendation		Condition Rating	
HEAVY REHABILITATION		2

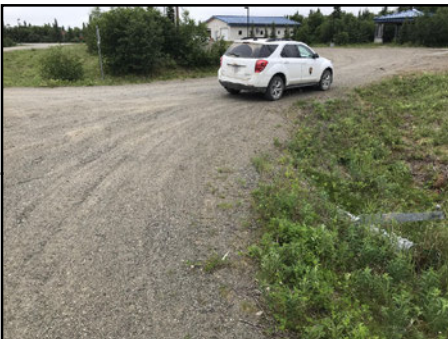
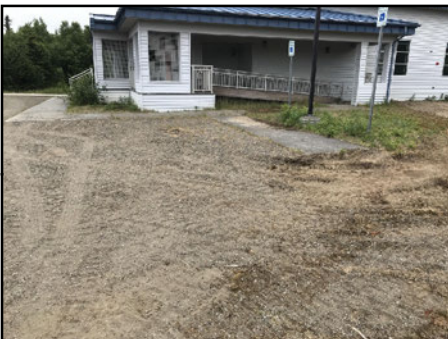
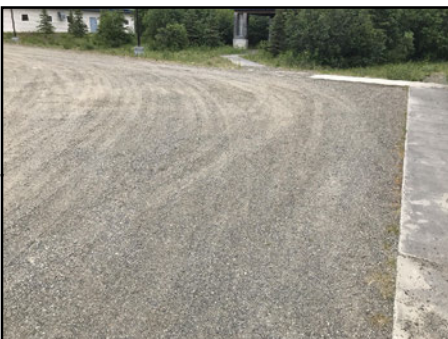
Inspection Date	FMSS Number	User Access	Surface Type
6/24/2019	N/A	PUBLIC	GRAVEL
Area (Sq. Ft.)	Lane Miles (11' Widths)	Curb Reveal (Inches)	Curb Recommendation
16,542	0.285	NOT APPLICABLE	NOT APPLICABLE
Curb Type		Curb & Gutter Type	
NO CURB		NO CURB AND GUTTER	
Treatment Recommendation		Condition Rating	
ROUTINE MAINTENANCE		4

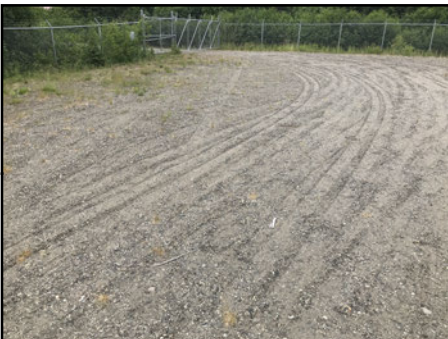
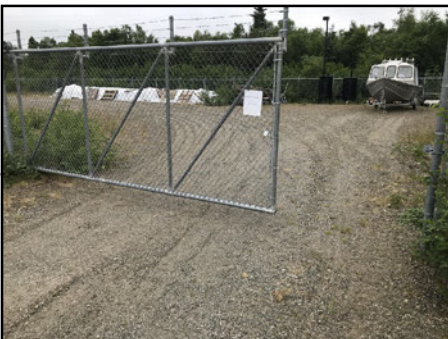
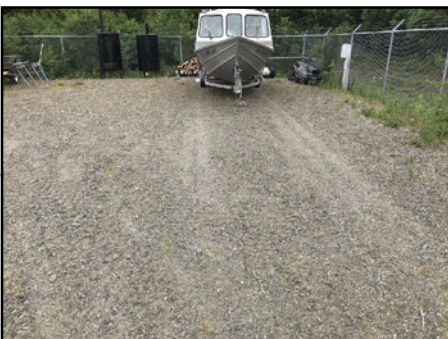
Inspection Date	FMSS Number	User Access	Surface Type
6/24/2019	N/A	PUBLIC	GRAVEL
Area (Sq. Ft.)	Lane Miles (11' Widths)	Curb Reveal (Inches)	Curb Recommendation
28,232	0.486	NOT APPLICABLE	NOT APPLICABLE
Curb Type		Curb & Gutter Type	
NO CURB		NO CURB AND GUTTER	
Treatment Recommendation		Condition Rating	
LIGHT REHABILITATION		3

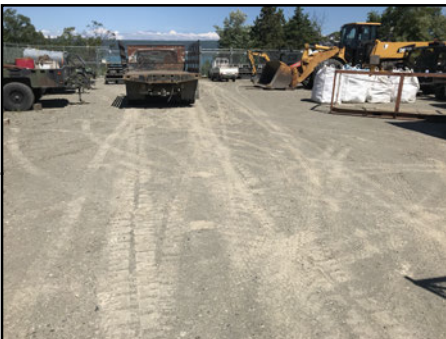
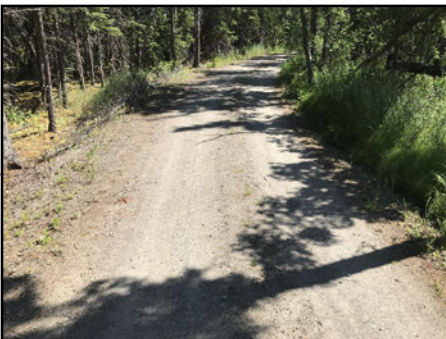
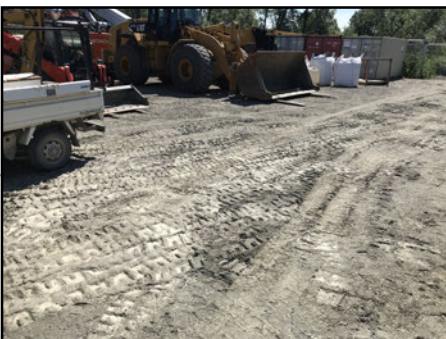
Inspection Date	FMSS Number	User Access	Surface Type
6/25/2019	N/A	NONPUBLIC	GRAVEL
Area (Sq. Ft.)	Lane Miles (11' Widths)	Curb Reveal (Inches)	Curb Recommendation
40,863	0.704	NOT APPLICABLE	NOT APPLICABLE
Curb Type		Curb & Gutter Type	
NO CURB		NO CURB AND GUTTER	
Treatment Recommendation		Condition Rating	
LIGHT REHABILITATION		3

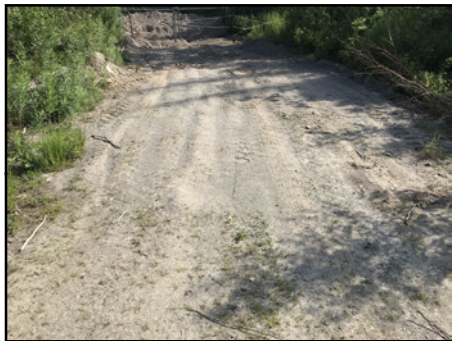
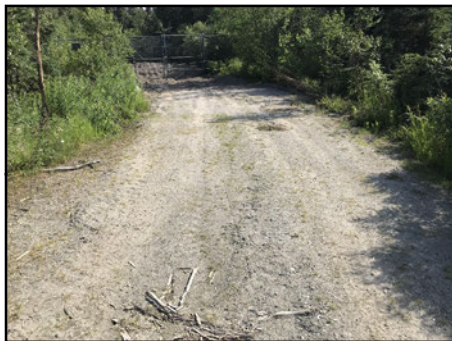
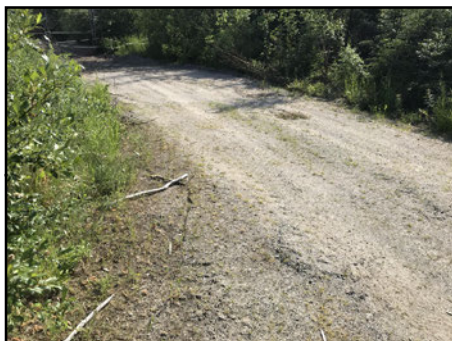
## ROUTE 0924: BC - ONE MILE SEPTAGE PIT PARKING

Inspection Date	FMSS Number	User Access	Surface Type
6/25/2019	N/A	NONPUBLIC	GRAVEL
Area (Sq. Ft.)	Lane Miles (11' Widths)	Curb Reveal (Inches)	Curb Recommendation
1,947	0.034	NOT APPLICABLE	NOT APPLICABLE
Curb Type		Curb & Gutter Type	
NO CURB		NO CURB AND GUTTER	
Treatment Recommendation		Condition Rating	
HEAVY REHABILITATION		2

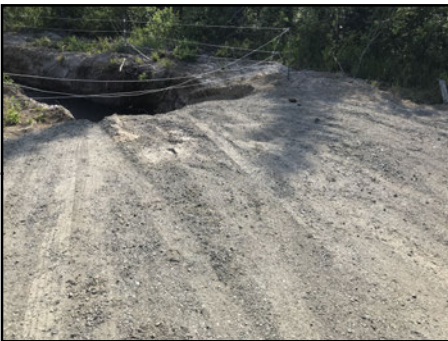
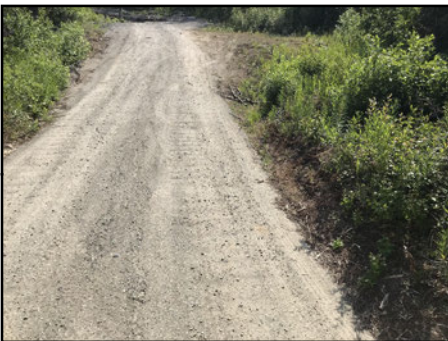
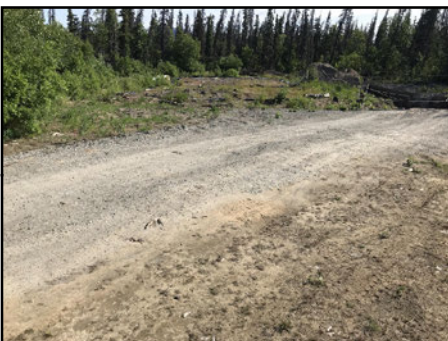
## ROUTE 0925: BC - TWO MILE PIT PARKING

Inspection Date	FMSS Number	User Access	Surface Type
6/25/2019	N/A	NONPUBLIC	GRAVEL
Area (Sq. Ft.)	Lane Miles (11' Widths)	Curb Reveal (Inches)	Curb Recommendation
5,761	0.099	NOT APPLICABLE	NOT APPLICABLE
Curb Type		Curb & Gutter Type	
NO CURB		NO CURB AND GUTTER	
Treatment Recommendation		Condition Rating	
HEAVY REHABILITATION		2

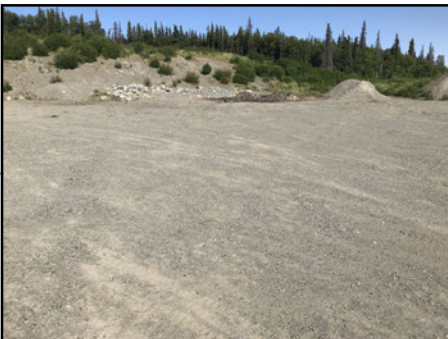
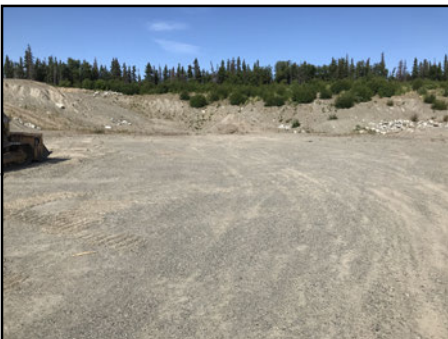
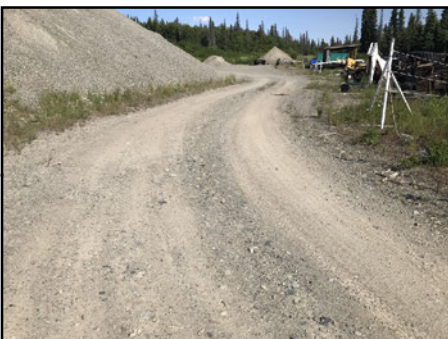
## ROUTE 0926: BC - FIVE MILE GRAVEL PIT PARKING

Inspection Date	FMSS Number	User Access	Surface Type
6/25/2019	N/A	NONPUBLIC	GRAVEL
Area (Sq. Ft.)	Lane Miles (11' Widths)	Curb Reveal (Inches)	Curb Recommendation
189,823	3.268	NOT APPLICABLE	NOT APPLICABLE
Curb Type		Curb & Gutter Type	
NO CURB		NO CURB AND GUTTER	
Treatment Recommendation		Condition Rating	
HEAVY REHABILITATION		2

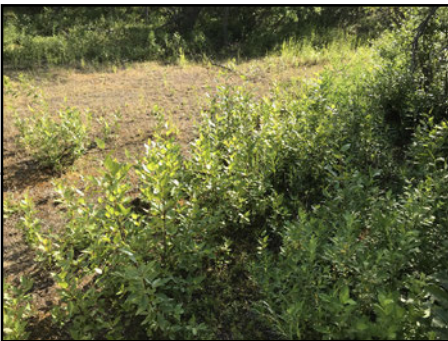
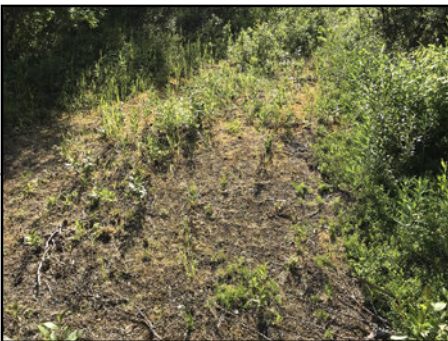
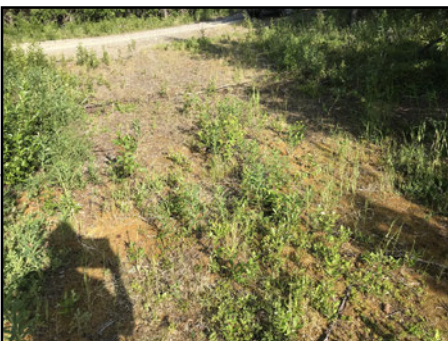
## ROUTE 0927: BC - MARGO FALLS PARKING

Inspection Date	FMSS Number	User Access	Surface Type
6/25/2019	N/A	NONPUBLIC	GRAVEL
Area (Sq. Ft.)	Lane Miles (11' Widths)	Curb Reveal (Inches)	Curb Recommendation
2,805	0.048	NOT APPLICABLE	NOT APPLICABLE
Curb Type		Curb & Gutter Type	
NO CURB		NO CURB AND GUTTER	
Treatment Recommendation		Condition Rating	
HEAVY REHABILITATION		2

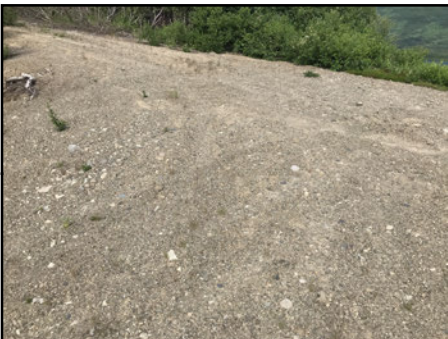
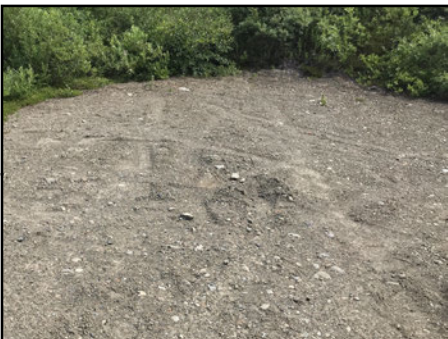
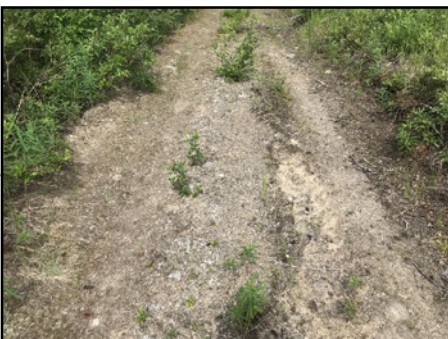
## ROUTE 0928: BC - AVO STAGING AREA PARKING

Inspection Date	FMSS Number	User Access	Surface Type
6/26/2019	N/A	NONPUBLIC	GRAVEL
Area (Sq. Ft.)	Lane Miles (11' Widths)	Curb Reveal (Inches)	Curb Recommendation
7,259	0.125	NOT APPLICABLE	NOT APPLICABLE
Curb Type		Curb & Gutter Type	
NO CURB		NO CURB AND GUTTER	
Treatment Recommendation		Condition Rating	
HEAVY REHABILITATION		2

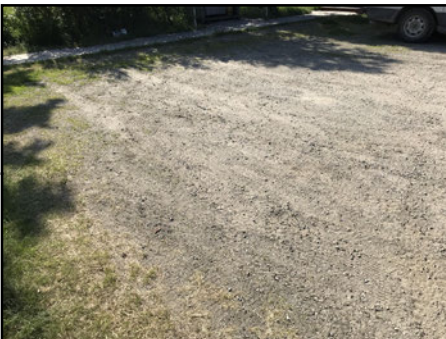
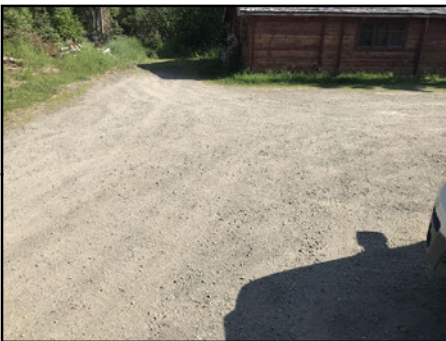
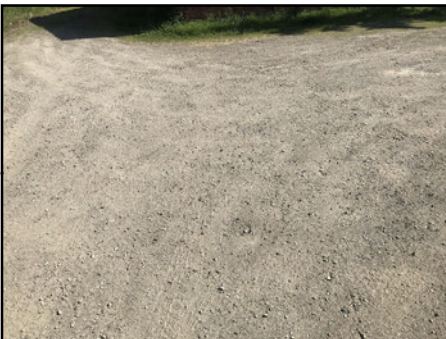
## ROUTE 0929: BC - BROOKS LAKE EMPLOYEE HOUSING PKG

Inspection Date	FMSS Number	User Access	Surface Type
6/25/2019	N/A	NONPUBLIC	GRAVEL
Area (Sq. Ft.)	Lane Miles (11' Widths)	Curb Reveal (Inches)	Curb Recommendation
1,325	0.023	NOT APPLICABLE	NOT APPLICABLE
Curb Type		Curb & Gutter Type	
NO CURB		NO CURB AND GUTTER	
Treatment Recommendation		Condition Rating	
ROUTINE MAINTENANCE		4

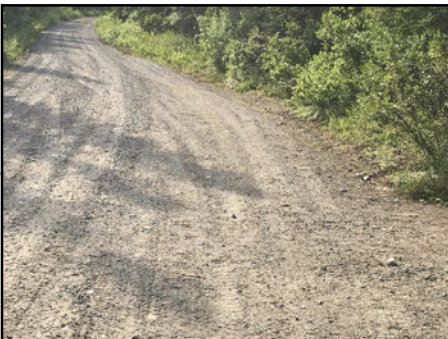
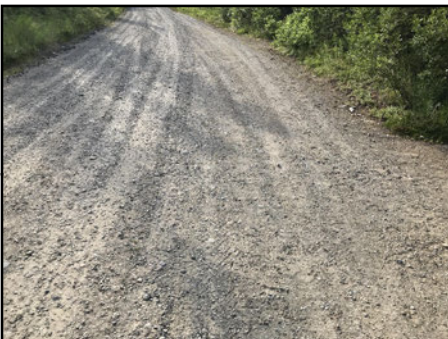
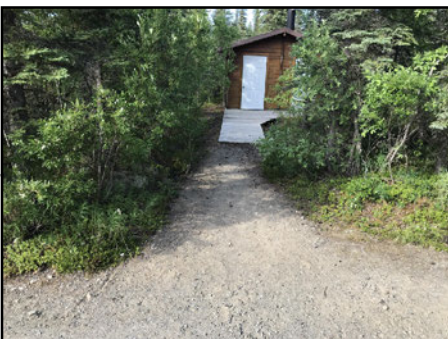
## ROUTE 0930: KS - PIKES RIDGE ENTRANCE AND PARKING AREA

Inspection Date	FMSS Number	User Access	Surface Type
6/26/2019	N/A	PUBLIC	GRAVEL
Area (Sq. Ft.)	Lane Miles (11' Widths)	Curb Reveal (Inches)	Curb Recommendation
16,671	0.287	NOT APPLICABLE	NOT APPLICABLE
Curb Type		Curb & Gutter Type	
NO CURB		NO CURB AND GUTTER	
Treatment Recommendation		Condition Rating	
LIMITED LOCAL MAINTENANCE		5
