KEFJ Cycle 6

Final Report

Road Inventory and Condition Assessment for Kenai Fjords National Park

**Federal Highway Administration
Eastern Federal Lands Highway Division
Road Inventory Program (RIP)**

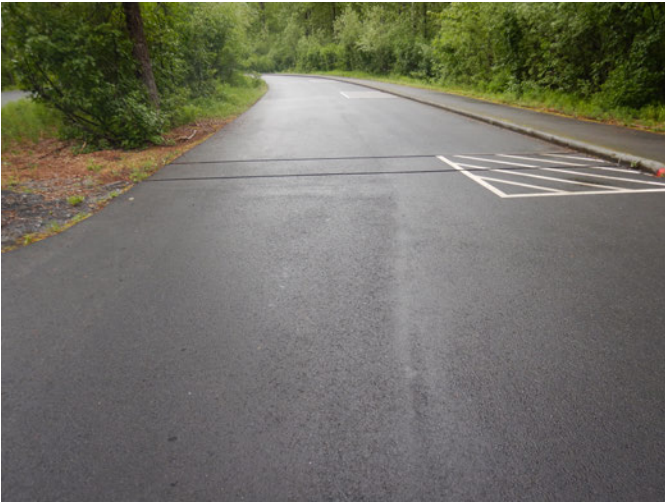
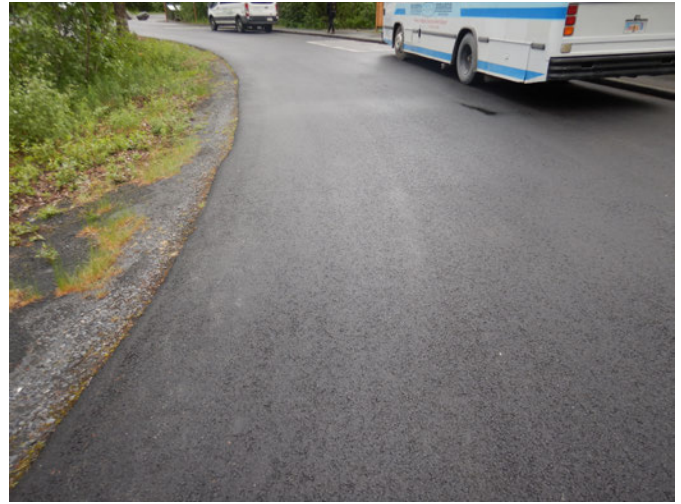
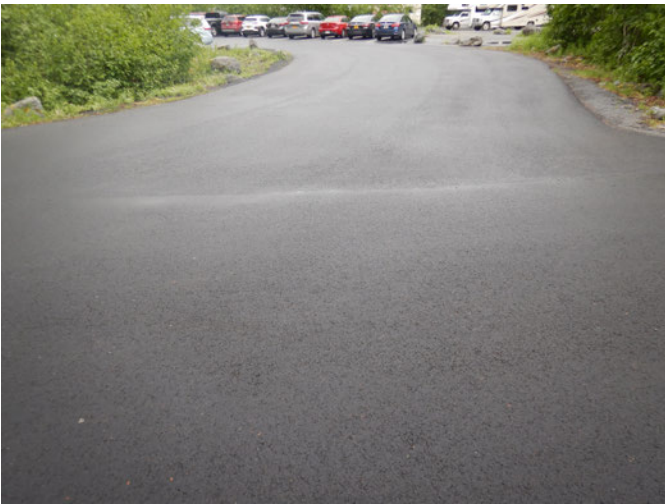
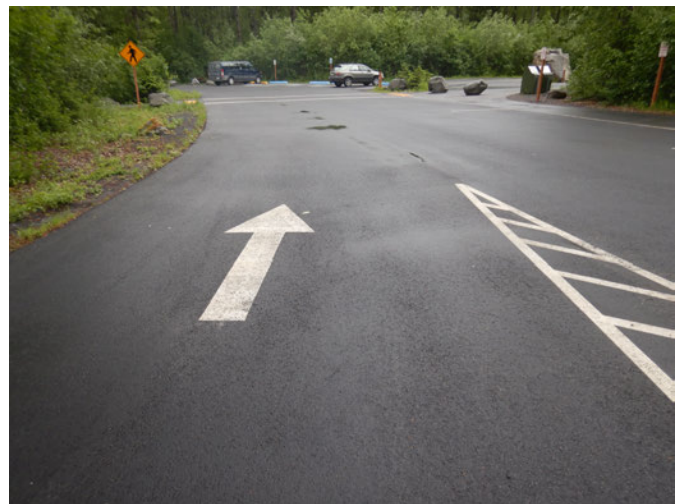
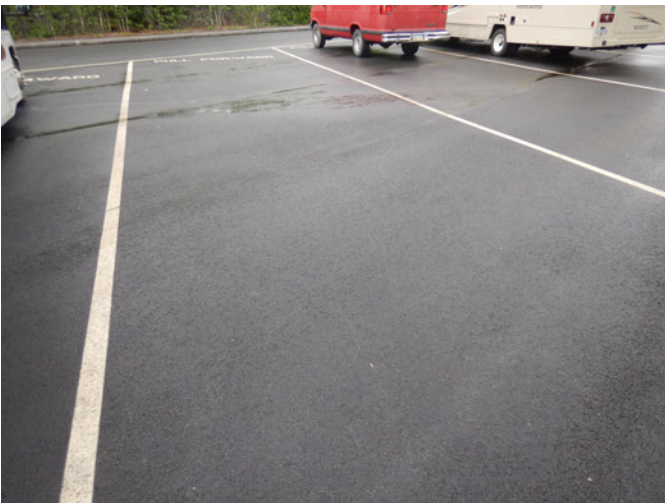
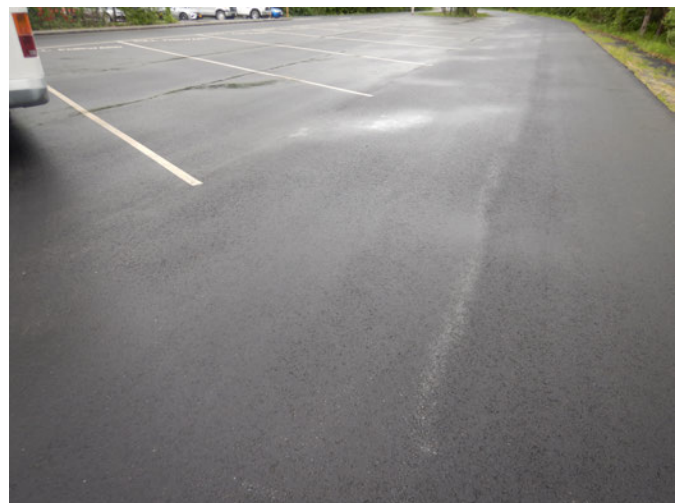
ROUTE 0900: EXIT GLACIER NATURE CENTER PARKING

Inspection Date	FMSS Number	User Access	Surface Type
6/14/2019	00001095	PUBLIC	ASPHALT
Area (Sq. Ft.)	Lane Miles (11' Widths)	Curb Reveal (Inches)	Curb Recommendation
109,375	1.883	NOT APPLICABLE	DO NOTHING
Curb Type		Curb & Gutter Type	
NO CURB		CONCRETE	
Pavement Recommendation		Condition Rating / PCR	
PREVENTIVE MAINTENANCE		GOOD / 90

CONDITION PHOTOS

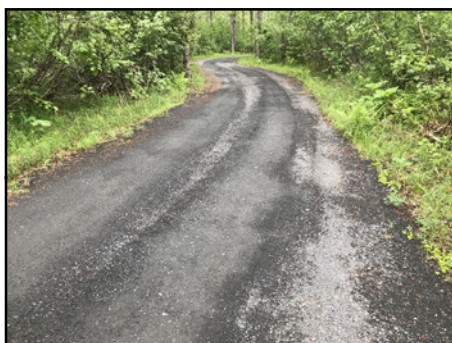
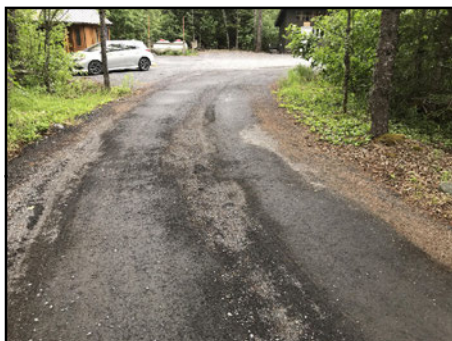
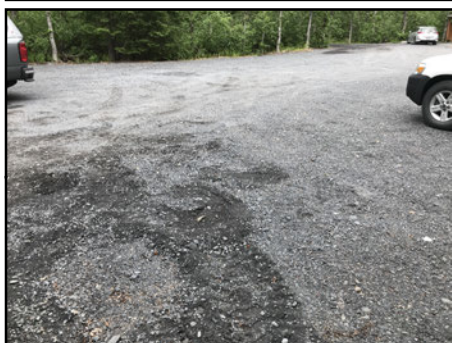
ROUTE 0901: EXIT GLACIER EMPLOYEE PARKING

Inspection Date	FMSS Number	User Access	Surface Type
6/14/2019	42813	NONPUBLIC	GRAVEL
Area (Sq. Ft.)	Lane Miles (11' Widths)	Curb Reveal (Inches)	Curb Recommendation
10,912	0.188	NOT APPLICABLE	NOT APPLICABLE
Curb Type		Curb & Gutter Type	
NOT APPLICABLE		NOT APPLICABLE	
Treatment Recommendation		Condition Rating	
ROUTINE MAINTENANCE		4

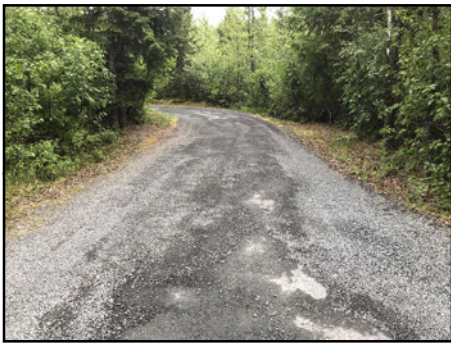
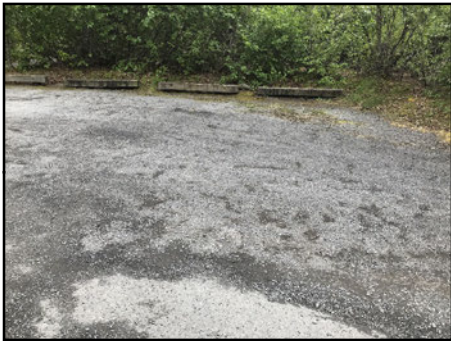
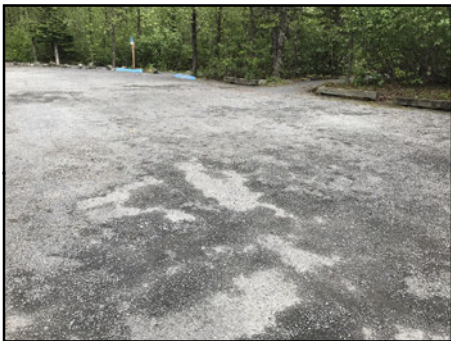
ROUTE 0902: EXIT GLACIER CAMPGROUND PARKING

Inspection Date	FMSS Number	User Access	Surface Type
6/14/2019	59937	PUBLIC	GRAVEL
Area (Sq. Ft.)	Lane Miles (11' Widths)	Curb Reveal (Inches)	Curb Recommendation
9,810	0.169	NOT APPLICABLE	NOT APPLICABLE
Curb Type		Curb & Gutter Type	
NOT APPLICABLE		NOT APPLICABLE	
Treatment Recommendation		Condition Rating	
LIGHT REHABILITATION		3

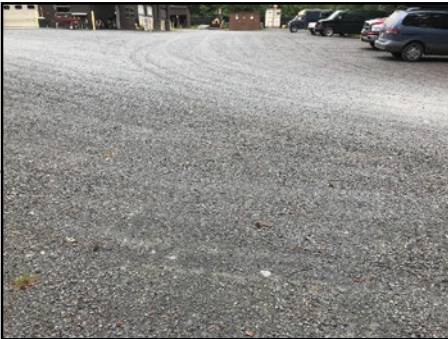
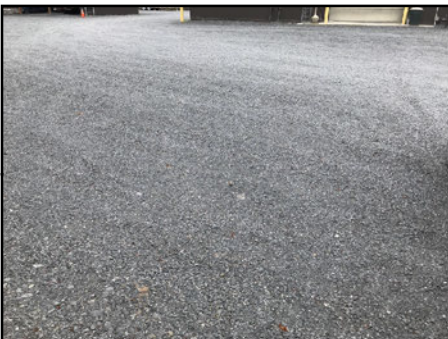
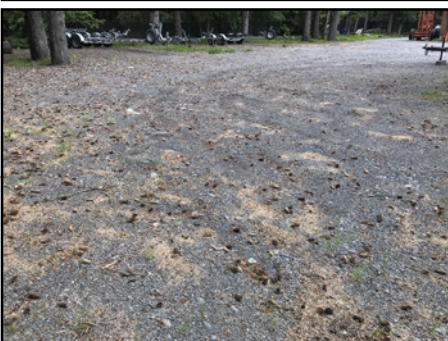
ROUTE 0903: MAINTENANCE PARKING

Inspection Date	FMSS Number	User Access	Surface Type
6/14/2019	59939	NONPUBLIC	GRAVEL
Area (Sq. Ft.)	Lane Miles (11' Widths)	Curb Reveal (Inches)	Curb Recommendation
76,212	1.312	NOT APPLICABLE	NOT APPLICABLE
Curb Type		Curb & Gutter Type	
NOT APPLICABLE		NOT APPLICABLE	
Treatment Recommendation		Condition Rating	
LIMITED LOCAL MAINTENANCE		5

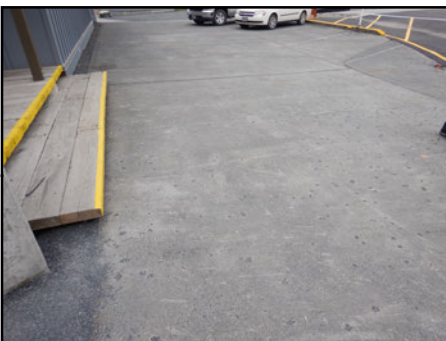
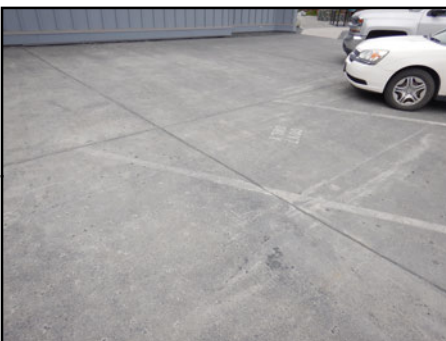
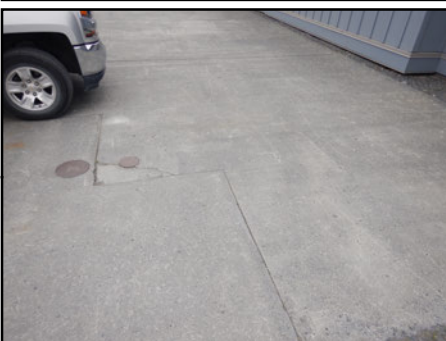
ROUTE 0904: VISITOR CENTER PARKING

Inspection Date	FMSS Number	User Access	Surface Type
6/14/2019	114381	NONPUBLIC	CONCRETE
Area (Sq. Ft.)	Lane Miles (11' Widths)	Curb Reveal (Inches)	Curb Recommendation
2,119	0.036	6	DO NOTHING
Curb Type		Curb & Gutter Type	
CONCRETE		NO CURB AND GUTTER	
Pavement Recommendation		Condition Rating / PCR	
HEAVY 3R TREATMENTS		POOR / 53

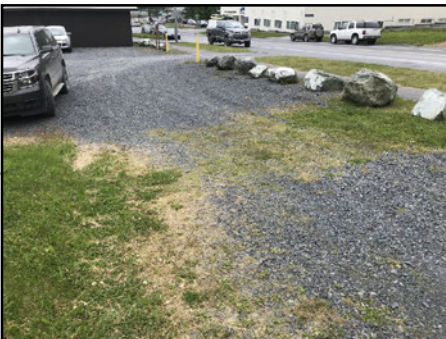
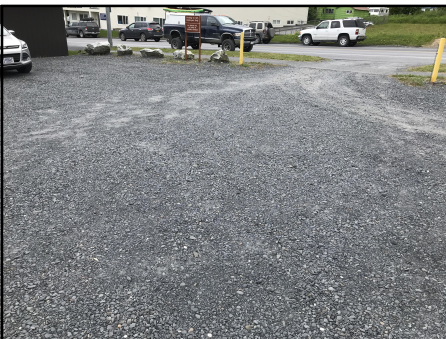
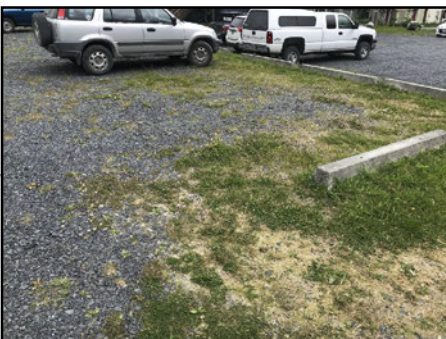
Inspection Date	FMSS Number	User Access	Surface Type
6/14/2019	230394	NONPUBLIC	GRAVEL
Area (Sq. Ft.)	Lane Miles (11' Widths)	Curb Reveal (Inches)	Curb Recommendation
13,138	0.226	NOT APPLICABLE	NOT APPLICABLE
Curb Type		Curb & Gutter Type	
NOT APPLICABLE		NOT APPLICABLE	
Treatment Recommendation		Condition Rating	
ROUTINE MAINTENANCE		4
