# KEWE Cycle 6

## Final Report

### Road Inventory and Condition Assessment of Paved Routes Keweenaw National Historical Park

Report Date: January 2019

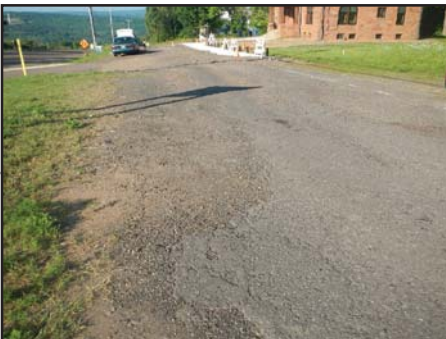
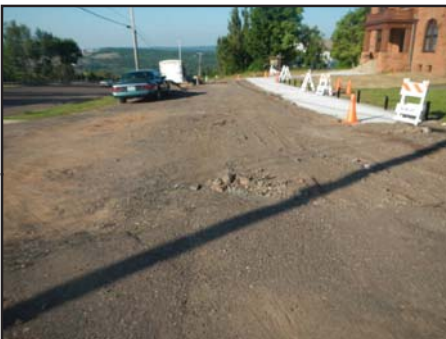
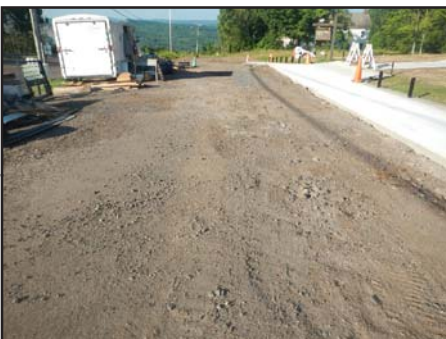
## ROUTE 0902: PAY OFFICE PARKING AREA

Note: Parking area was under construction and could not be rated.
