# KIMO Cycle 6

## Final Report

### Road Inventory and Condition Assessment of Paved Routes Kings Mountain National Military Park

**Federal Highway Administration  
Eastern Federal Lands Highway Division  
Road Inventory Program (RIP)**

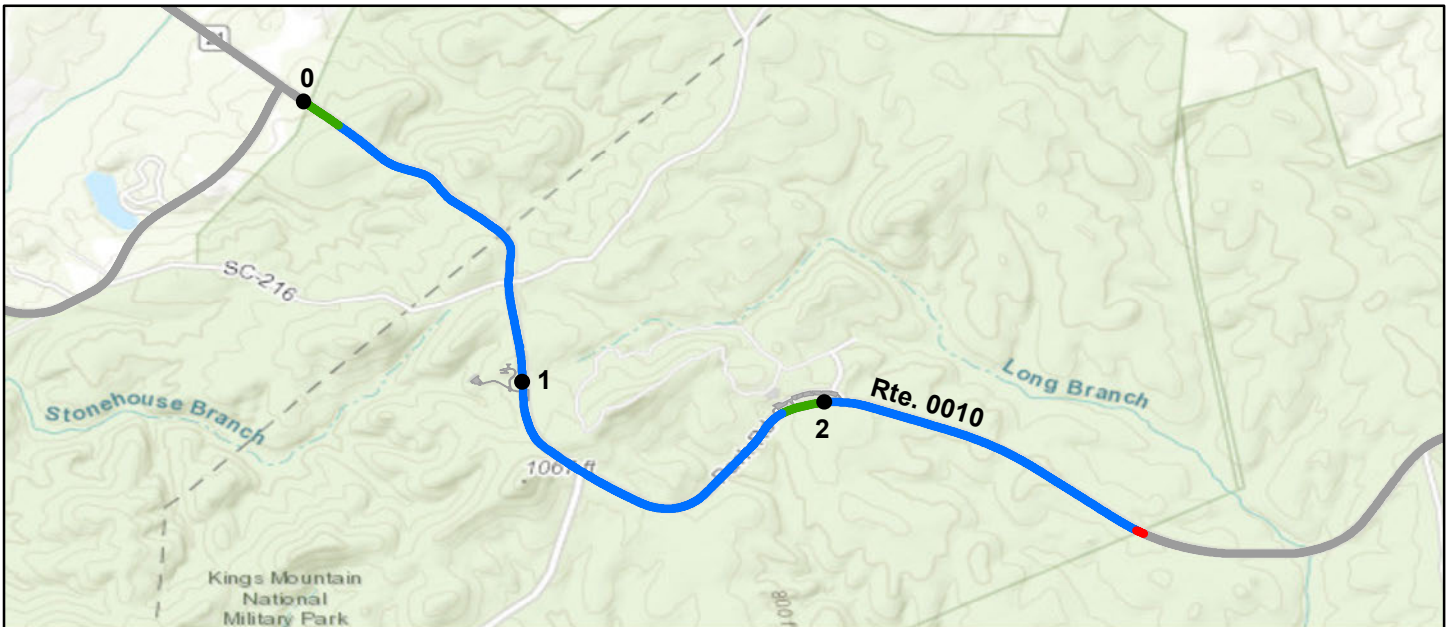
## ROUTE 0010: MAIN PARK DRIVE

Inspection Date:	2/8/2021	Beginning Section MP	0	1	2		
Paved Length (Miles):	2.82	Section Length (MI)	1	1	0.82		
Surface Type:	ASPHALT	Route Summary					
Roadway Condition Information							
Pavement Condition Rating (PCR)	98	99	97	97			
Surface Condition Rating (SCR)	97	99	97	96			
Roughness Condition Index (RCI)	100	100	98	98			
Distress Index Values							
Structural Crack Index	99	100	98	99			
Alligator Crack Index	100	100	100	100			
Longitudinal Crack Index	99	100	98	99			
Transverse Cracking Index	97	99	97	96			
Patching Index	100	100	100	100			
Rutting Index	100	99	100	100			
International Roughness Index (IRI)	112	97	120	120			
Lane & Width Information							
Number of Lanes	2	2	2	2			
Paved Width (ft)	21.4	21.4	21.6	21.1			
Lane Width (ft)	9.6	9.5	9.6	9.6

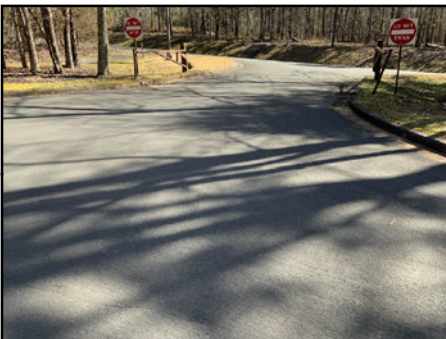
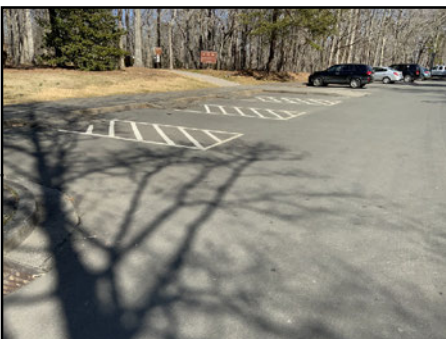
Inspection Date	FMSS Number	User Access	Surface Type
2/8/2021	54287	PUBLIC	ASPHALT
Area (Sq. Ft.)	Lane Miles (11' Widths)	Curb Reveal (Inches)	Curb Recommendation
46,317	0.797	NOT APPLICABLE	LIGHT REPAIR
Curb Type		Curb & Gutter Type	
NO CURB		CONCRETE	
Pavement Recommendation		Condition Rating / PCR	
PREVENTIVE MAINTENANCE		GOOD / 90

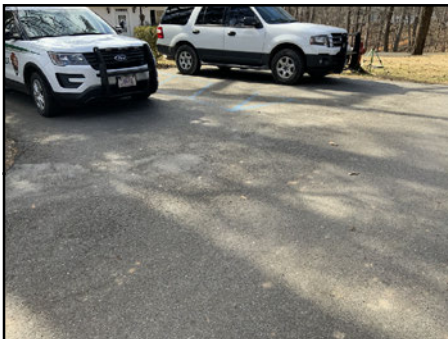
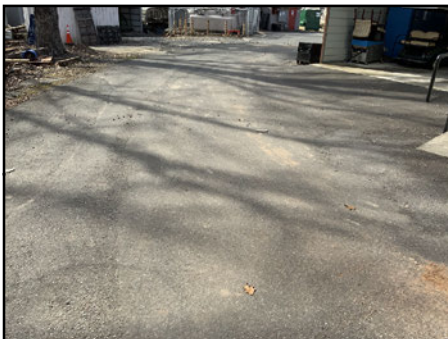
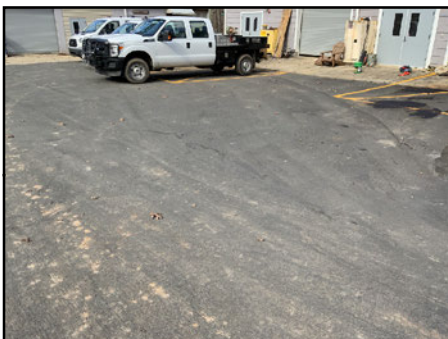
## ROUTE 0901: MAINTENANCE AREA PARKING

Inspection Date	FMSS Number	User Access	Surface Type
2/8/2021	54288	NONPUBLIC	ASPHALT
Area (Sq. Ft.)	Lane Miles (11' Widths)	Curb Reveal (Inches)	Curb Recommendation
15,648	0.269	NOT APPLICABLE	NOT APPLICABLE
Curb Type		Curb & Gutter Type	
NO CURB		NO CURB AND GUTTER	
Pavement Recommendation		Condition Rating / PCR	
PREVENTIVE MAINTENANCE		GOOD / 90

MULTIPLE SURFACE TYPES: ASPHALT = 13,412 SQ FT; CONCRETE = 2,236 SQ FT.

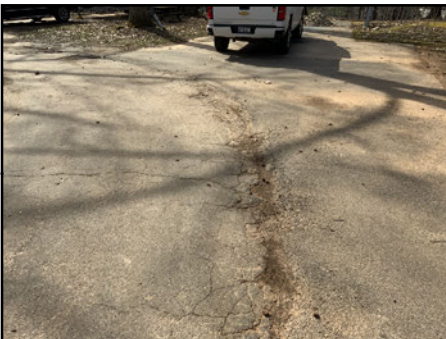
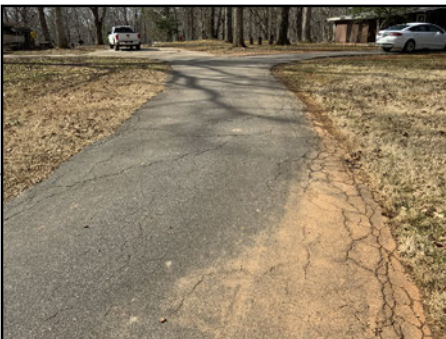
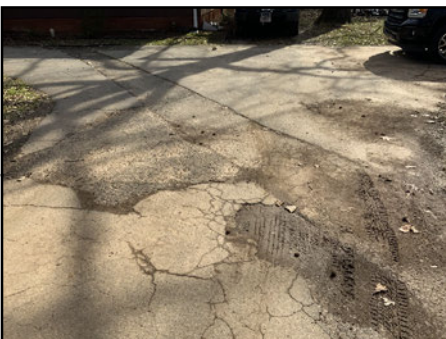
## ROUTE 0902: RESIDENCE PARKING

Inspection Date	FMSS Number	User Access	Surface Type
2/8/2021	54289	NONPUBLIC	ASPHALT
Area (Sq. Ft.)	Lane Miles (11' Widths)	Curb Reveal (Inches)	Curb Recommendation
10,473	0.18	NOT APPLICABLE	NOT APPLICABLE
Curb Type		Curb & Gutter Type	
NO CURB		NO CURB AND GUTTER	
Pavement Recommendation		Condition Rating / PCR	
HEAVY 3R TREATMENTS		POOR / 53

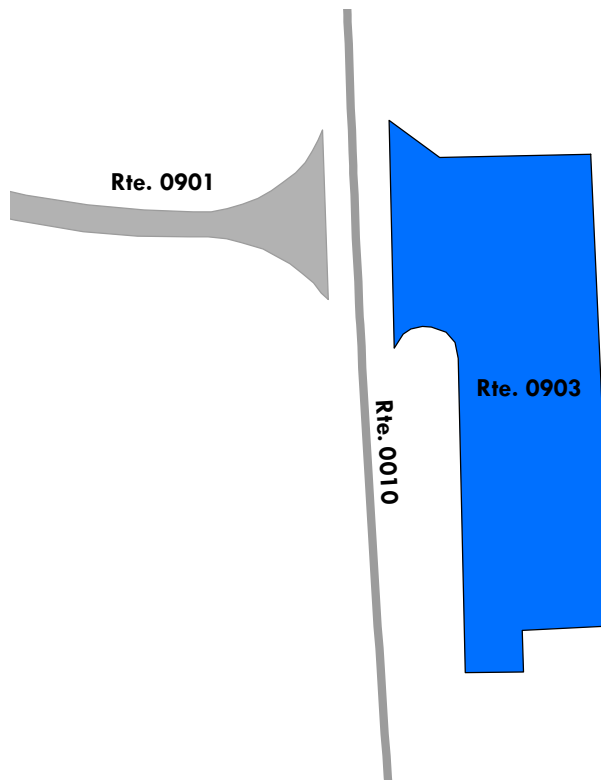
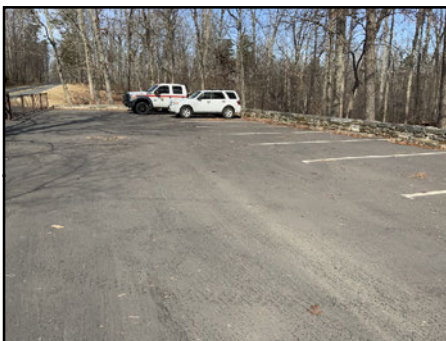
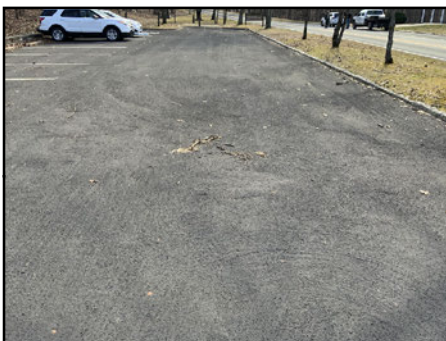
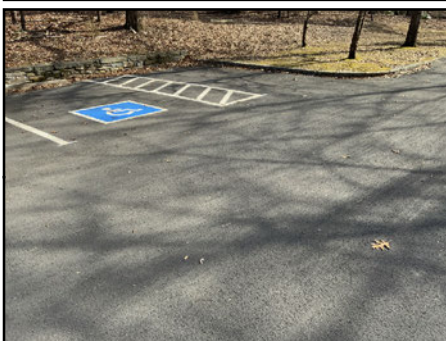
## ROUTE 0903: HEADQUARTERS PARKING

Inspection Date	FMSS Number	User Access	Surface Type
2/8/2021	54290	PUBLIC	ASPHALT
Area (Sq. Ft.)	Lane Miles (11' Widths)	Curb Reveal (Inches)	Curb Recommendation
7,967	0.137	4	DO NOTHING
Curb Type		Curb & Gutter Type	
STONE		NO CURB AND GUTTER	
Pavement Recommendation		Condition Rating / PCR	
DO NOTHING		EXCELLENT / 97
