LACL Cycle 6

Final Report

Road Inventory and Condition Assessments for Lake Clark National Park & Preserve

Report Date: December 2019

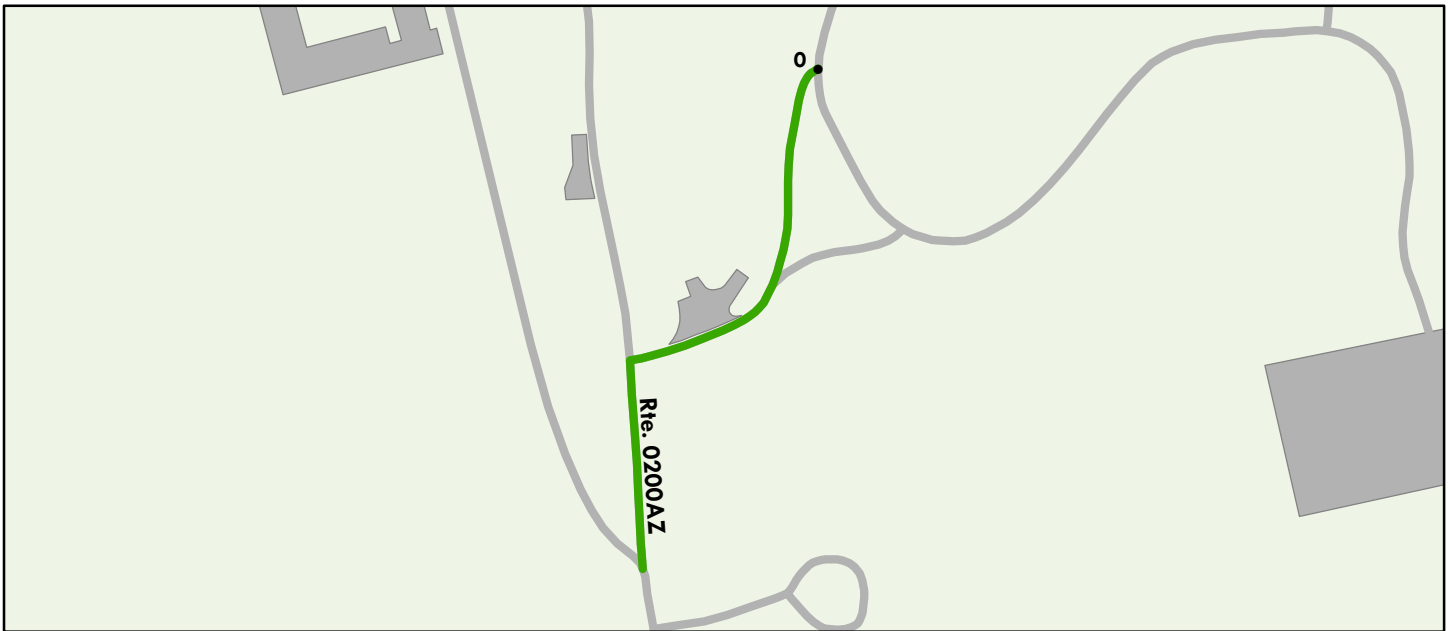
ROUTE 0200AZ: PA-RHQ CONNECTOR ROAD

Begin MP	End MP	Section Length	# of Lanes	Lane Width	Road Width	Treatment Recommendation	Treatment Cost	Unpaved Rating (Paser +)	Crown Severity	Drainage Severity	Rutting, Washboard Severity	Potholes / Loose Aggregate Severity
0.00	0.10	0.10	2	7.0	14.0	Routine Maintenance	\$1,030	4	Med	Low	Low	Med
Route Level Data:		0.10	2	7.0	14.0	Routine Maintenance	\$1,030	4	Med	Low	Low	Med

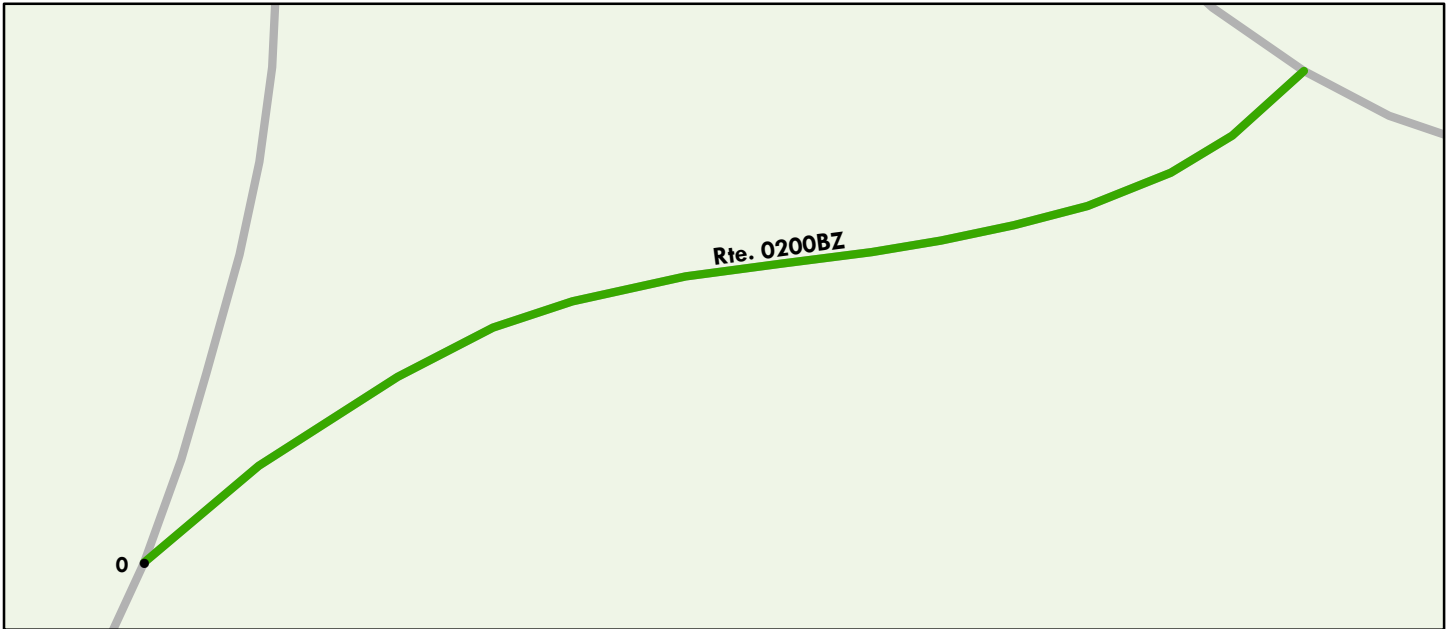
ROUTE 0200BZ: PA-RHQ CONNECTOR SPUR ROAD

Route Condition Legend					
Poor (1)	Poor (2)	Fair (3)	Good (4)	Excellent (5)	Not Rated
See Appendix for definitions and formulas					
Inspection Date: 6/17/2019		Unpaved Length (Miles): 0.03		Surface Type: GRAVEL

Begin MP	End MP	Section Length	# of Lanes	Lane Width	Road Width	Treatment Recommendation	Treatment Cost	Unpaved Rating (Paser +)	Crown Severity	Drainage Severity	Rutting, Washboard Severity	Potholes / Loose Aggregate Severity
0.00	0.03	0.03	1	11.0	11.0	Routine Maintenance	\$250	4	Low	Low	Med	Med
Route Level Data:		0.03	1	11.0	11.0	Routine Maintenance	\$250	4	Low	Low	Med	Med

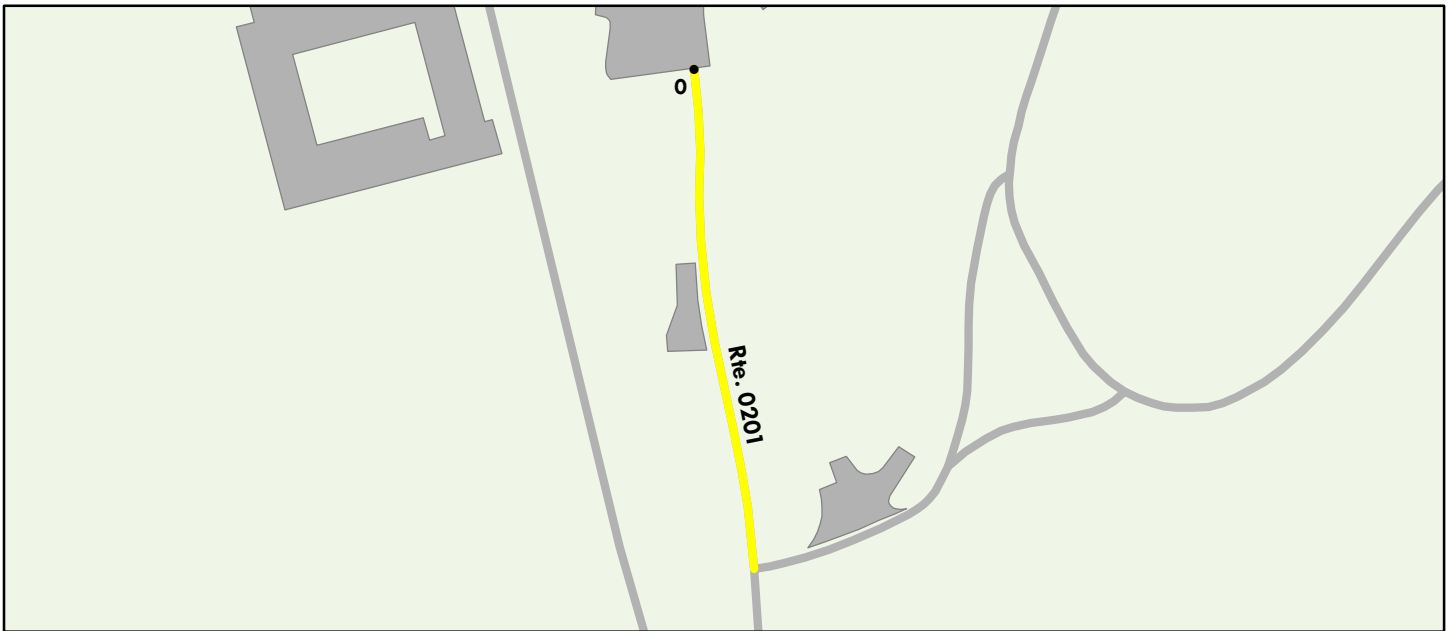
ROUTE 0201: PA-RHQ ROAD

Begin MP	End MP	Section Length	# of Lanes	Lane Width	Road Width	Treatment Recommendation	Treatment Cost	Unpaved Rating (Paser +)	Crown Severity	Drainage Severity	Rutting, Washboard Severity	Potholes / Loose Aggregate Severity
0.00	0.06	0.06	2	7.0	14.0	Light Rehabilitation	\$6,400	3	Med	Low	Low	High
Route Level Data:		0.06	2	7.0	14.0	Light Rehabilitation	\$6,400	3	Med	Low	Low	High

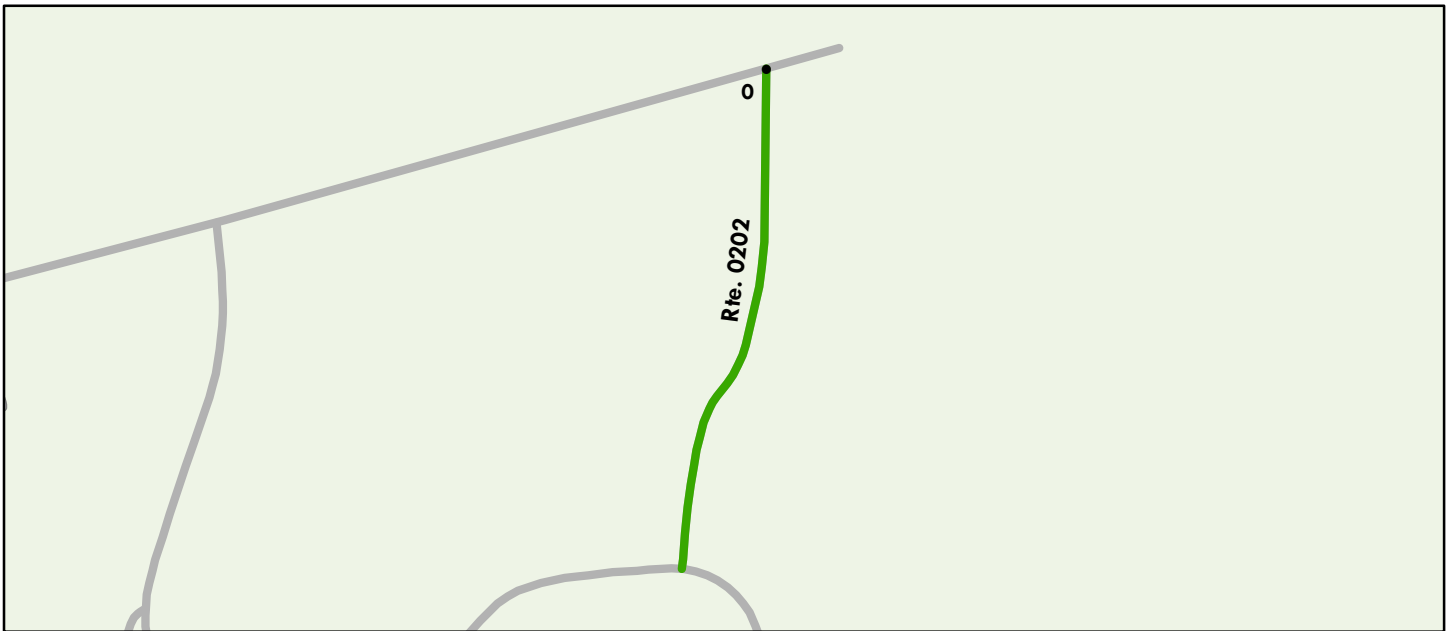
ROUTE 0202: PA-RME ROAD MID ENTRANCE ROAD

Route Condition Legend					
Poor (1)	Poor (2)	Fair (3)	Good (4)	Excellent (5)	Not Rated
See Appendix for definitions and formulas					
Inspection Date: 6/17/2019		Unpaved Length (Miles): 0.08		Surface Type: GRAVEL

Begin MP	End MP	Section Length	# of Lanes	Lane Width	Road Width	Treatment Recommendation	Treatment Cost	Unpaved Rating (Paser +)	Crown Severity	Drainage Severity	Rutting, Washboard Severity	Potholes / Loose Aggregate Severity
0.00	0.08	0.08	2	7.0	14.0	Routine Maintenance	\$830	4	Med	Low	Low	Med
Route Level Data:		0.08	2	7.0	14.0	Routine Maintenance	\$830	4	Med	Low	Low	Med

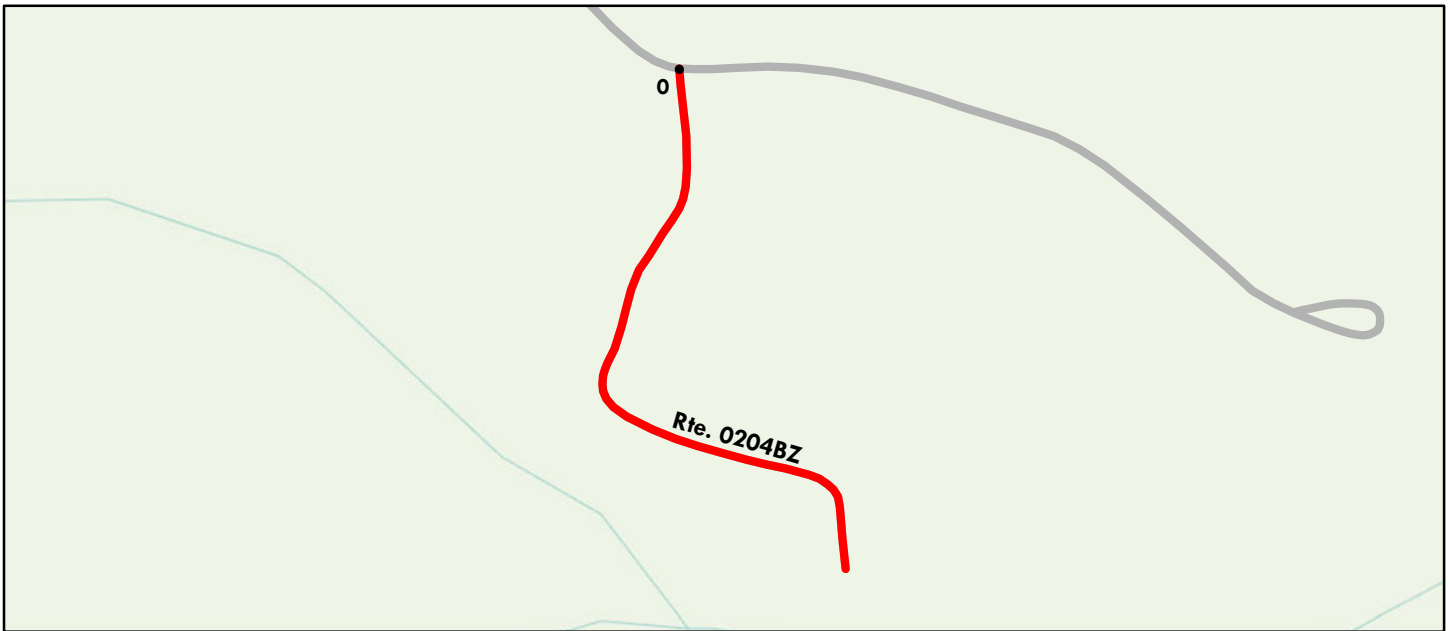
ROUTE 0204BZ: PA-WOOD LOT SPUR ROAD

Begin MP	End MP	Section Length	# of Lanes	Lane Width	Road Width	Treatment Recommendation	Treatment Cost	Unpaved Rating (Paser +)	Crown Severity	Drainage Severity	Rutting, Washboard Severity	Potholes / Loose Aggregate Severity
0.00	0.18	0.18	1	8.0	8.0	Heavy Rehabilitation	\$7,160	1	High	High	High	High
Route Level Data:		0.18	1	8.0	8.0	Heavy Rehabilitation	\$7,160	1	High	High	High	High
