# LIBO Cycle 6

## Final Report

### Road Inventory and Condition Assessment of Paved Routes Lincoln Boyhood National Memorial

**Report Date: April 2019**

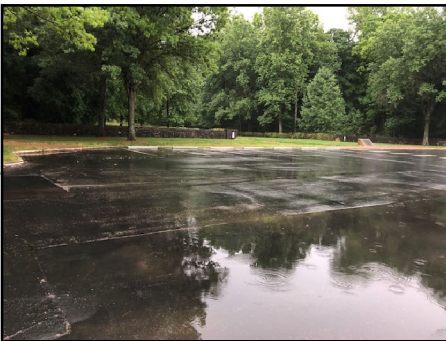
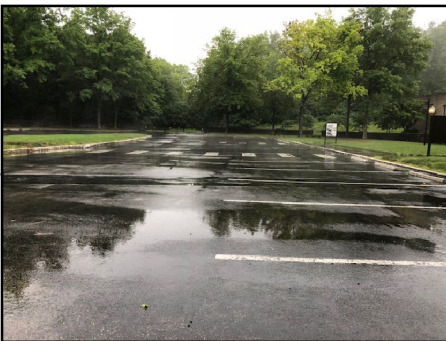
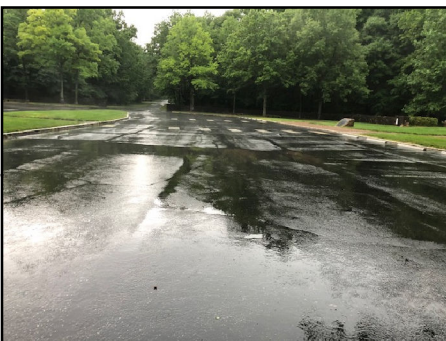
Inspection Date	FMSS Number	User Access	Surface Type
6/12/2018	73410	PUBLIC	ASPHALT
Area (Sq. Ft.)	Lane Miles (11' Widths)	Curb Reveal (Inches)	Curb Recommendation
38,630	0.665	3	LIGHT REPAIR
Curb Type		Curb & Gutter Type	
CONCRETE		NO CURB AND GUTTER	
Pavement Recommendation		Condition Rating / PCR	
PREVENTIVE MAINTENANCE		GOOD / 90

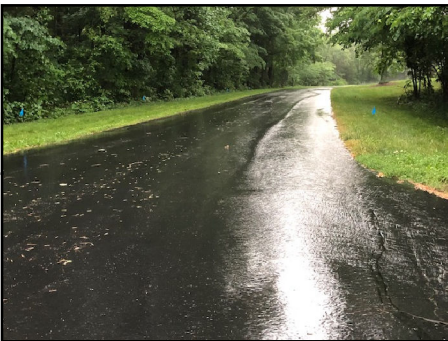
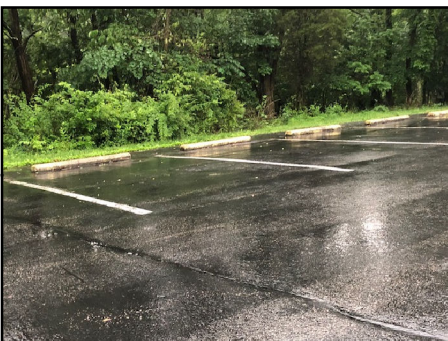
## ROUTE 0901: MAINTENANCE COMPOUND GROUND

Inspection Date	FMSS Number	User Access	Surface Type
6/12/2018	73733	NONPUBLIC	ASPHALT
Area (Sq. Ft.)	Lane Miles (11' Widths)	Curb Reveal (Inches)	Curb Recommendation
23,870	0.411	NOT APPLICABLE	NOT APPLICABLE
Curb Type		Curb & Gutter Type	
NO CURB		NO CURB AND GUTTER	
Pavement Recommendation		Condition Rating / PCR	
PREVENTIVE MAINTENANCE		GOOD / 90

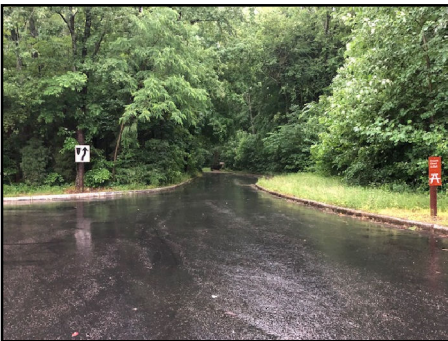
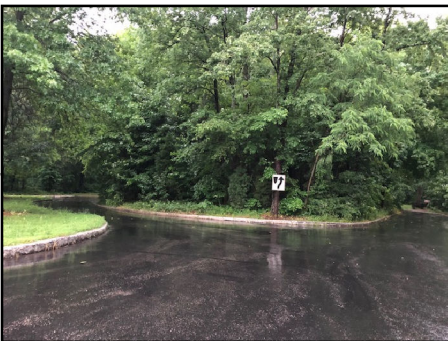
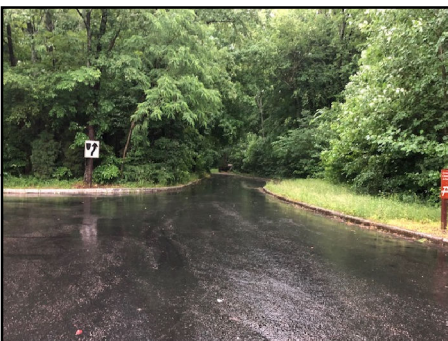
## ROUTE 0902: LIVING HISTORIC FARM PARKING

Inspection Date	FMSS Number	User Access	Surface Type
6/12/2018	73422	PUBLIC	ASPHALT
Area (Sq. Ft.)	Lane Miles (11' Widths)	Curb Reveal (Inches)	Curb Recommendation
17,377	0.299	3	DO NOTHING
Curb Type		Curb & Gutter Type	
CONCRETE		NO CURB AND GUTTER	
Pavement Recommendation		Condition Rating / PCR	
PREVENTIVE MAINTENANCE		GOOD / 90
