LIRI Cycle 6

Final Report

Road Inventory and Condition Assessment of Paved Routes Little River Canyon National Preserve

Report Date: June 2020

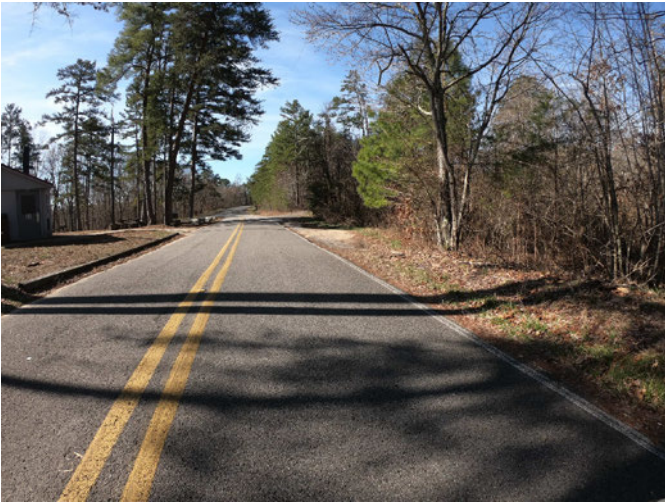
LIRI_0213_69.JPG

Inspection Date: 2/22/2020	Beginning Section MP	0.00				
Paved Length (Miles): 0.08	Section Length (MI)	0.08				
Surface Type: ASPHALT	Route Summary					
Roadway Condition Information						
Pavement Condition Rating (PCR)	44	44				
Surface Condition Rating (SCR)	44	44				
Roughness Condition Index (RCI)	N/A	N/A				
Distress Index Values						
Structural Crack Index	44	44				
Alligator Crack Index	97	97				
Longitudinal Crack Index	47	47				
Transverse Cracking Index	66	66				
Patching Index	100	100				
Rutting Index	100	100				
International Roughness Index (IRI)	N/A	N/A				
Lane & Width Information						
Number of Lanes	2	2				
Paved Width (ft)	18	18				
Lane Width (ft)	9	9

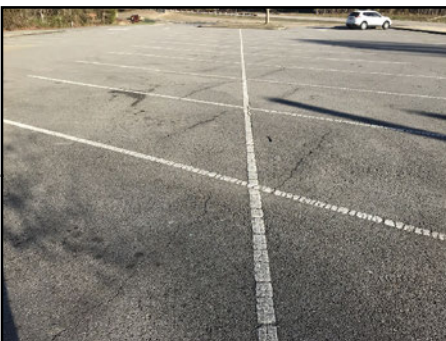
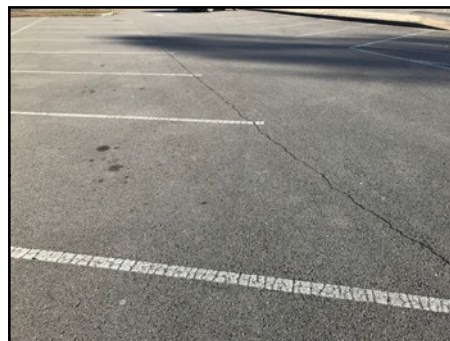
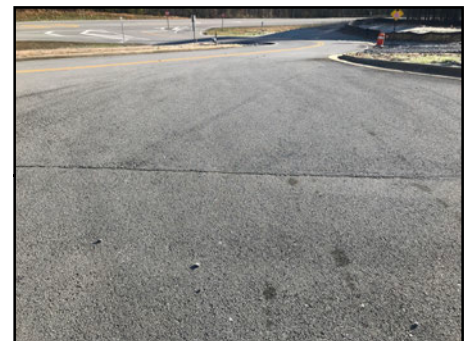
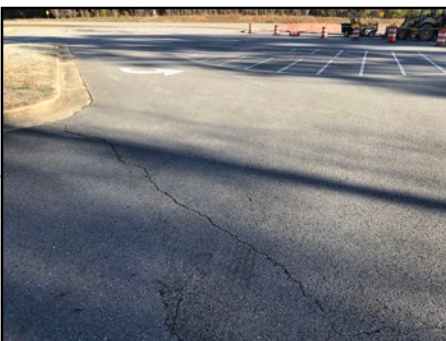
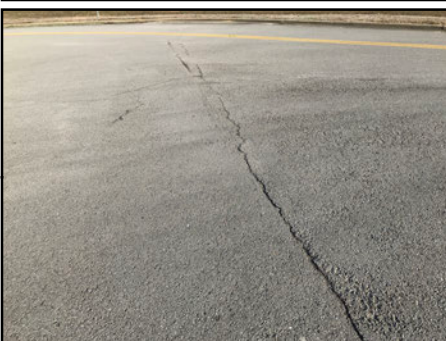
Inspection Date	FMSS Number	User Access	Surface Type
2/22/2020	66408	PUBLIC	ASPHALT
Area (Sq. Ft.)	Lane Miles (11' Widths)	Curb Reveal (Inches)	Curb Recommendation
67,136	1.155	NOT APPLICABLE	LIGHT REPAIR
Curb Type		Curb & Gutter Type	
NO CURB		CONCRETE	
Pavement Recommendation		Condition Rating / PCR	
PREVENTIVE MAINTENANCE		GOOD / 90

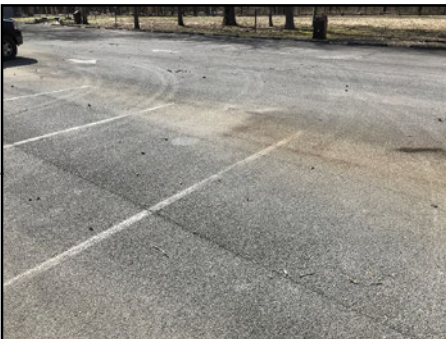
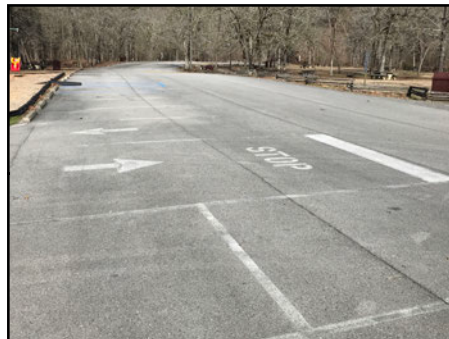
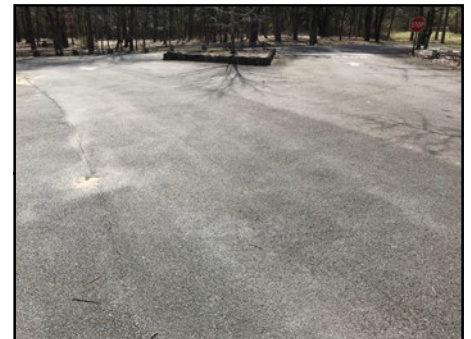
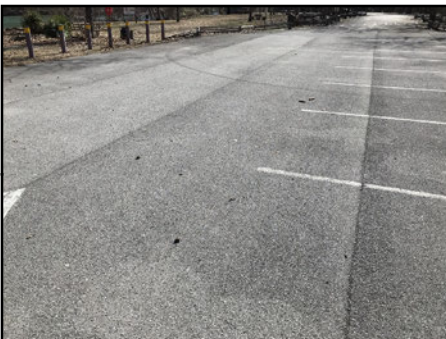
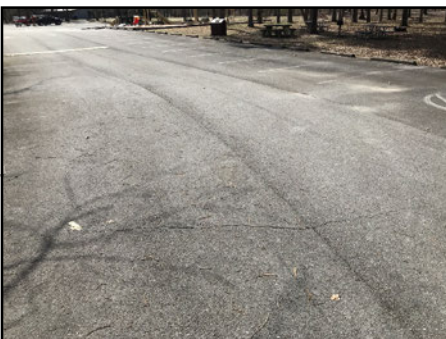
ROUTE 0906: CANYON MOUTH PARKING

Inspection Date	FMSS Number	User Access	Surface Type
2/22/2020	66402	PUBLIC	ASPHALT
Area (Sq. Ft.)	Lane Miles (11' Widths)	Curb Reveal (Inches)	Curb Recommendation
71,806	1.236	NOT APPLICABLE	NOT APPLICABLE
Curb Type		Curb & Gutter Type	
NO CURB		NO CURB AND GUTTER	
Pavement Recommendation		Condition Rating / PCR	
PREVENTIVE MAINTENANCE		GOOD / 90
