LOWE Cycle 6

Road Inventory and Condition Assessment of Paved Routes Lowell National Historical Park

**Federal Highway Administration
Eastern Federal Lands Highway Division
Road Inventory Program (RIP)**

Report Date: October 2020

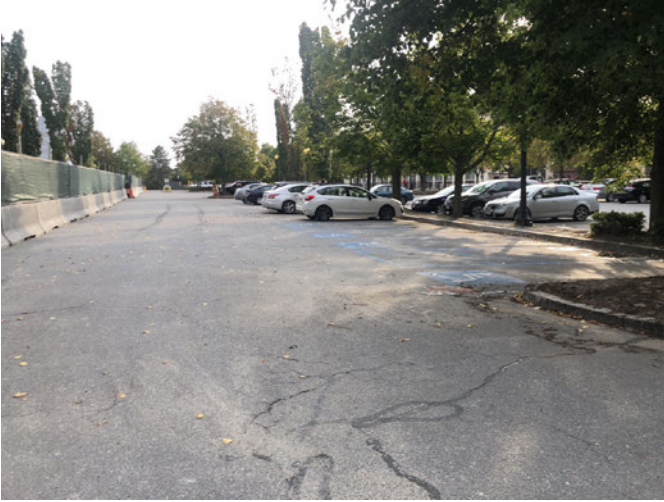
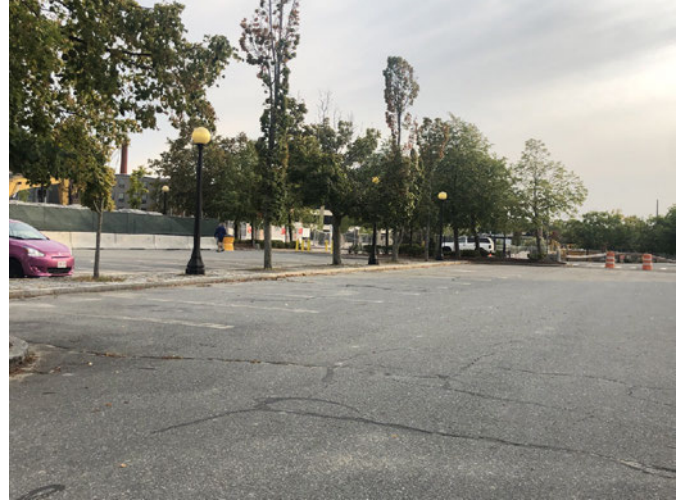
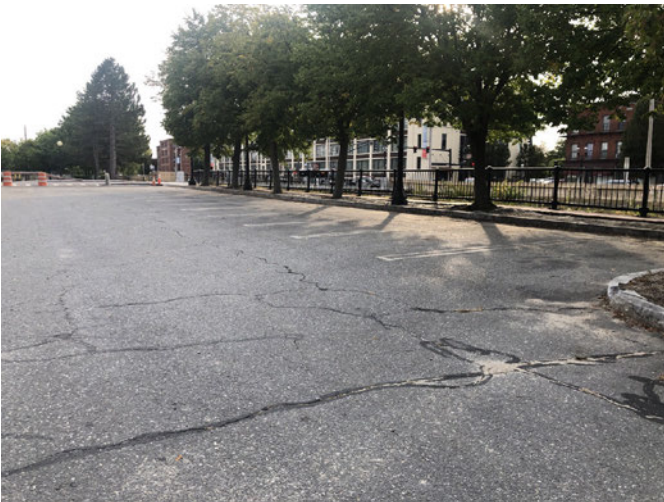
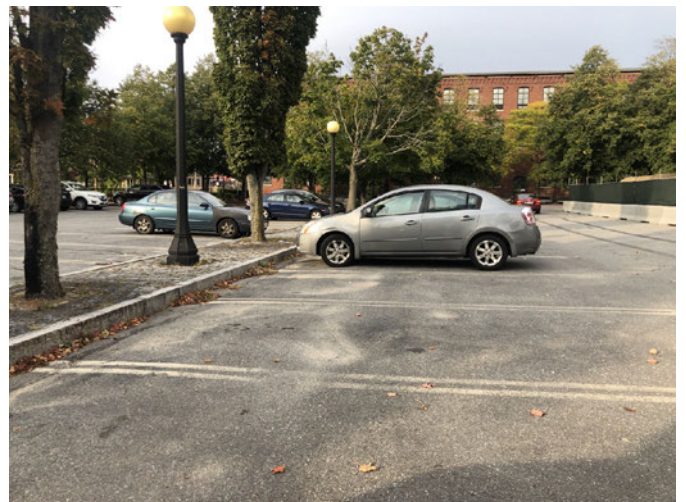
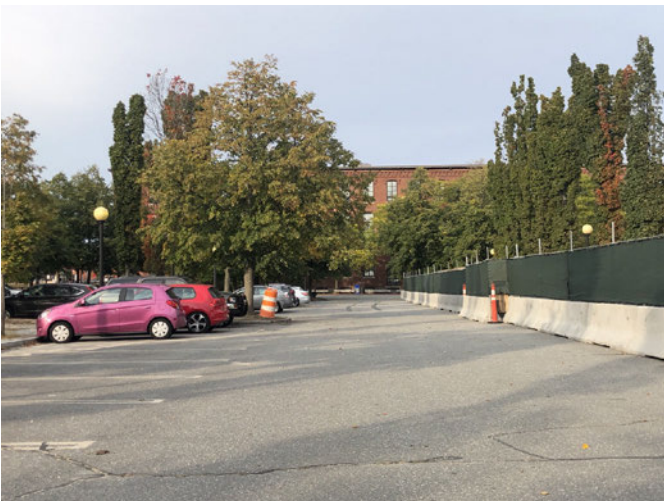
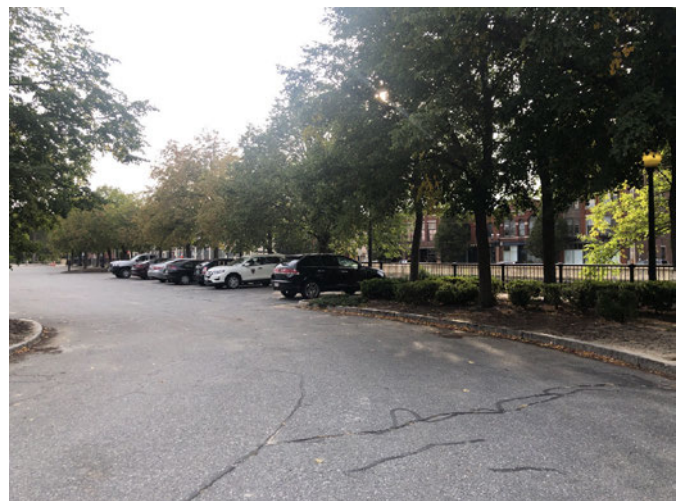
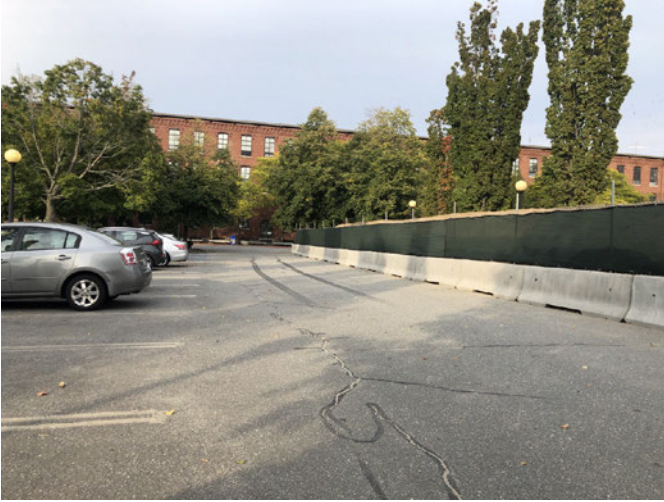
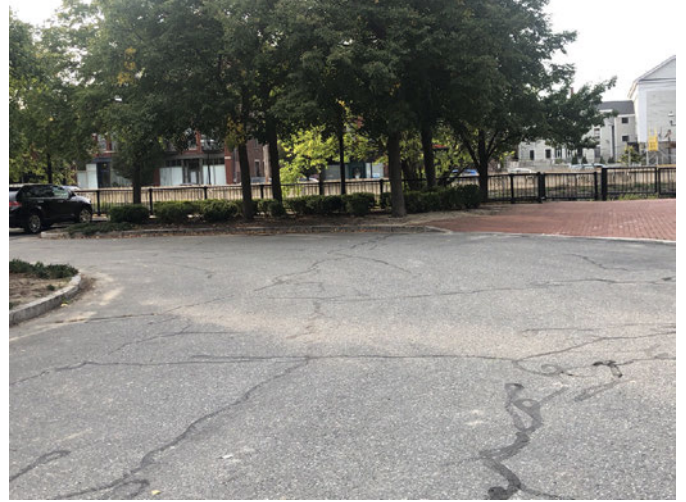
Inspection Date	FMSS Number	User Access	Surface Type
9/22/2020	00001795	PUBLIC	ASPHALT
Area (Sq. Ft.)	Lane Miles (11' Widths)	Curb Reveal (Inches)	Curb Recommendation
57,021	0.982	6	DO NOTHING
Curb Type		Curb & Gutter Type	
STONE		NO CURB AND GUTTER	
Pavement Recommendation		Condition Rating / PCR	
HEAVY 3R TREATMENTS		POOR / 53

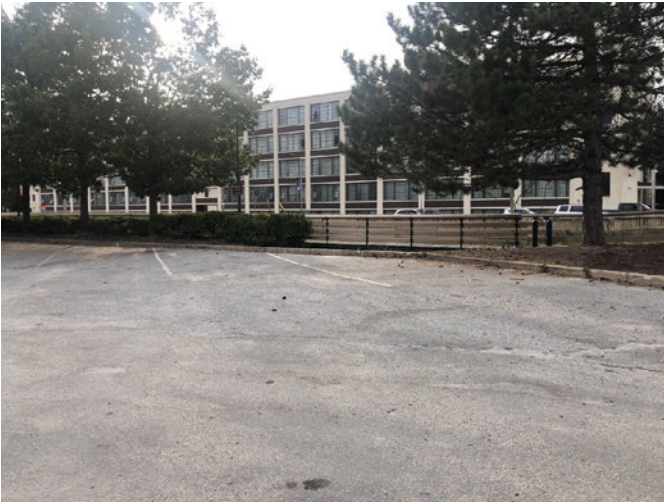
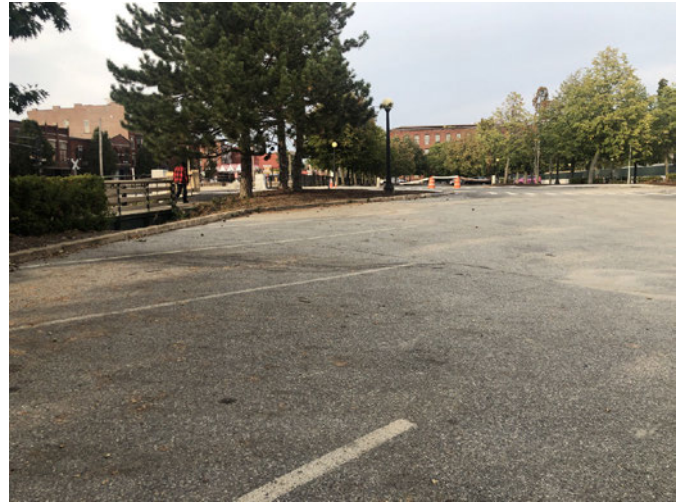
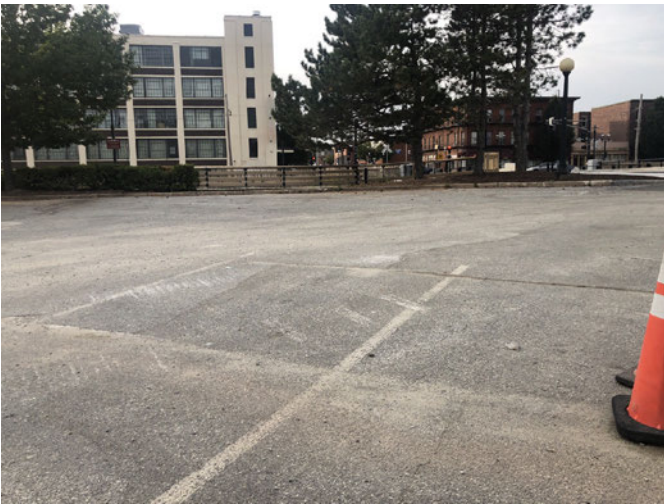
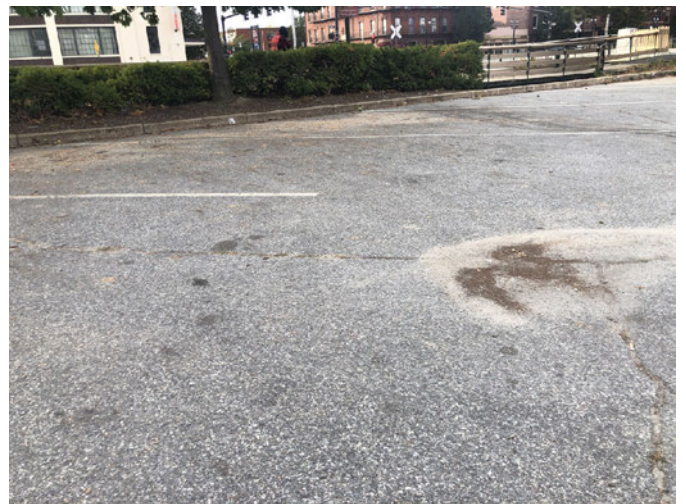
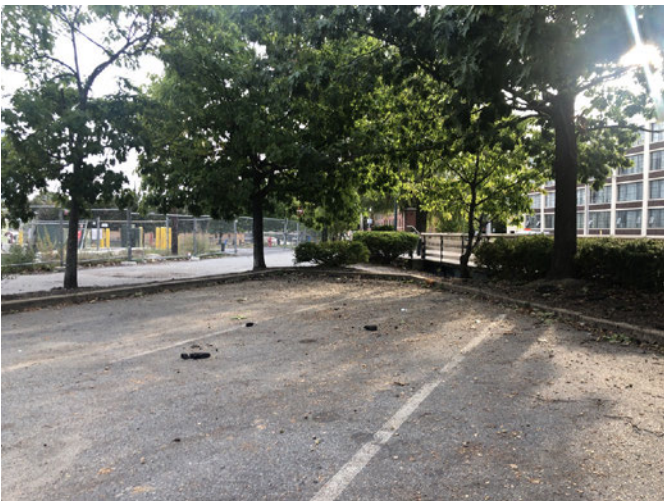
Inspection Date	FMSS Number	User Access	Surface Type
9/22/2020	00001795	PUBLIC	ASPHALT
Area (Sq. Ft.)	Lane Miles (11' Widths)	Curb Reveal (Inches)	Curb Recommendation
8,593	0.148	6	DO NOTHING
Curb Type		Curb & Gutter Type	
CONCRETE AND STONE		NO CURB AND GUTTER	
Pavement Recommendation		Condition Rating / PCR	
LIGHT 3R TREATMENTS		FAIR / 73

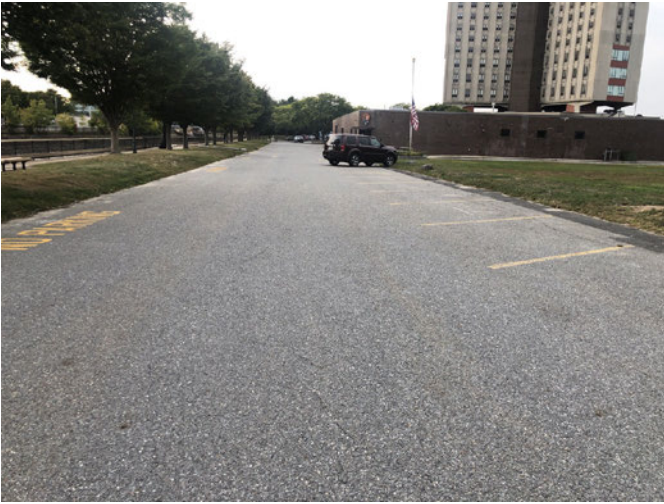
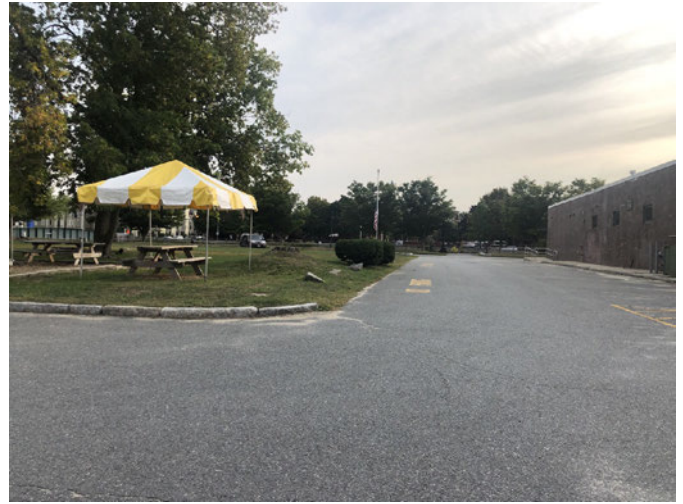
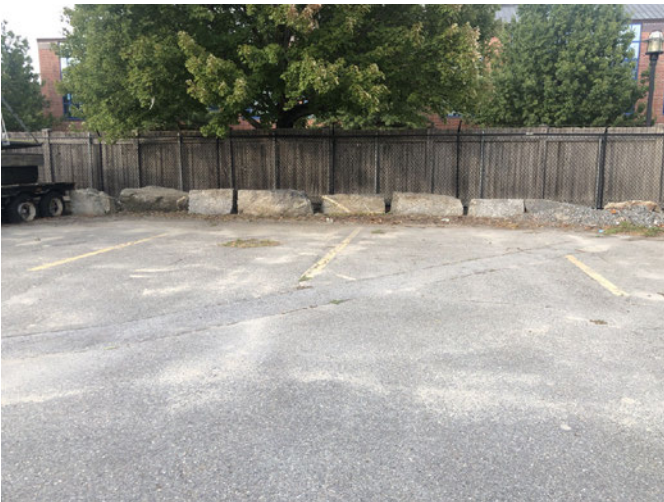
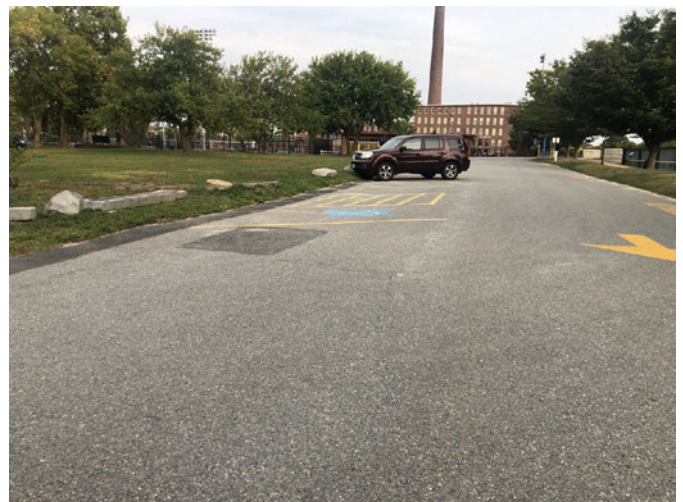
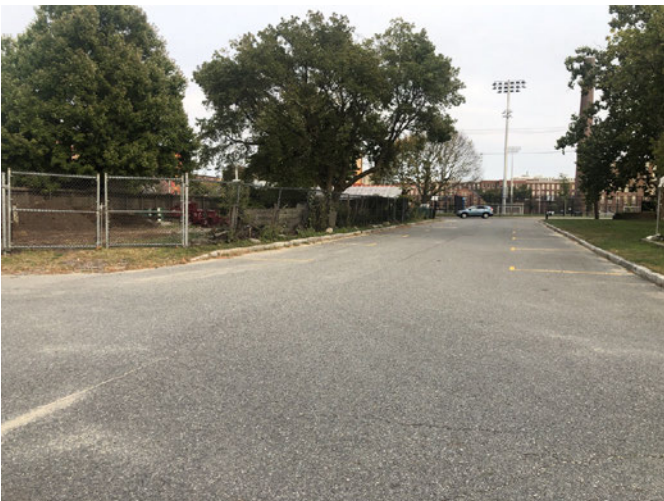
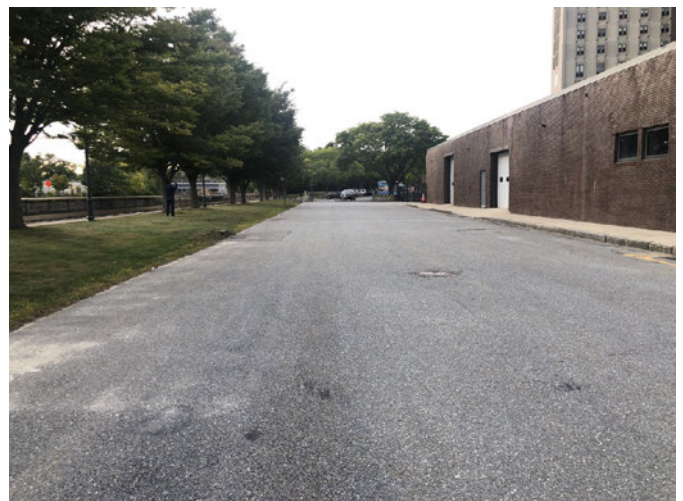
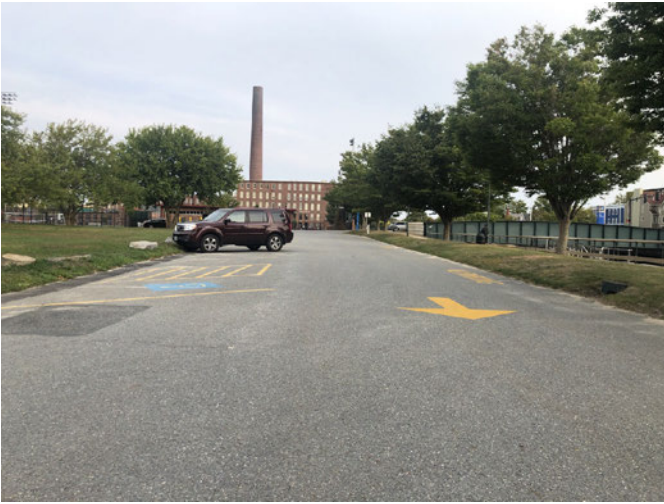
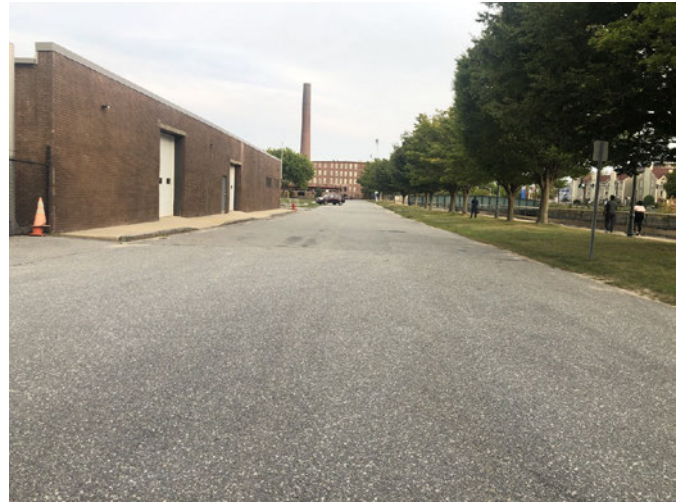
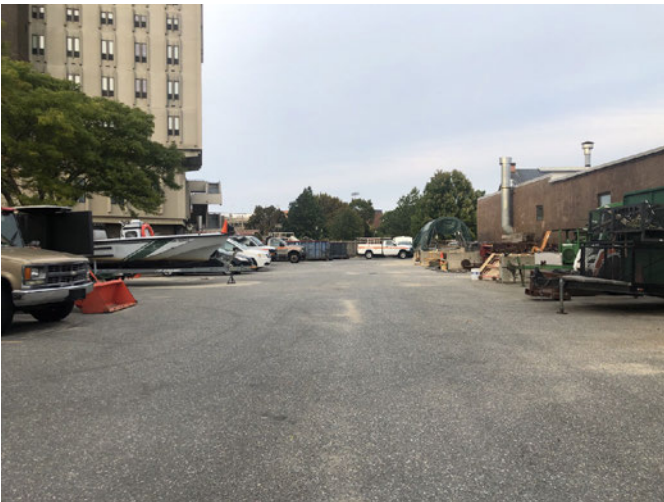
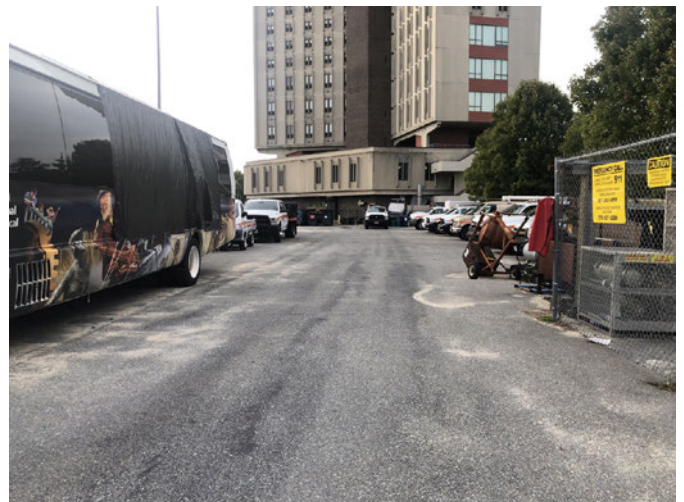
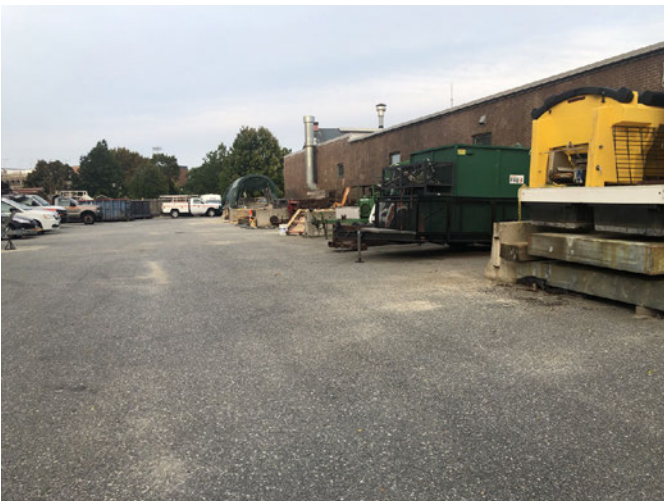
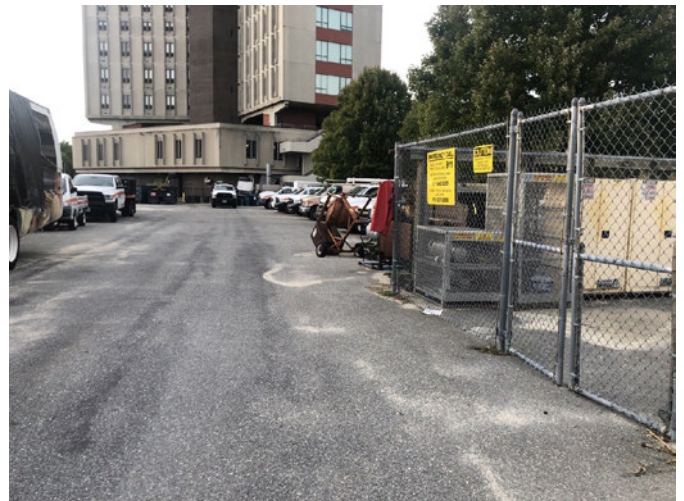
Inspection Date	FMSS Number	User Access	Surface Type
9/22/2020	104088	NONPUBLIC	ASPHALT
Area (Sq. Ft.)	Lane Miles (11' Widths)	Curb Reveal (Inches)	Curb Recommendation
56,689	0.976	6	LIGHT REPAIR
Curb Type		Curb & Gutter Type	
STONE AND WOOD		NO CURB AND GUTTER	
Pavement Recommendation		Condition Rating / PCR	
LIGHT 3R TREATMENTS		FAIR / 73
