# MAVA Cycle 6

## Final Report

### Road Inventory and Condition Assessment of Paved Routes Martin Van Buren National Historic Site

**Report Date: June 2021**

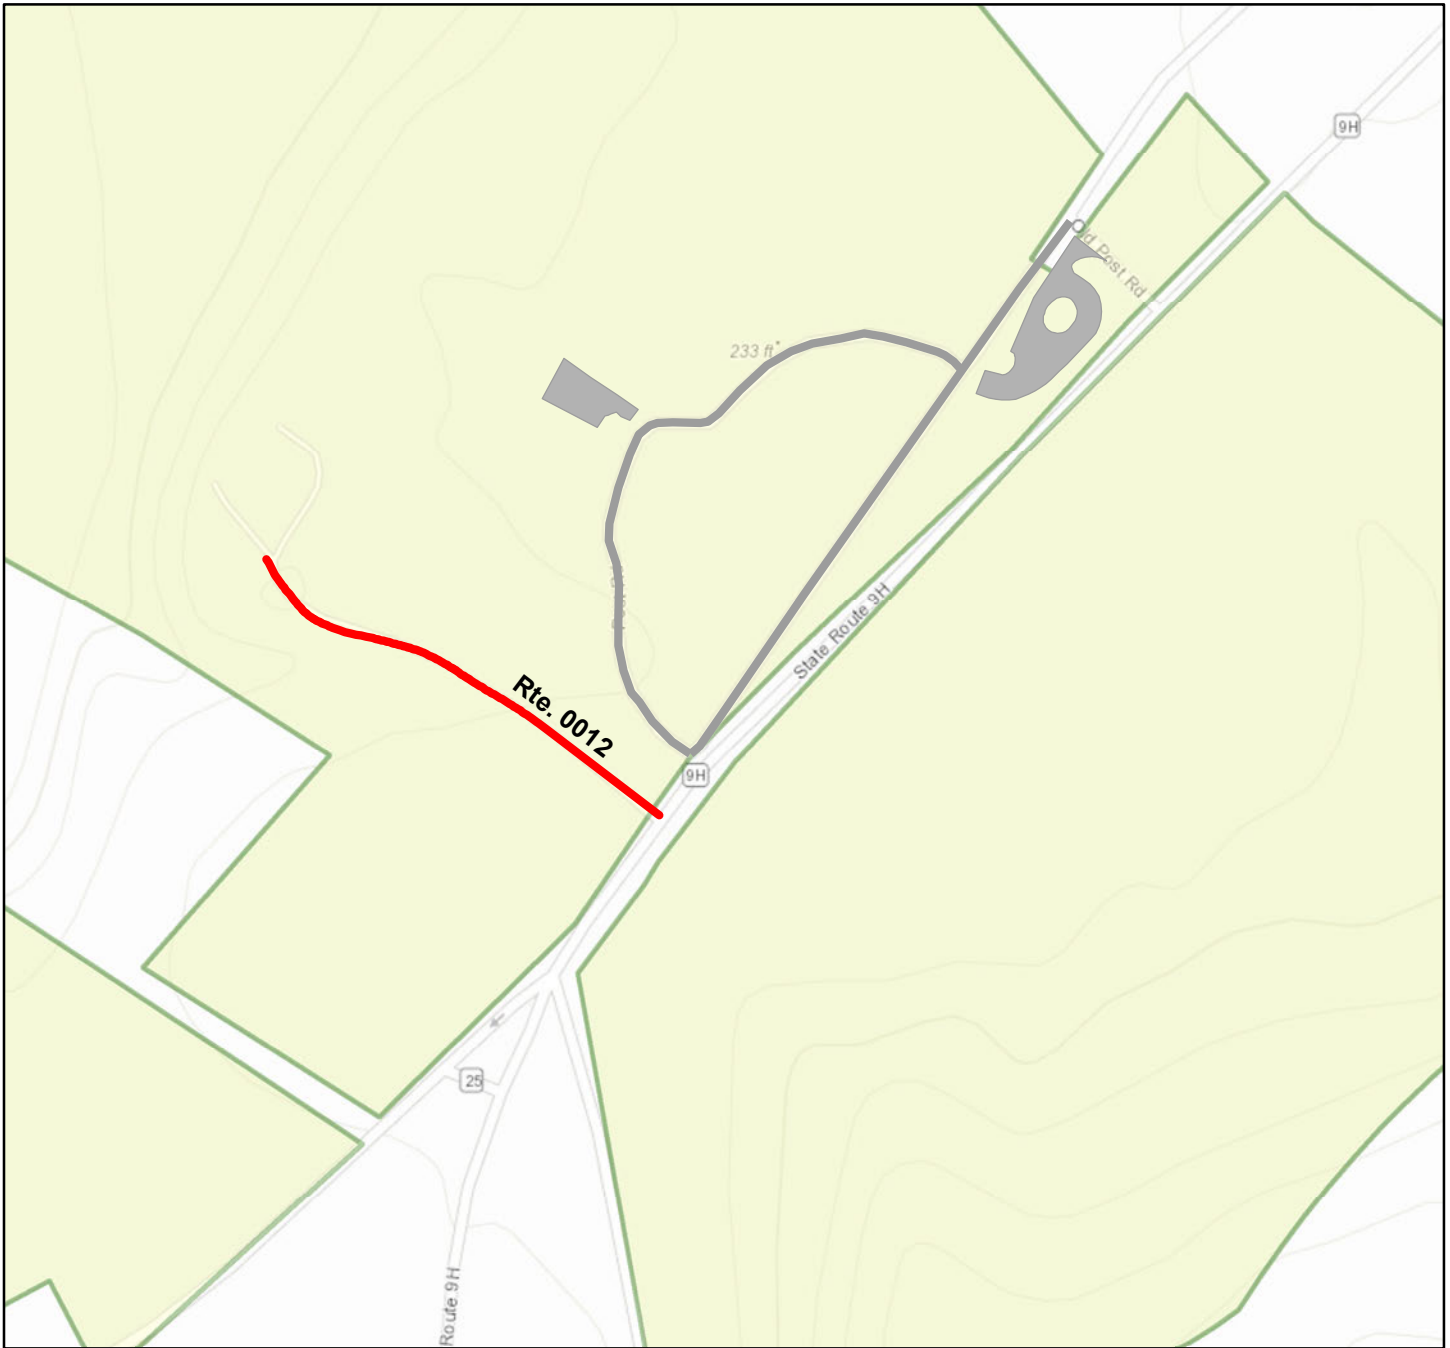
#### Area Map 1

### PCR - MILE BY MILE

Colors on map represent condition scores at 1-mile intervals. See Appendix for definitions and formulas  
Only Data Collection Vehicle and Manually Rated Roads are displayed

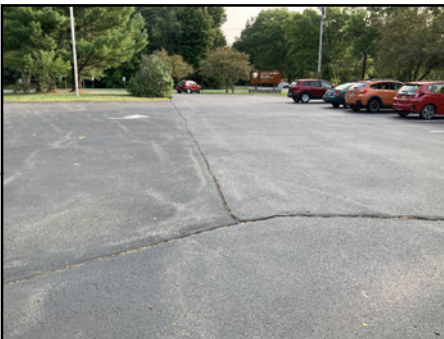
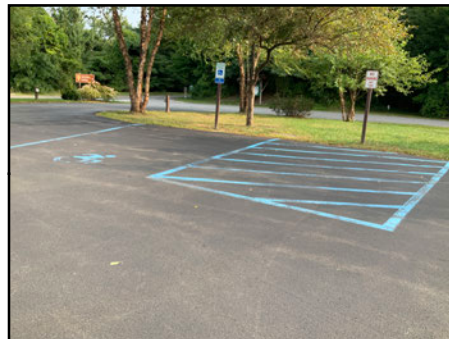
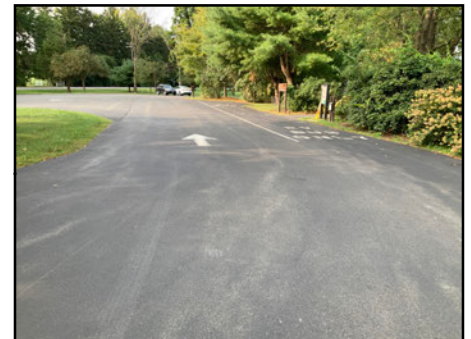
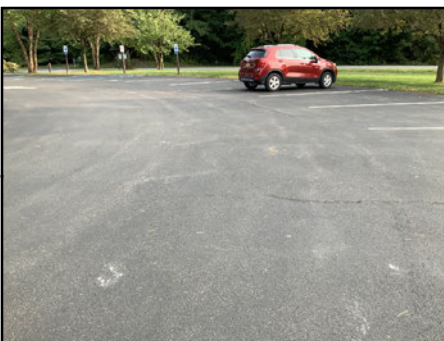
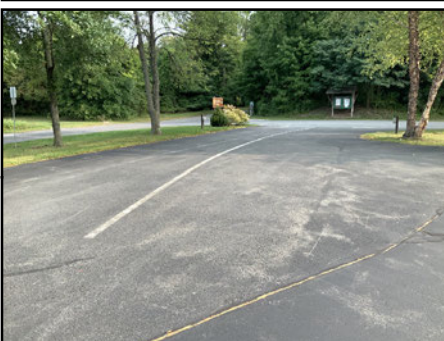
Inspection Date	FMSS Number	User Access	Surface Type
9/15/2020	75917	PUBLIC	ASPHALT
Area (Sq. Ft.)	Lane Miles (11' Widths)	Curb Reveal (Inches)	Curb Recommendation
24,378	0.42	NOT APPLICABLE	NOT APPLICABLE
Curb Type		Curb & Gutter Type	
NO CURB		NO CURB AND GUTTER	
Pavement Recommendation		Condition Rating / PCR	
PREVENTIVE MAINTENANCE		GOOD / 90
