MIMI Cycle 6

Final Report

Road Inventory and Condition Assessment of Paved Routes Minuteman Missile National Historic Site

Report Date: August 2017

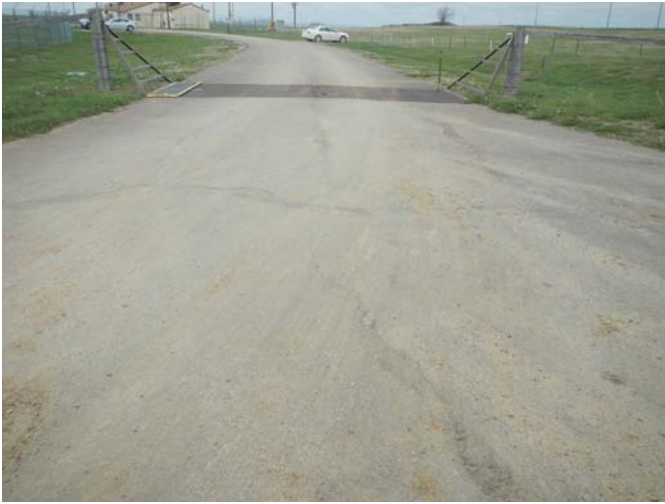
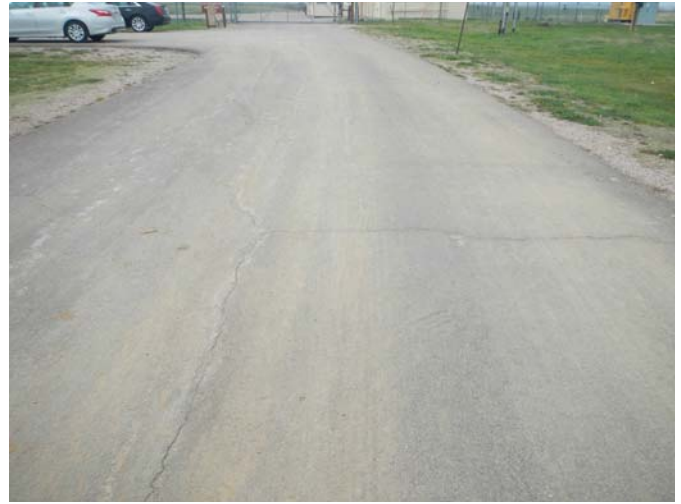
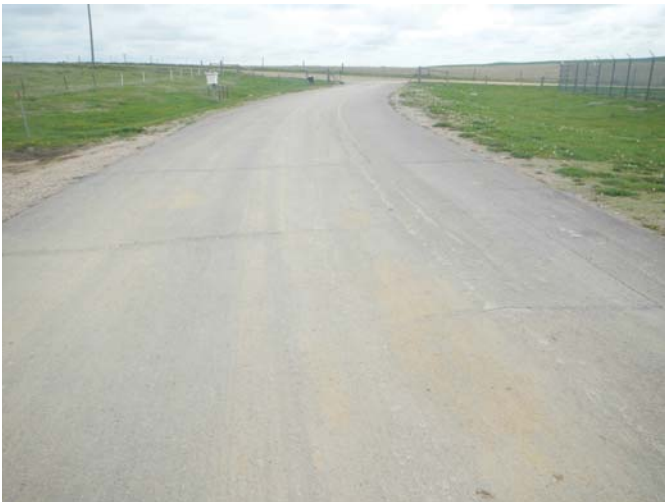
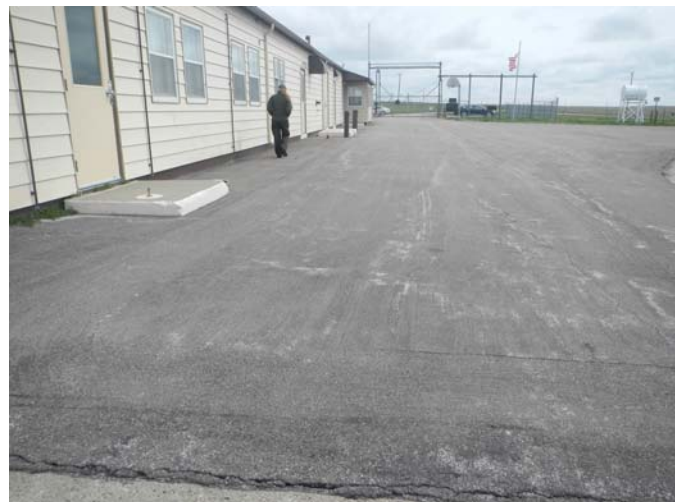
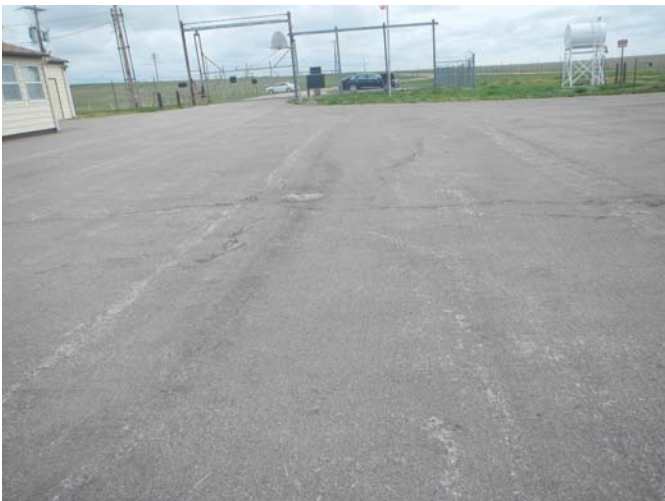
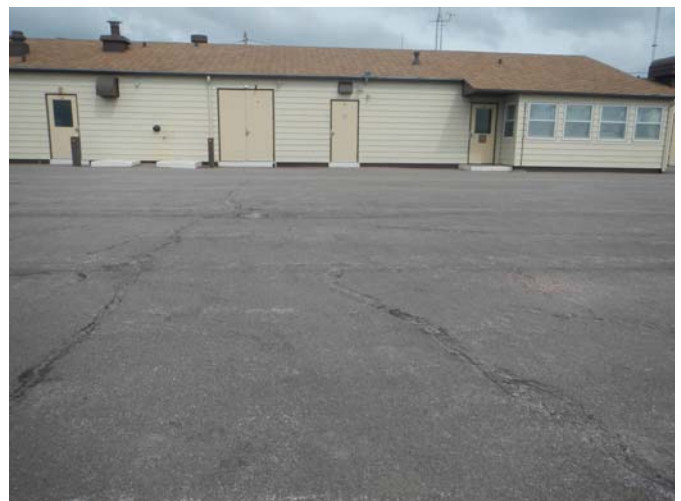
ROUTE 0900: DELTA-01 SITE OVERFLOW PARKING A

Inspection Date	FMSS Number	User Access	Surface Type
4/28/2017	103984	PUBLIC	ASPHALT
Area (Sq. Ft.)	Lane Miles (11' Widths)	Curb Reveal (Inches)	Curb Recommendation
18,400	0.317	NOT APPLICABLE	LIGHT REPAIR
Curb Type		Curb & Gutter Type	
NO CURB		CONCRETE	
Pavement Recommendation		Condition Rating / PCR	
PREVENTIVE MAINTENANCE		GOOD / 90

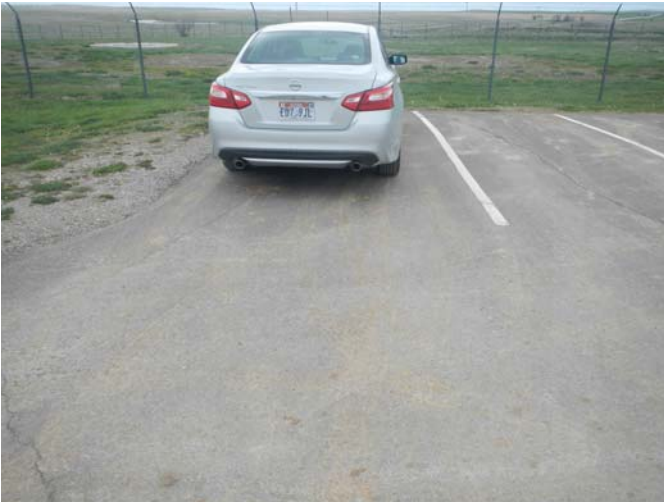
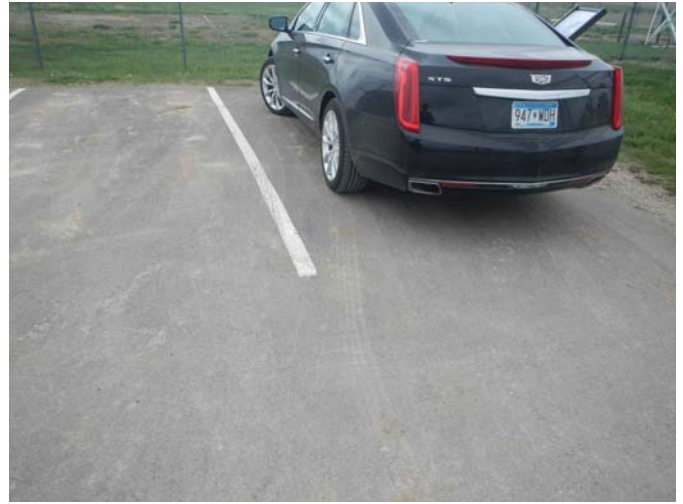
ROUTE 0901: DELTA-01 SITE VISITOR PARKING

Inspection Date	FMSS Number	User Access	Surface Type
4/28/2017	70844	PUBLIC	ASPHALT
Area (Sq. Ft.)	Lane Miles (11' Widths)	Curb Reveal (Inches)	Curb Recommendation
1,180	0.02	NOT APPLICABLE	NOT APPLICABLE
Curb Type		Curb & Gutter Type	
NO CURB		NO CURB AND GUTTER	
Pavement Recommendation		Condition Rating / PCR	
PREVENTIVE MAINTENANCE		GOOD / 90

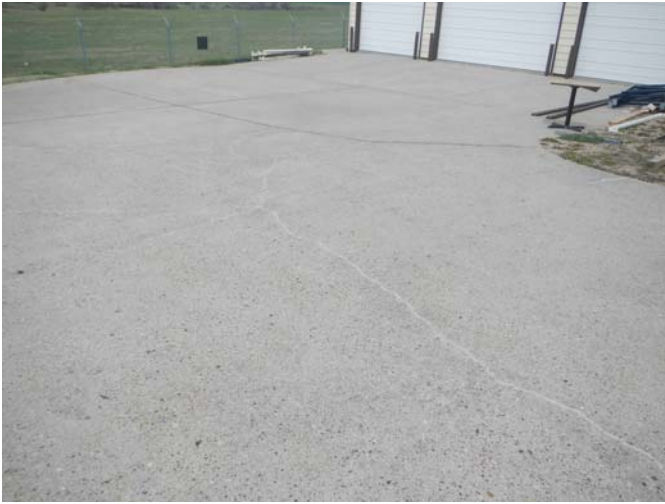
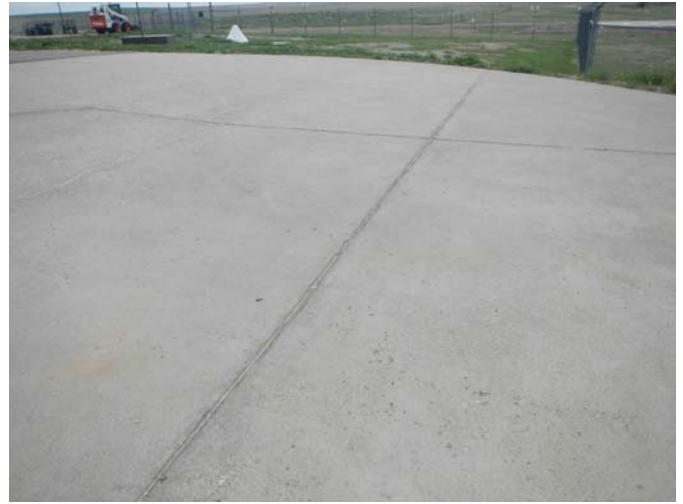
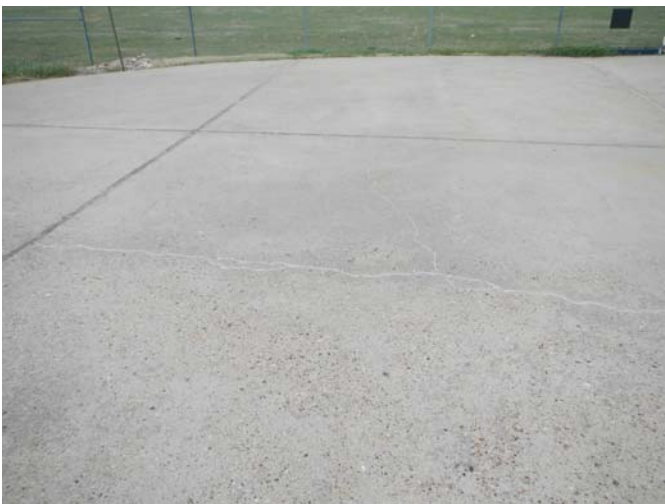
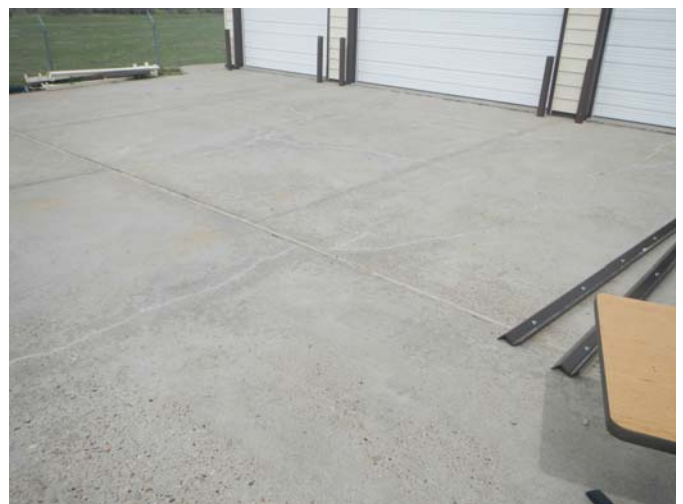
ROUTE 0902: DELTA-01 SITE OVERFLOW PARKING B

Inspection Date	FMSS Number	User Access	Surface Type
4/28/2017	70534	PUBLIC	CONCRETE
Area (Sq. Ft.)	Lane Miles (11' Widths)	Curb Reveal (Inches)	Curb Recommendation
2,193	0.038	NOT APPLICABLE	NOT APPLICABLE
Curb Type		Curb & Gutter Type	
NO CURB		NO CURB AND GUTTER	
Pavement Recommendation		Condition Rating / PCR	
PREVENTIVE MAINTENANCE		GOOD / 90

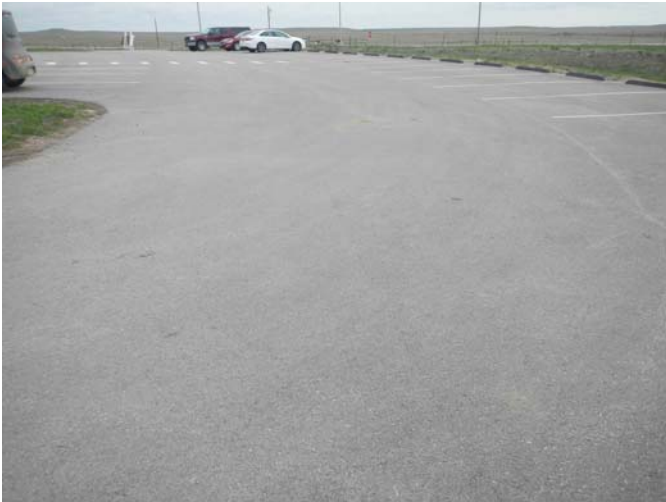
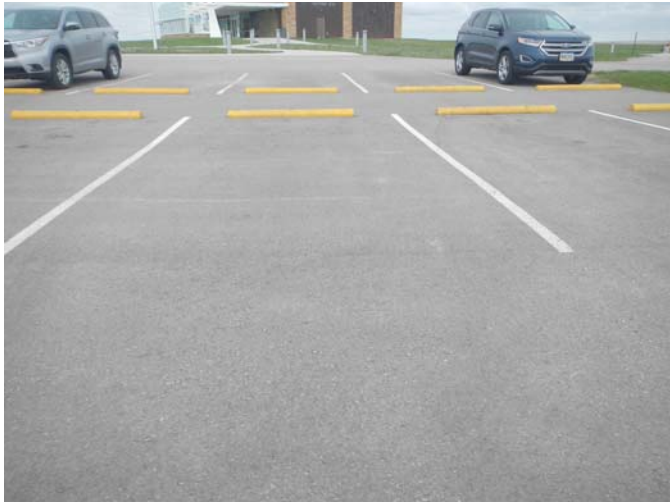
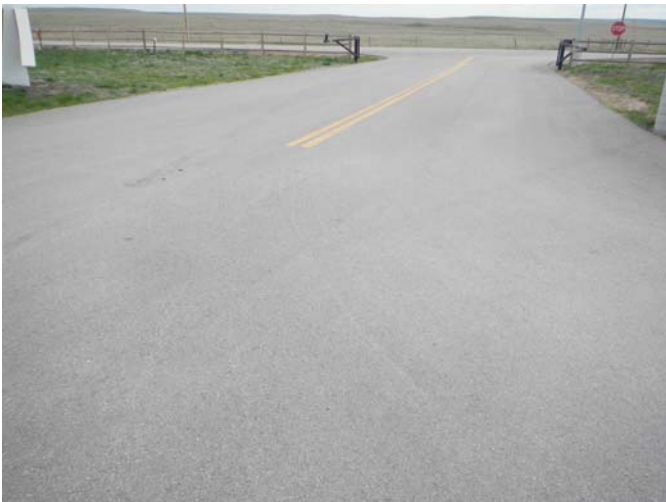
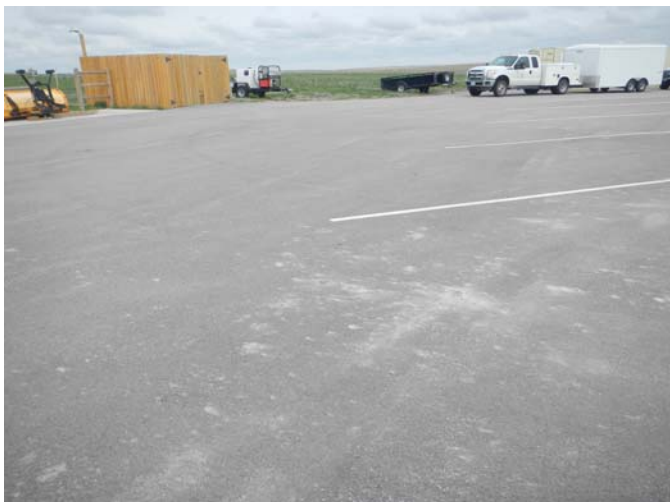
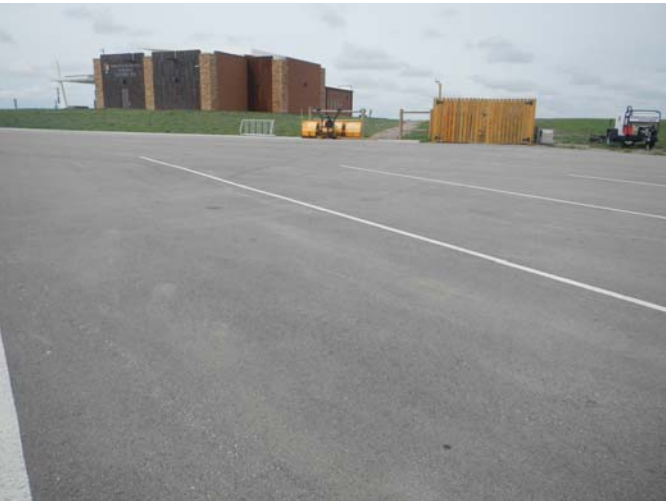
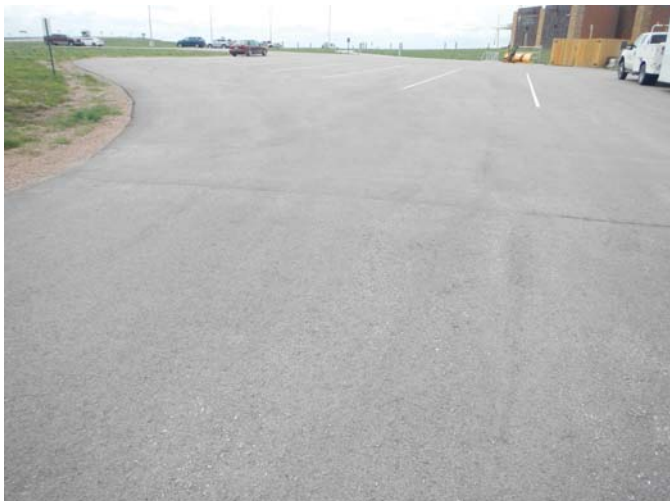
ROUTE 0904: VISITOR CENTER PARKING

Inspection Date	FMSS Number	User Access	Surface Type
4/28/2017	230936	PUBLIC	ASPHALT
Area (Sq. Ft.)	Lane Miles (11' Widths)	Curb Reveal (Inches)	Curb Recommendation
53,902	0.928	NOT APPLICABLE	NOT APPLICABLE
Curb Type		Curb & Gutter Type	
NO CURB		NO CURB AND GUTTER	
Pavement Recommendation		Condition Rating / PCR	
PREVENTIVE MAINTENANCE		GOOD / 90
