MNRR Cycle 6

Final Report

Road Inventory and Condition Assessment of Paved Routes Missouri National Recreational River

ROUTE 0900: MULBERRY BEND OVERLOOK

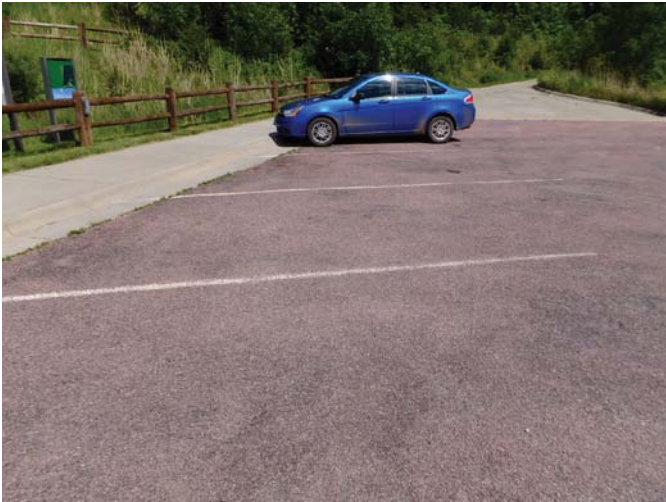
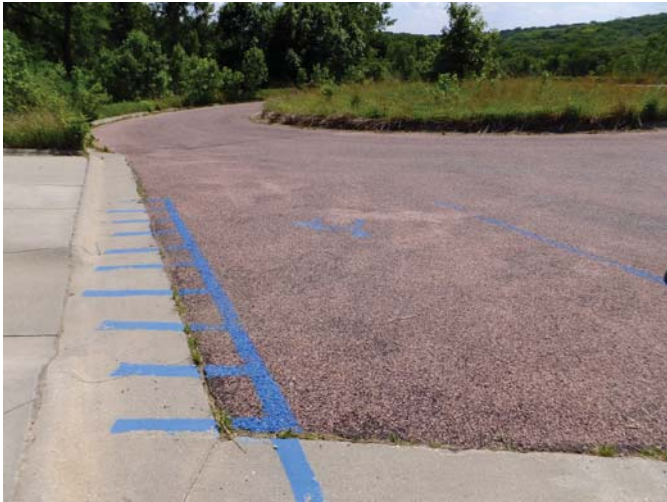
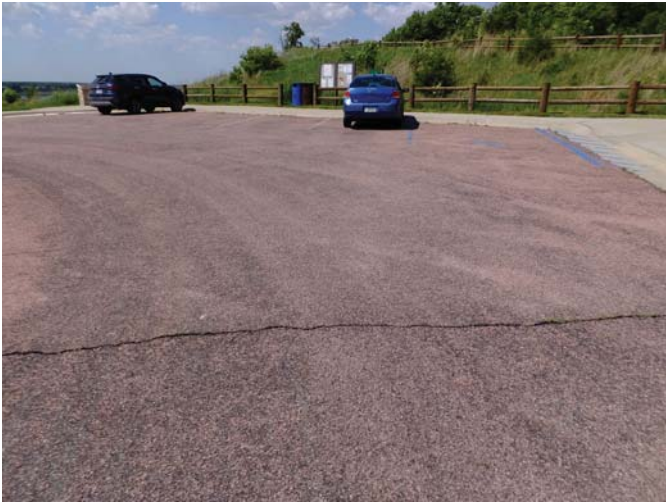
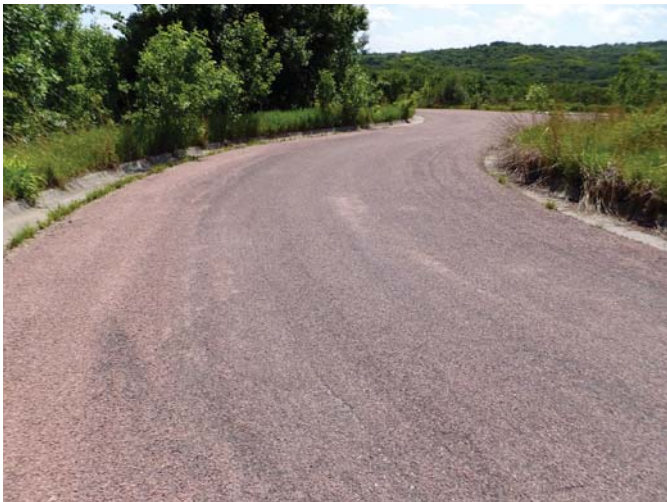
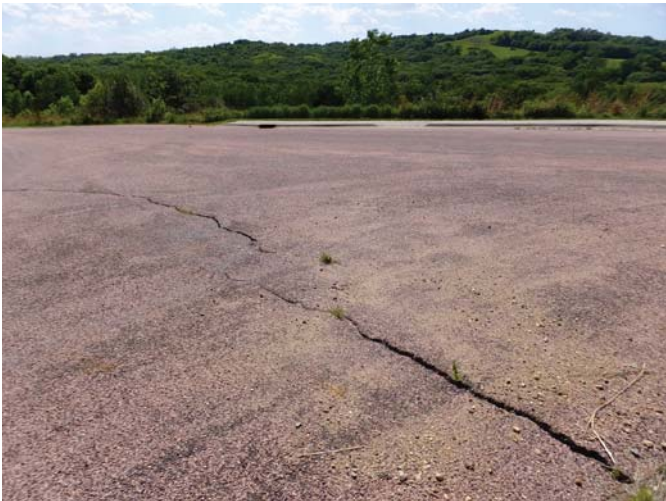
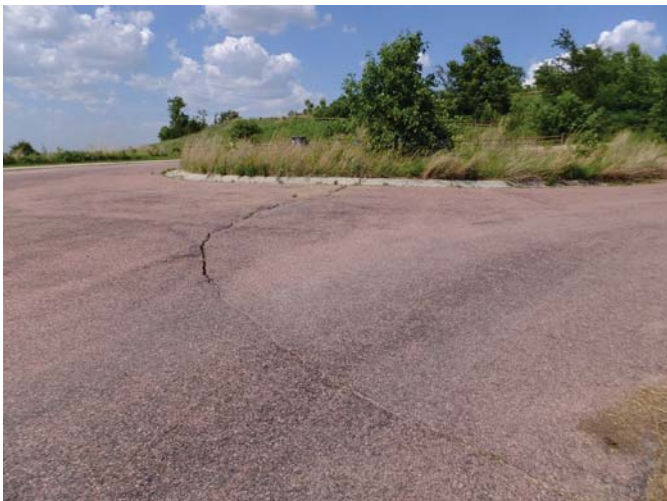
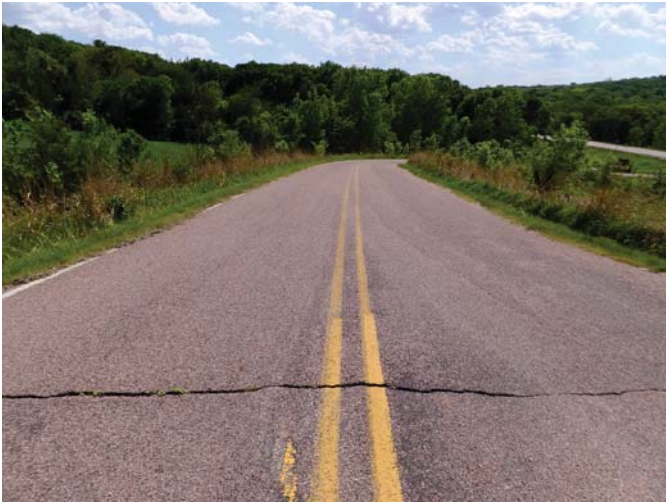
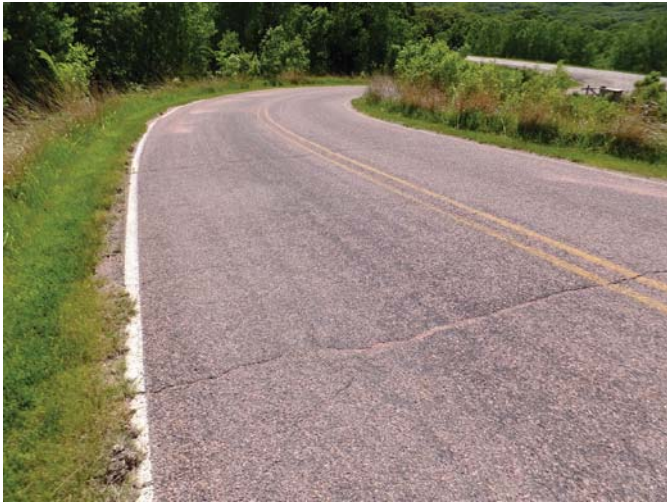
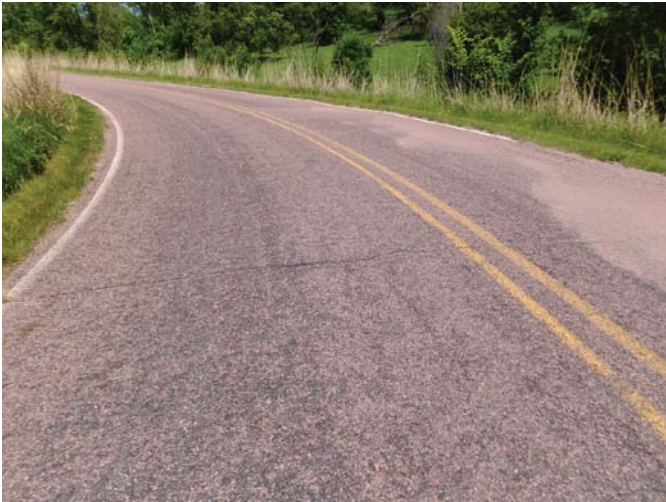
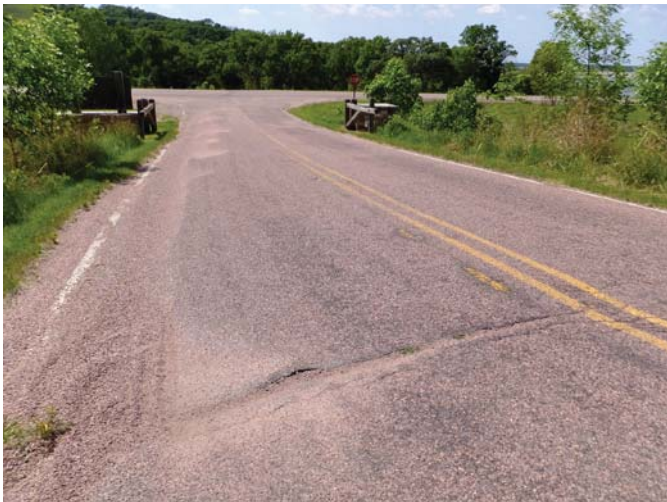
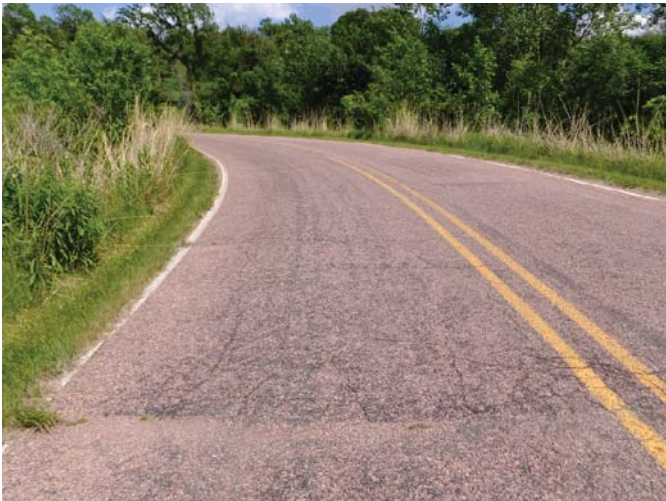
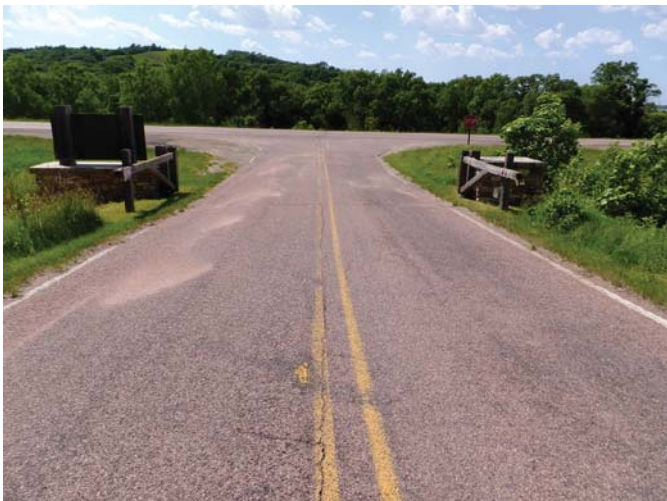
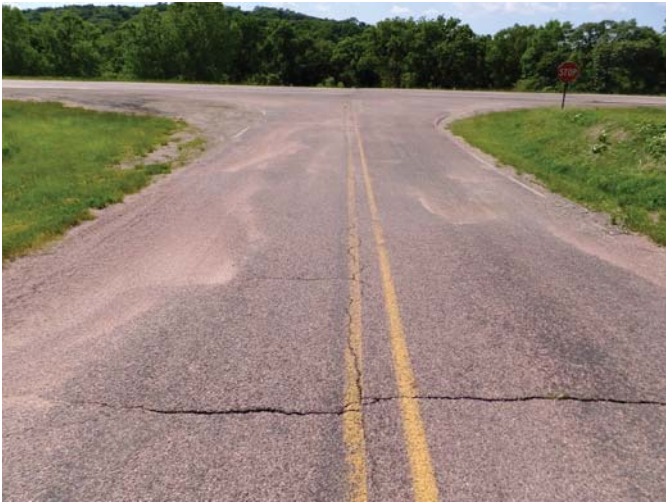
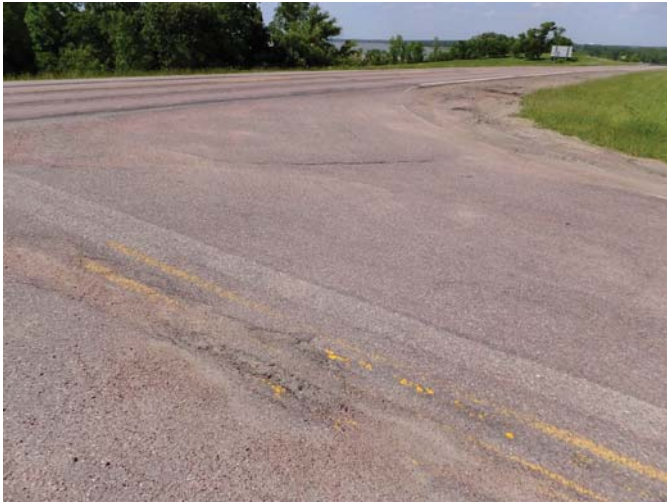
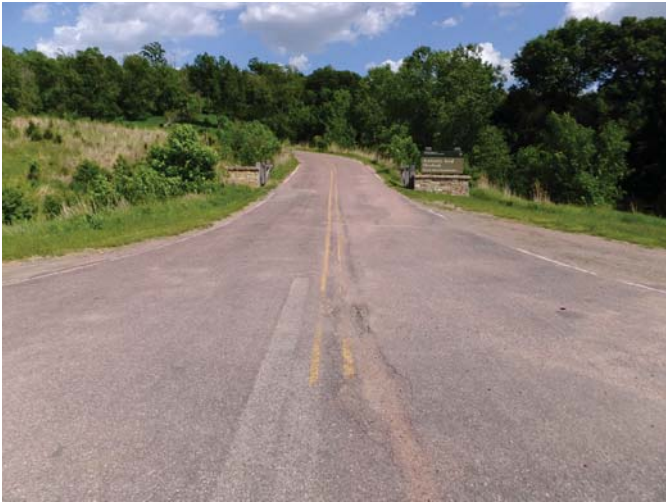
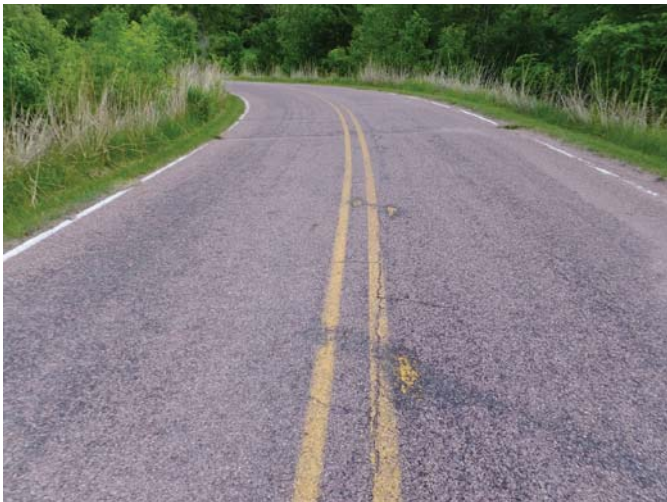
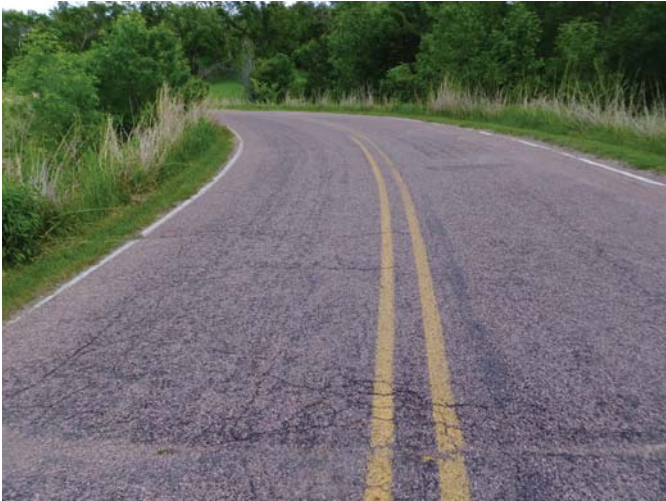
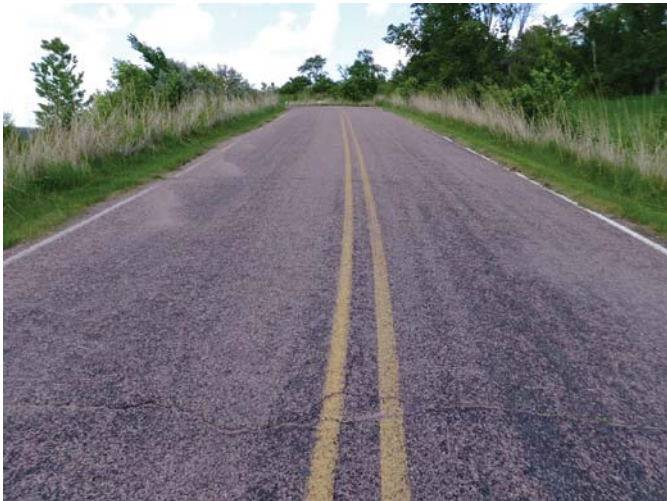
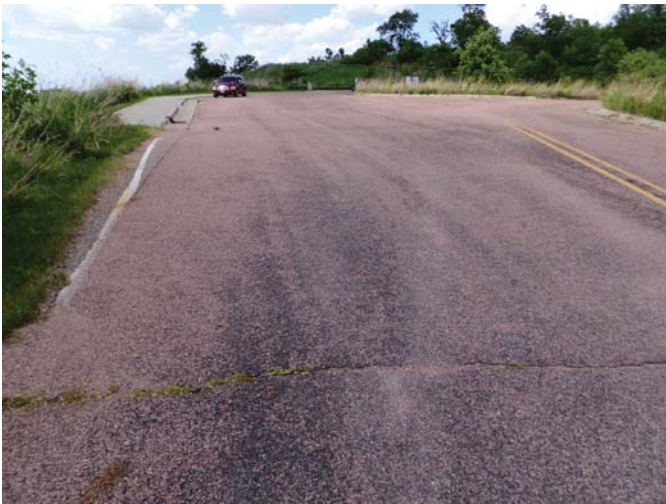
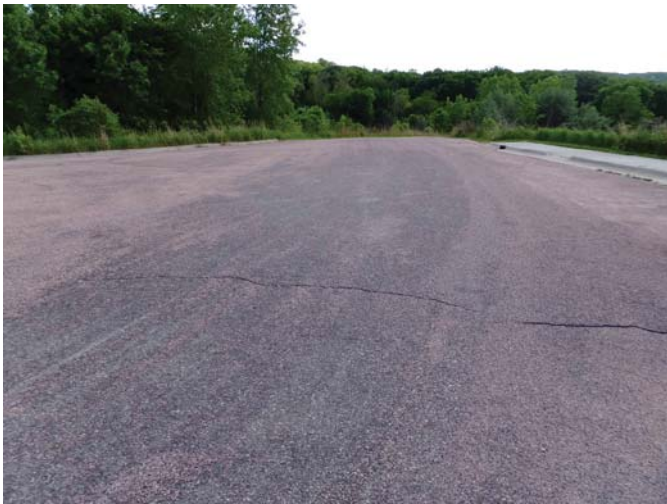
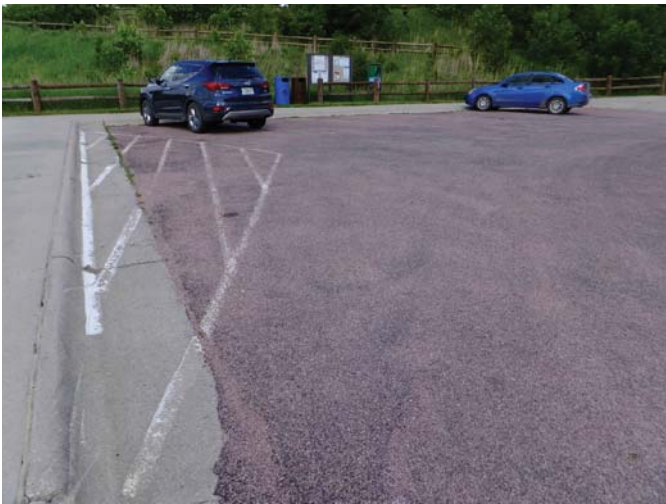
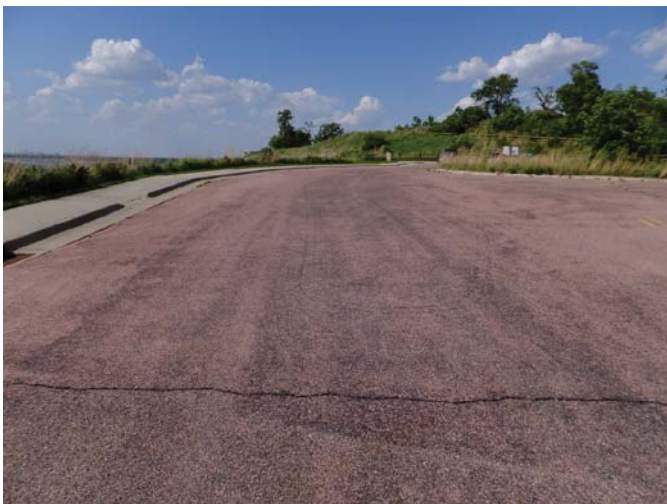
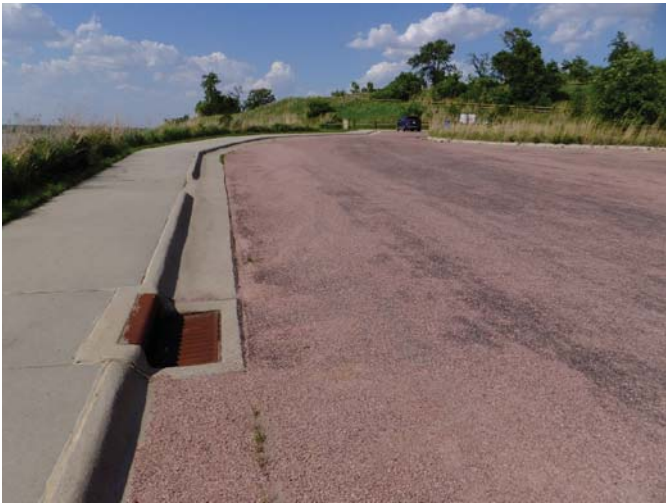
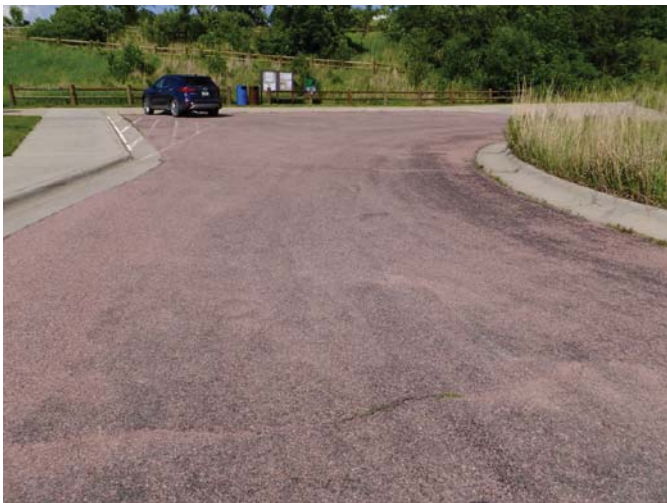
Condition Photos

Inspection Date	FMSS Number	User Access	Surface Type
6/2/2017	79897	PUBLIC	ASPHALT
Area (Sq. Ft.)	Lane Miles (11' Widths)	Curb Reveal (Inches)	Curb Recommendation
24,965	0.43	NOT APPLICABLE	DO NOTHING
Curb Type		Curb & Gutter Type	
NO CURB		CONCRETE	
Pavement Recommendation		Condition Rating / PCR	
LIGHT 3R TREATMENTS		FAIR / 73
