### MOCR Cycle 6

### Final Report

### Road Inventory and Condition Assessment of Paved Routes Moores Creek National Battlefield

**Report Date: October 2021**

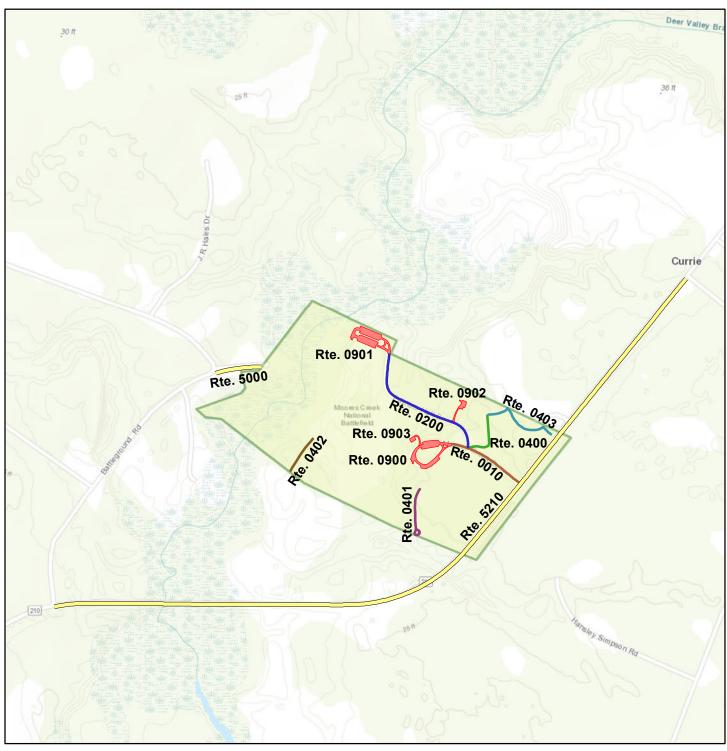
ROUTE LOCATION MAP MAP 1

Note: Unique colors are used to differentiate roads

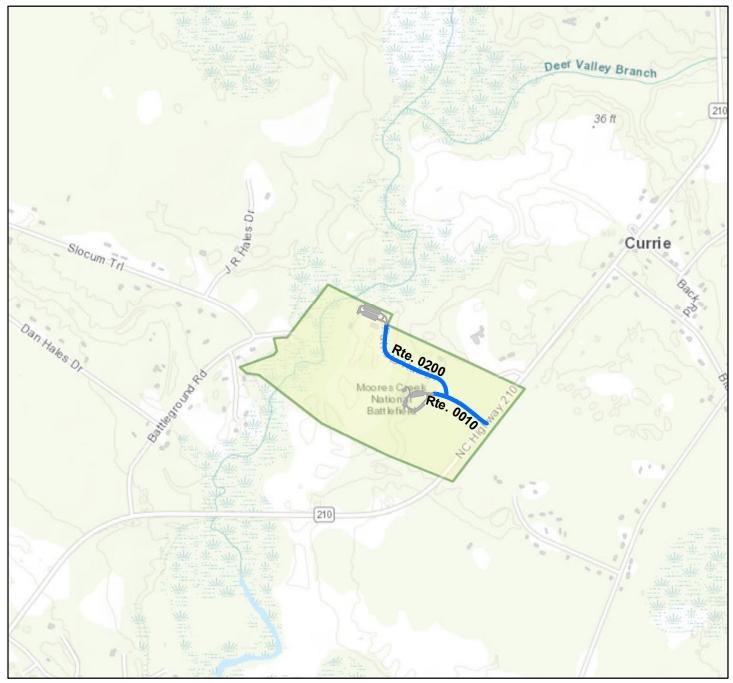
ROUTE CONDITION MAP PCR - MILE BY MILE Area Map 1

Colors on map represent condition scores at 1-mile intervals. See Appendix for definitions and formulas
Only Data Collection Vehicle and Manually Rated Roads are displayed
