MUWO Cycle 6

Final Report

Road Inventory and Condition Assessment of Paved Routes Muir Woods National Monument

Report Date: August 2015

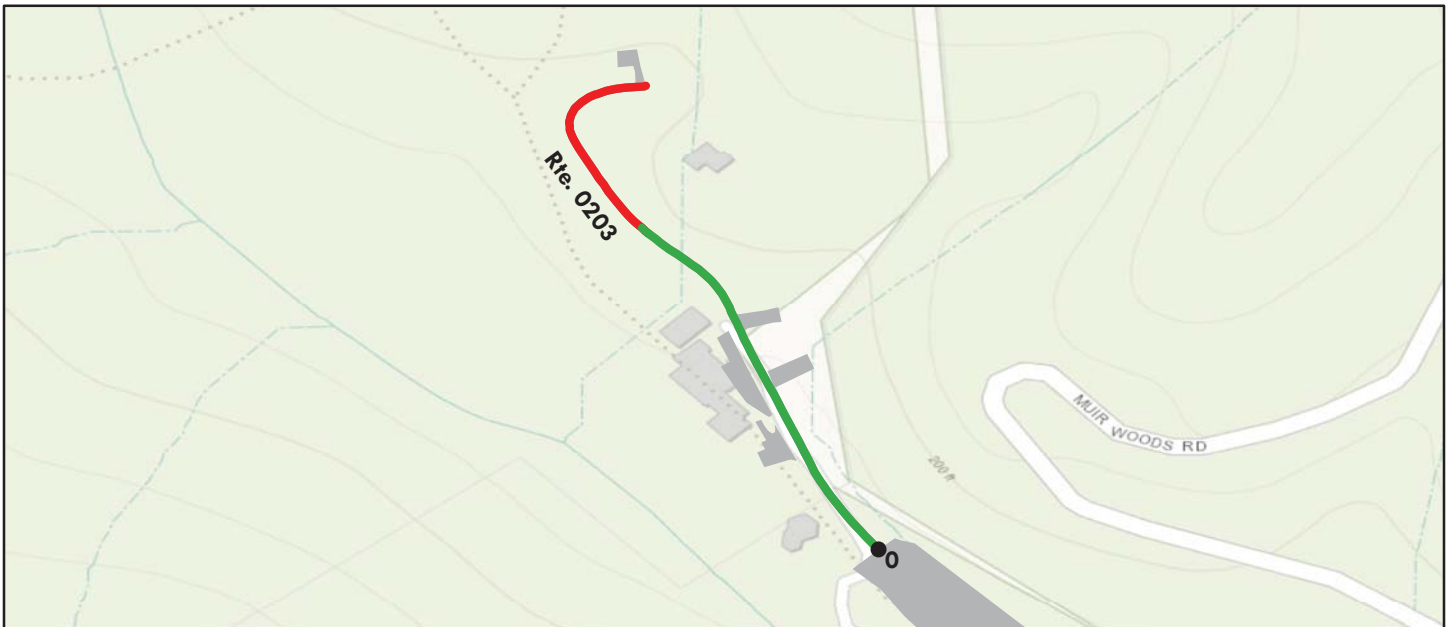
ROUTE 0203: MUIR WOODS ACCESS ROAD

Route Condition Legend – Pavement Condition Rating (PCR)						
Poor (0 - 60)	Fair (61- 84)	Good (85 - 94)	Excellent (95 - 100)	Not Rated		
See Appendix for definitions and formulas						
Inspection Date: 1/20/2015	Beginning Section MP	0				
Paved Length (Miles): 0.16	Section Length (MI)	0.16				
Surface Type: ASPHALT	Route Summary					
Roadway Condition Information						
Pavement Condition Rating (PCR)	67	67				
Surface Condition Rating (SCR)	67	67				
Roughness Condition Index (RCI)	N/A	N/A				
Distress Index Values						
Structural Crack Index	67	67				
Alligator Crack Index	91	91				
Longitudinal Crack Index	76	76				
Transverse Cracking Index	90	90				
Patching Index	97	97				
Rutting Index	88	88				
International Roughness Index (IRI)	N/A	N/A				
Lane & Width Information						
Number of Lanes	1	1				
Paved Width (ft)	9.6	9.6				
Lane Width (ft)	9.6	9.6

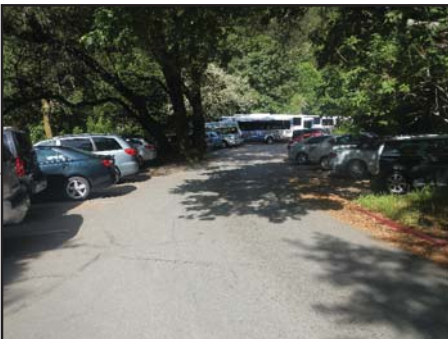
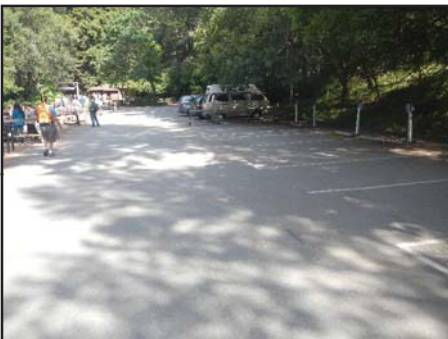
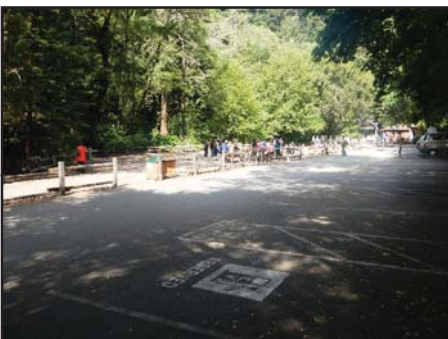
Inspection Date	FMSS Number	User Access	Surface Type
5/2/2014	80164	PUBLIC	ASPHALT
Area (Sq. Ft.)	Lane Miles (11' Widths)	Curb Reveal (Inches)	Curb Recommendation
45,447	0.782	5	LIGHT REPAIR
Curb Type		Curb & Gutter Type	
ASPHALT AND WOOD		NO CURB AND GUTTER	
Pavement Recommendation		Condition Rating / PCR	
PREVENTIVE MAINTENANCE		GOOD / 90

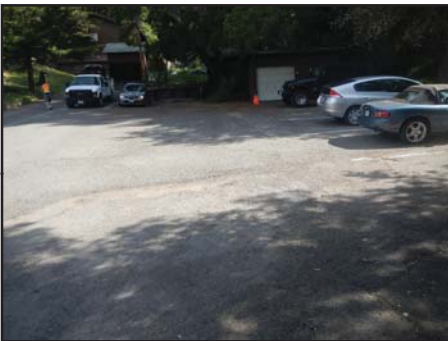
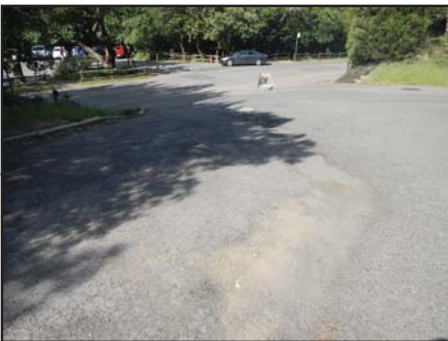
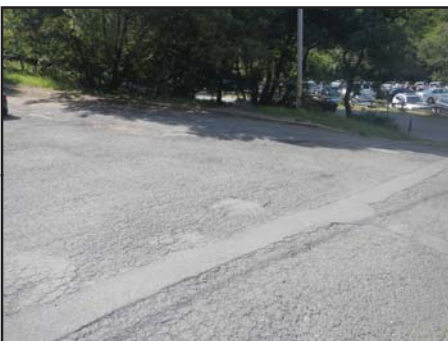
ROUTE 0901: MUIR WOODS OLD INN PARKING

Inspection Date	FMSS Number	User Access	Surface Type
5/2/2014	80165	NONPUBLIC	ASPHALT
Area (Sq. Ft.)	Lane Miles (11' Widths)	Curb Reveal (Inches)	Curb Recommendation
13,790	0.237	3	LIGHT REPAIR
Curb Type		Curb & Gutter Type	
CONCRETE AND WOOD		NO CURB AND GUTTER	
Pavement Recommendation		Condition Rating / PCR	
RECONSTRUCTION		POOR / 30

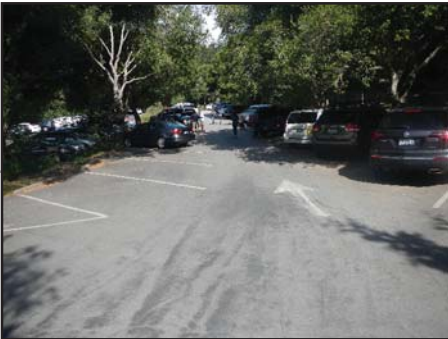
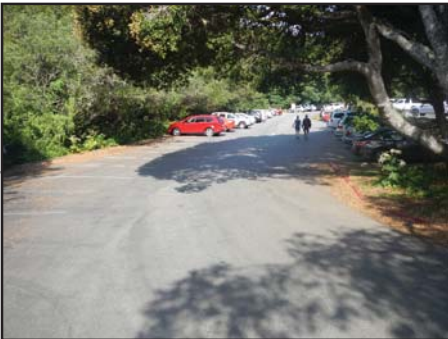
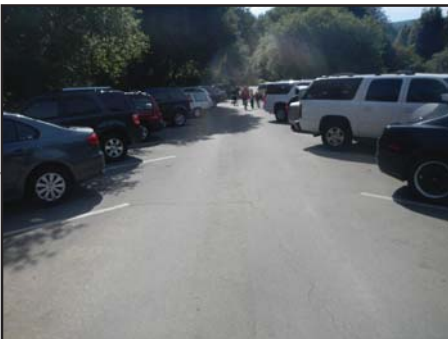
ROUTE 0902: MUIR WOODS LOWER ANNEX PARKING

Inspection Date	FMSS Number	User Access	Surface Type
5/2/2014	80166	PUBLIC	ASPHALT
Area (Sq. Ft.)	Lane Miles (11' Widths)	Curb Reveal (Inches)	Curb Recommendation
33,860	0.583	NOT APPLICABLE	NOT APPLICABLE
Curb Type		Curb & Gutter Type	
NO CURB		NO CURB AND GUTTER	
Pavement Recommendation		Condition Rating / PCR	
HEAVY 3R TREATMENTS		POOR / 53

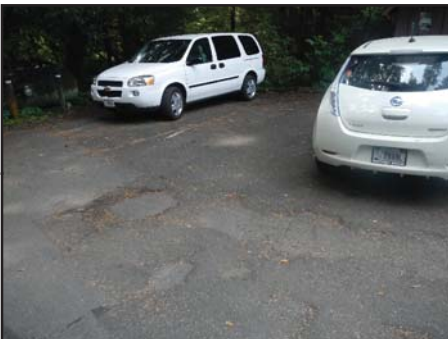
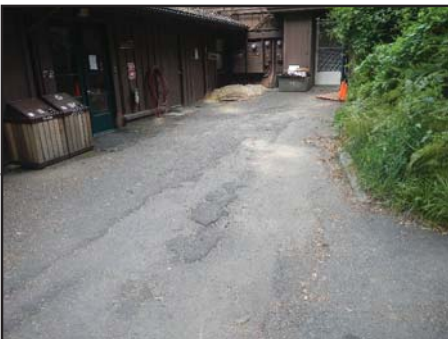
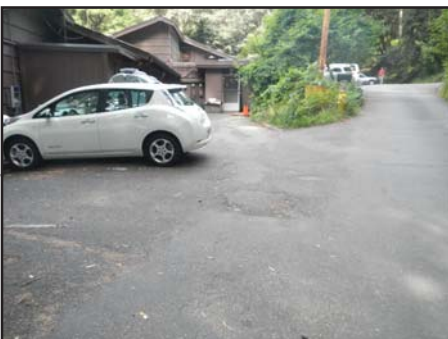
ROUTE 0903AZ: MUIR WOODS ARAMARK-NPS ADMINISTRATIVE PARKING A

Inspection Date	FMSS Number	User Access	Surface Type
5/2/2014	80169	NONPUBLIC	ASPHALT
Area (Sq. Ft.)	Lane Miles (11' Widths)	Curb Reveal (Inches)	Curb Recommendation
1,221	0.021	NOT APPLICABLE	NOT APPLICABLE
Curb Type		Curb & Gutter Type	
NO CURB		NO CURB AND GUTTER	
Pavement Recommendation		Condition Rating / PCR	
RECONSTRUCTION		POOR / 30

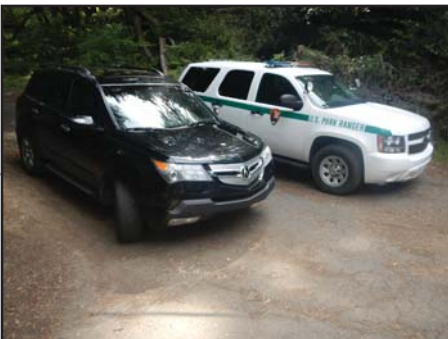
ROUTE 0903BZ: MUIR WOODS ARAMARK-NPS ADMINISTRATIVE PARKING B

Inspection Date	FMSS Number	User Access	Surface Type
5/2/2014	80169	NONPUBLIC	ASPHALT
Area (Sq. Ft.)	Lane Miles (11' Widths)	Curb Reveal (Inches)	Curb Recommendation
1,016	0.017	NOT APPLICABLE	NOT APPLICABLE
Curb Type		Curb & Gutter Type	
NO CURB		NO CURB AND GUTTER	
Pavement Recommendation		Condition Rating / PCR	
RECONSTRUCTION		POOR / 30

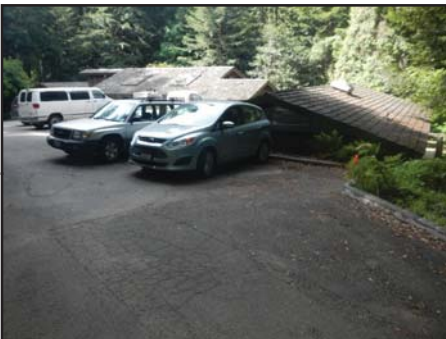
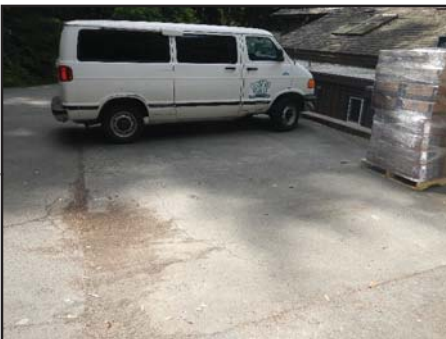
ROUTE 0903CZ: MUIR WOODS ARAMARK-NPS ADMINISTRATIVE PARKING C

Inspection Date	FMSS Number	User Access	Surface Type
5/2/2014	80169	NONPUBLIC	CONCRETE
Area (Sq. Ft.)	Lane Miles (11' Widths)	Curb Reveal (Inches)	Curb Recommendation
2,010	0.035	5	DO NOTHING
Curb Type		Curb & Gutter Type	
CONCRETE		NO CURB AND GUTTER	
Pavement Recommendation		Condition Rating / PCR	
HEAVY 3R TREATMENTS		POOR / 53

This parking area consists of multiple surface types: 1 part Asphalt at 844 square feet; 1 part concrete at 1,166 square feet.

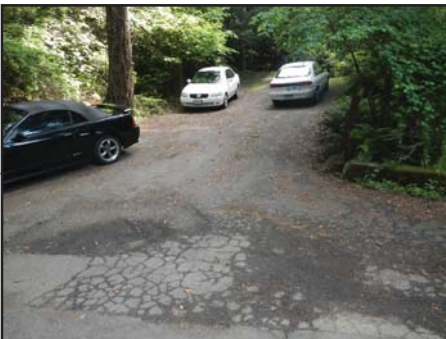
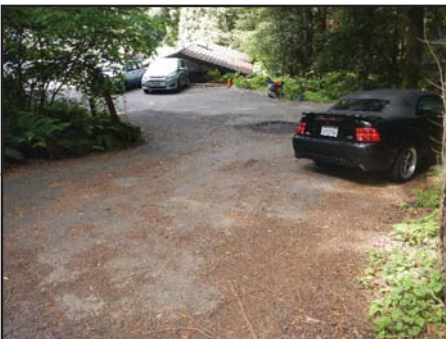
ROUTE 0903DZ: MUIR WOODS ARAMARK-NPS ADMINISTRATIVE PARKING D

Inspection Date	FMSS Number	User Access	Surface Type
5/2/2014	80169	NONPUBLIC	ASPHALT
Area (Sq. Ft.)	Lane Miles (11' Widths)	Curb Reveal (Inches)	Curb Recommendation
836	0.014	NOT APPLICABLE	NOT APPLICABLE
Curb Type		Curb & Gutter Type	
NO CURB		NO CURB AND GUTTER	
Pavement Recommendation		Condition Rating / PCR	
RECONSTRUCTION		POOR / 30

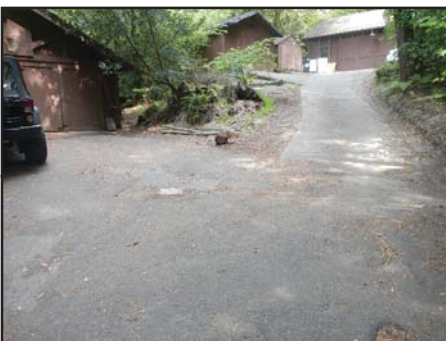
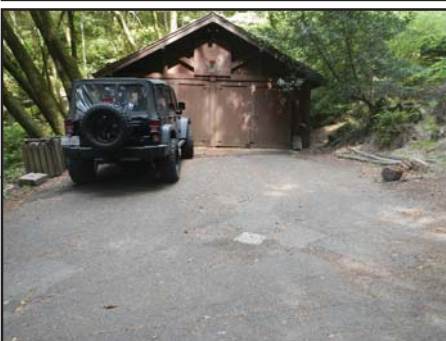
ROUTE 0903EZ: MUIR WOODS ARAMARK-NPS ADMINISTRATIVE PARKING E

Inspection Date	FMSS Number	User Access	Surface Type
5/2/2014	80169	NONPUBLIC	ASPHALT
Area (Sq. Ft.)	Lane Miles (11' Widths)	Curb Reveal (Inches)	Curb Recommendation
656	0.011	NOT APPLICABLE	NOT APPLICABLE
Curb Type		Curb & Gutter Type	
NO CURB		NO CURB AND GUTTER	
Pavement Recommendation		Condition Rating / PCR	
HEAVY 3R TREATMENTS		POOR / 53

This parking area consists of multiple surface types: 1 part Asphalt at 454 square feet; 1 part concrete at 202 square feet.
