# NISI Cycle 6

### Road Inventory and Condition Assessment of Paved Routes Ninety Six National Historic Site

**Federal Highway Administration  
Eastern Federal Lands Highway Division  
Road Inventory Program (RIP)**

**Report Date: November 2021**

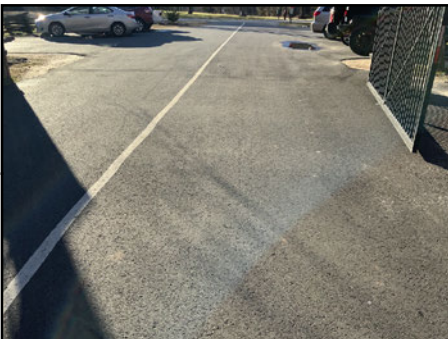
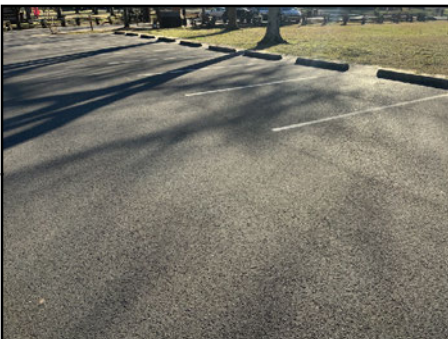
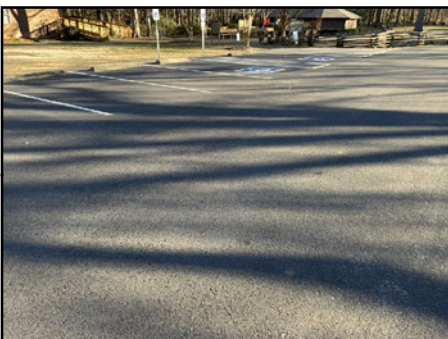
Inspection Date	FMSS Number	User Access	Surface Type
2/7/2021	75619	PUBLIC	ASPHALT
Area (Sq. Ft.)	Lane Miles (11' Widths)	Curb Reveal (Inches)	Curb Recommendation
20,974	0.361	NOT APPLICABLE	NOT APPLICABLE
Curb Type		Curb & Gutter Type	
NO CURB		NO CURB AND GUTTER	
Pavement Recommendation		Condition Rating / PCR	
DO NOTHING		EXCELLENT / 97

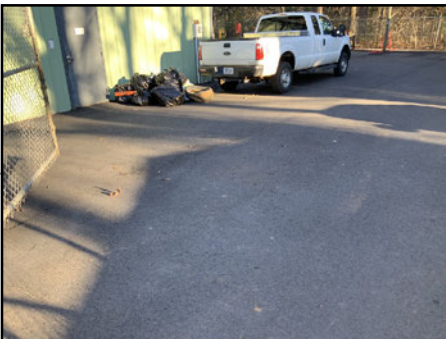
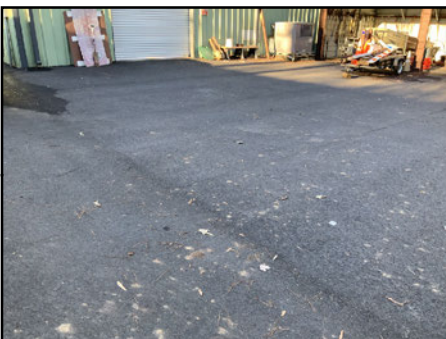
## ROUTE 0901: MAINTENANCE AREA PARKING

Inspection Date	FMSS Number	User Access	Surface Type
2/7/2021	75622	NONPUBLIC	ASPHALT
Area (Sq. Ft.)	Lane Miles (11' Widths)	Curb Reveal (Inches)	Curb Recommendation
6,978	0.12	NOT APPLICABLE	NOT APPLICABLE
Curb Type		Curb & Gutter Type	
NO CURB		NO CURB AND GUTTER	
Pavement Recommendation		Condition Rating / PCR	
DO NOTHING		EXCELLENT / 97
