# OBRI Cycle 6

## Final Report

### Road Inventory and Condition Assessment of Paved Routes Obed Wild and Scenic River

**Report Date: October 2021**

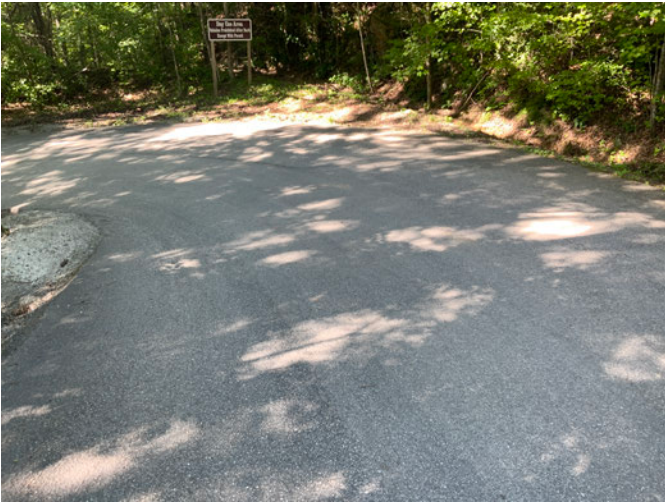
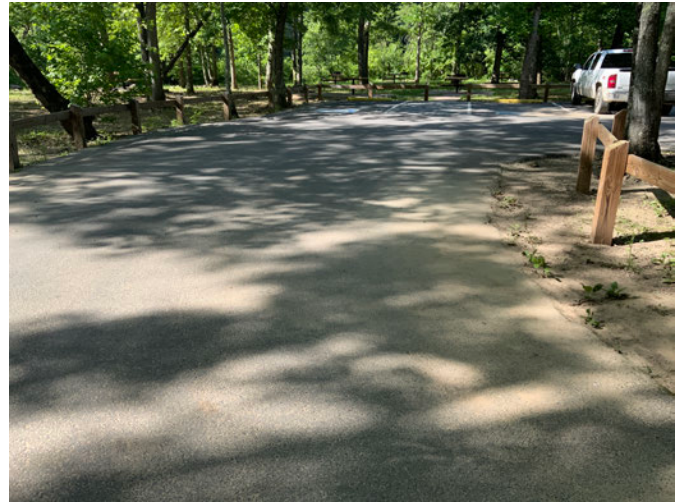
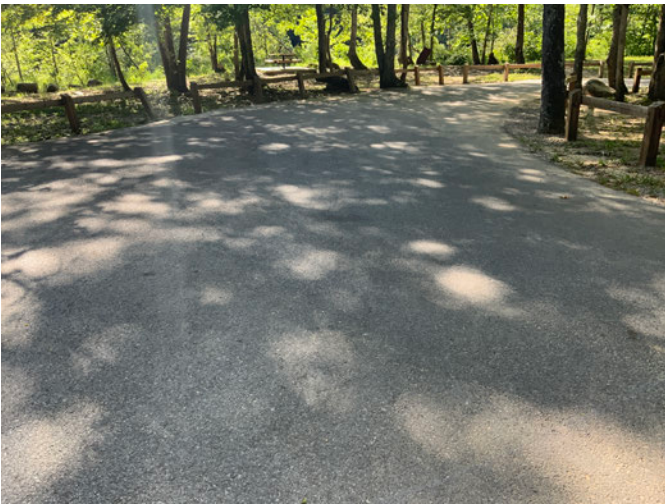
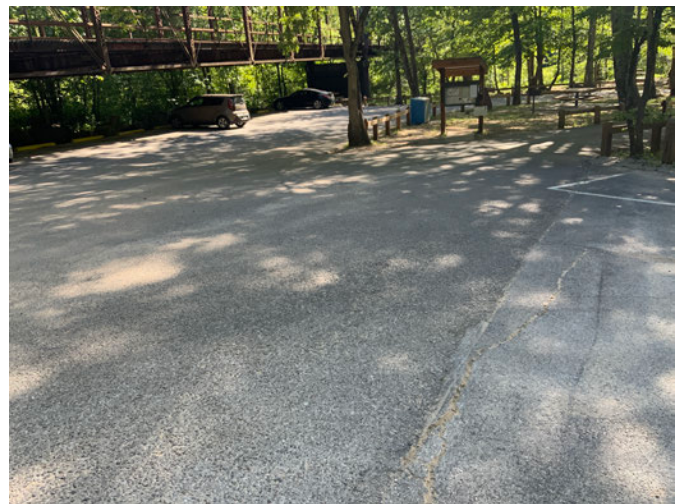
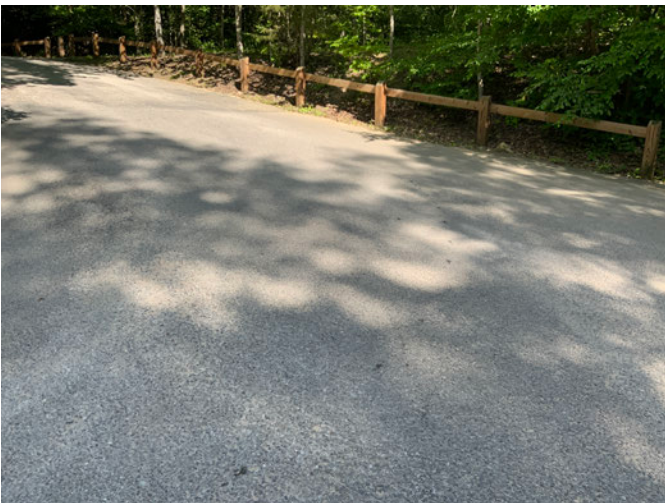
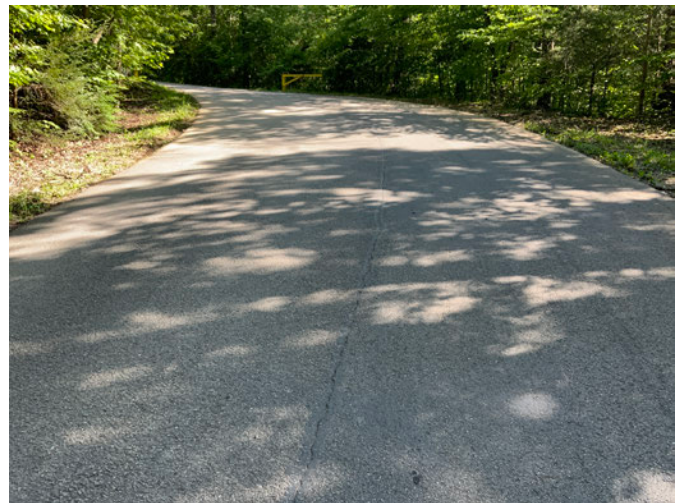
## ROUTE 0900: NEMO PICNIC AREA PARKING

Inspection Date	FMSS Number	User Access	Surface Type
6/16/2021	68585	PUBLIC	ASPHALT
Area (Sq. Ft.)	Lane Miles (11' Widths)	Curb Reveal (Inches)	Curb Recommendation
27,792	0.479	NOT APPLICABLE	NOT APPLICABLE
Curb Type		Curb & Gutter Type	
NO CURB		NO CURB AND GUTTER	
Pavement Recommendation		Condition Rating / PCR	
PREVENTIVE MAINTENANCE		GOOD / 90

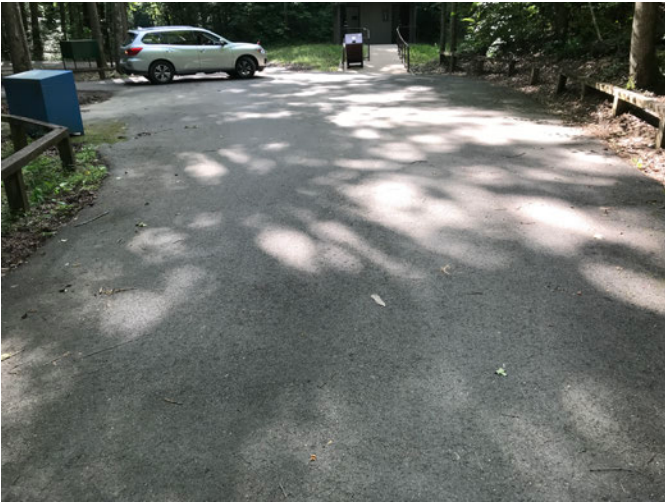
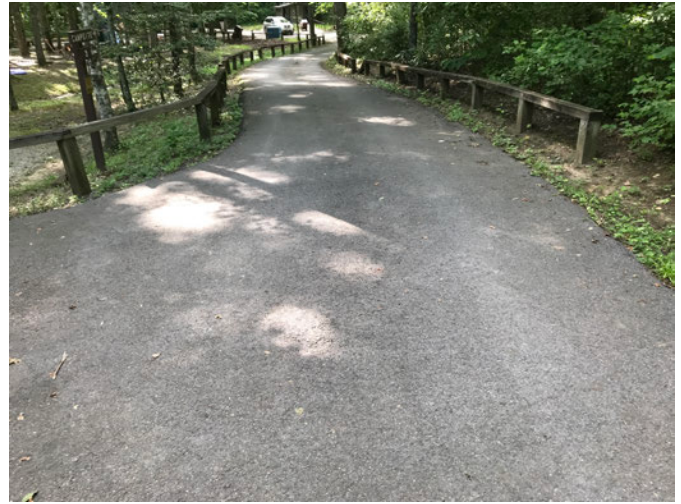
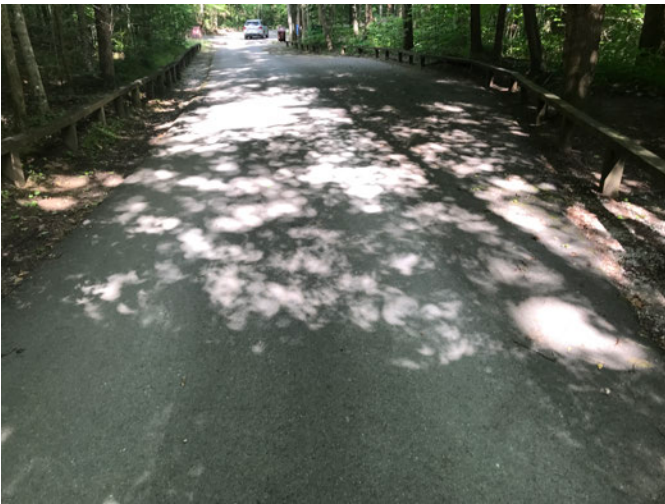
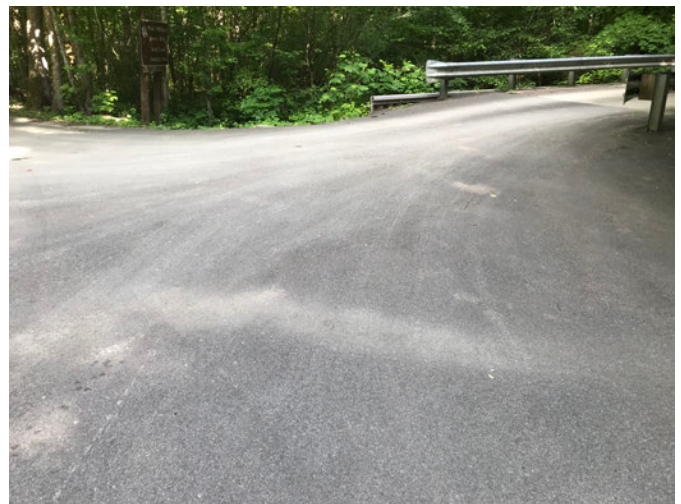
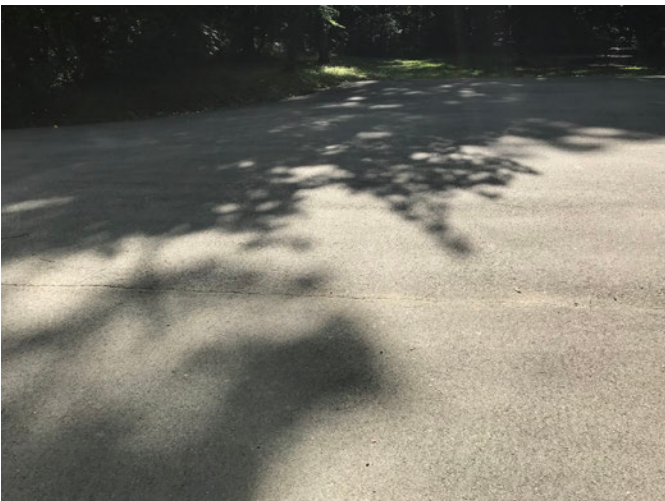
## ROUTE 0901: ROCK CREEK CAMPGROUND PARKING

Inspection Date	FMSS Number	User Access	Surface Type
6/16/2021	68643	PUBLIC	ASPHALT
Area (Sq. Ft.)	Lane Miles (11' Widths)	Curb Reveal (Inches)	Curb Recommendation
18,407	0.317	NOT APPLICABLE	NOT APPLICABLE
Curb Type		Curb & Gutter Type	
NO CURB		NO CURB AND GUTTER	
Pavement Recommendation		Condition Rating / PCR	
PREVENTIVE MAINTENANCE		GOOD / 90

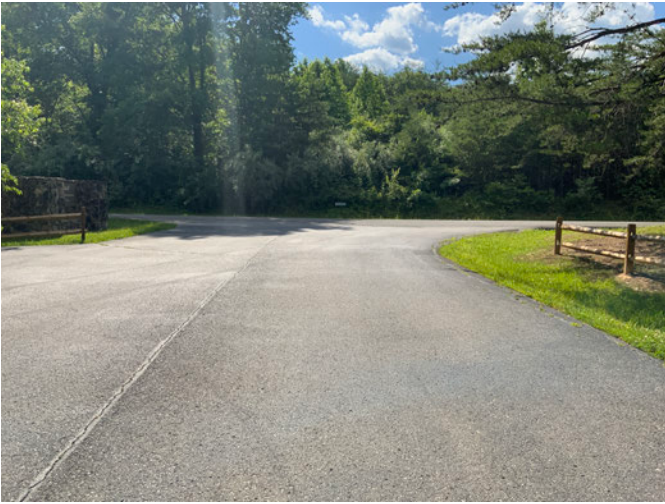
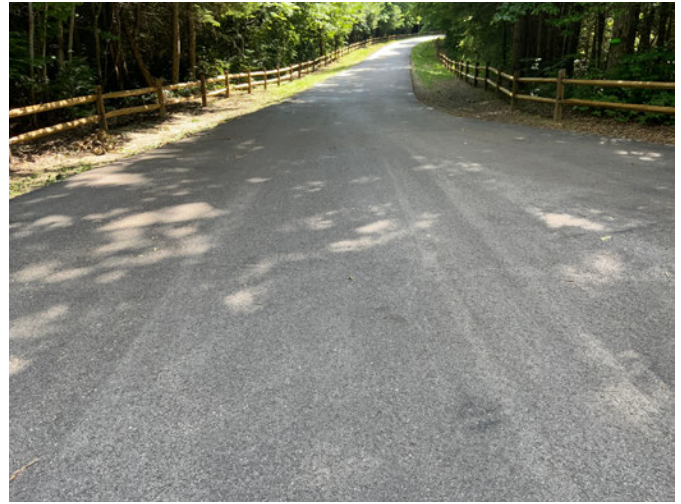
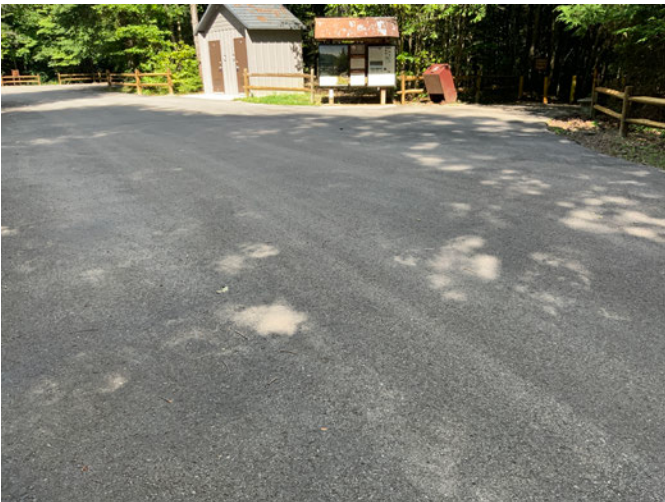
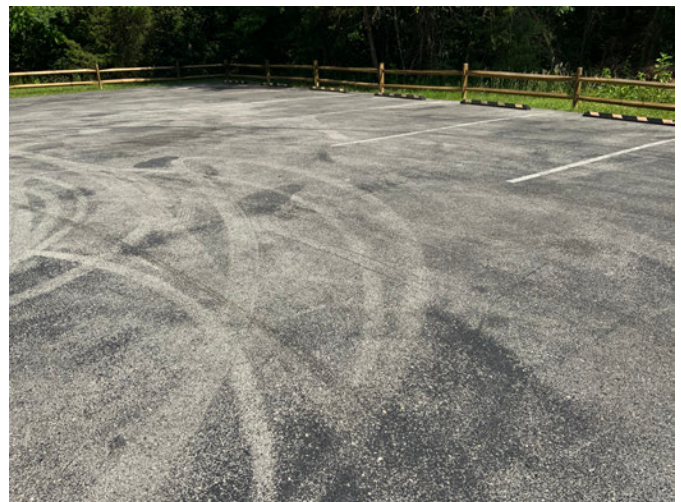
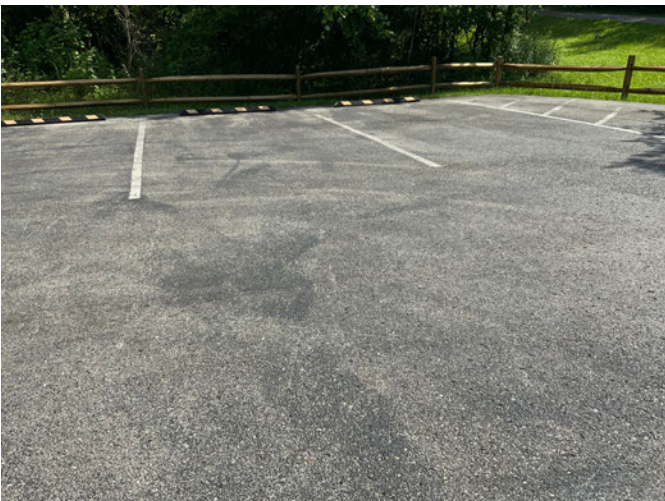
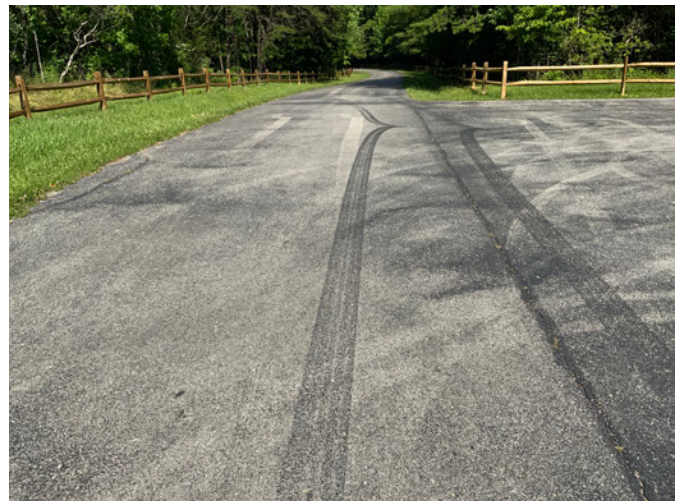
## ROUTE 0904: LILLY BLUFF PARKING

Inspection Date	FMSS Number	User Access	Surface Type
6/16/2021	105085	PUBLIC	ASPHALT
Area (Sq. Ft.)	Lane Miles (11' Widths)	Curb Reveal (Inches)	Curb Recommendation
30,707	0.529	NOT APPLICABLE	NOT APPLICABLE
Curb Type		Curb & Gutter Type	
NO CURB		NO CURB AND GUTTER	
Pavement Recommendation		Condition Rating / PCR	
PREVENTIVE MAINTENANCE		GOOD / 90

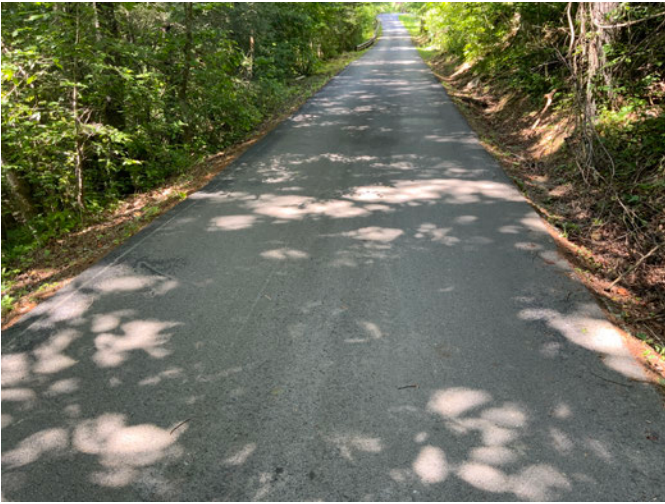
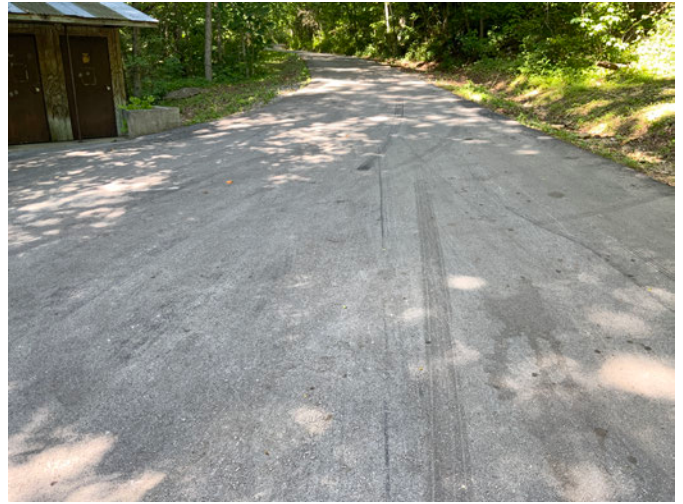
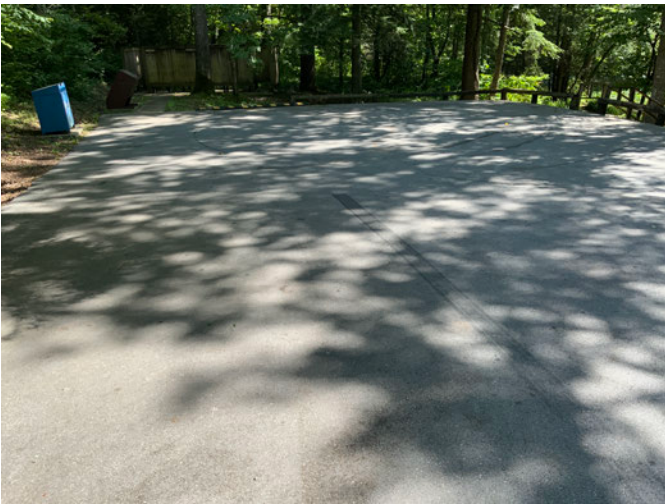
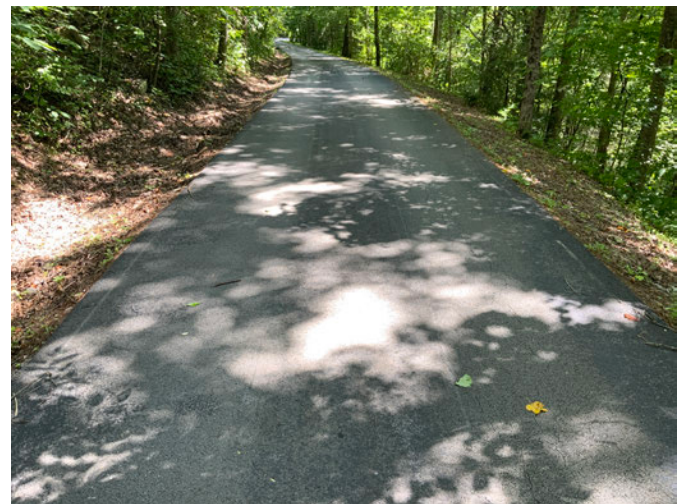
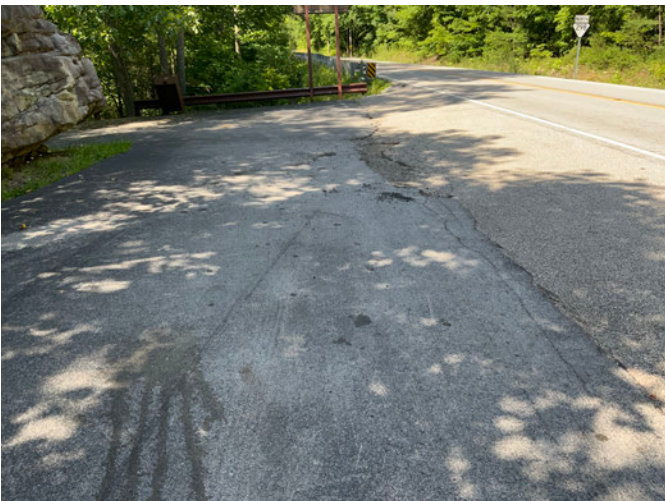
## ROUTE 0906: JETT BRIDGE PARKING

Inspection Date	FMSS Number	User Access	Surface Type
6/16/2021	69017	PUBLIC	ASPHALT
Area (Sq. Ft.)	Lane Miles (11' Widths)	Curb Reveal (Inches)	Curb Recommendation
13,547	0.233	NOT APPLICABLE	NOT APPLICABLE
Curb Type		Curb & Gutter Type	
NO CURB		NO CURB AND GUTTER	
Pavement Recommendation		Condition Rating / PCR	
PREVENTIVE MAINTENANCE		GOOD / 90
