Final Report

Road Inventory and Condition Assessment of Paved Routes Old Santa Fe Trail Building

**Federal Lands Highway
Road Inventory Program**

Report Date: July 2017

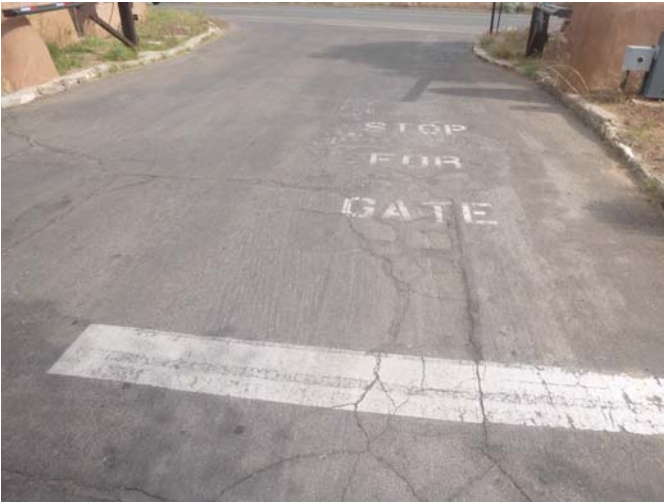
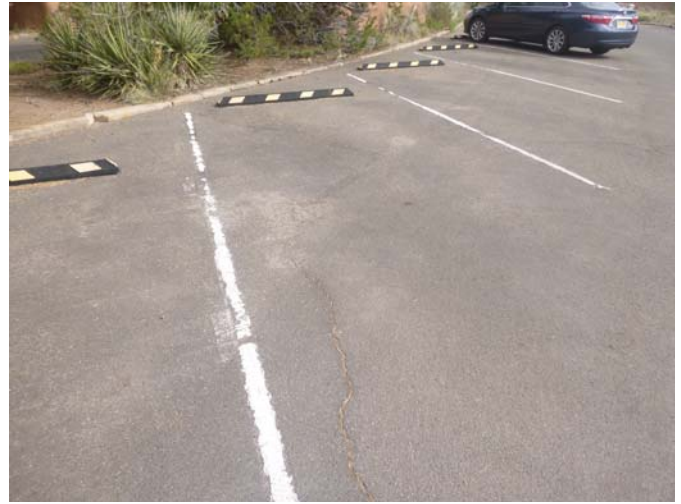
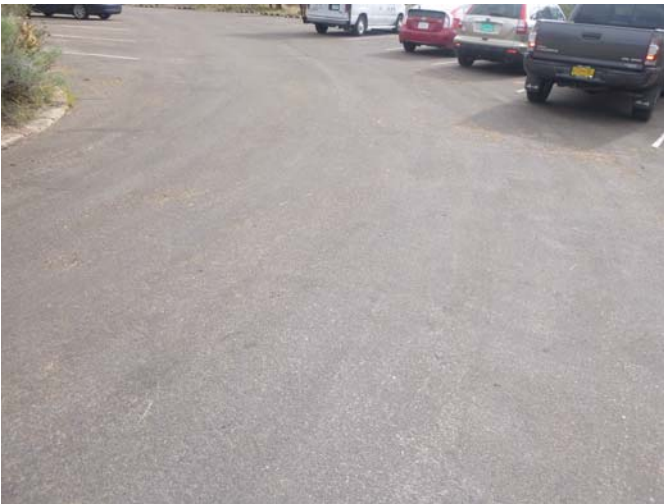
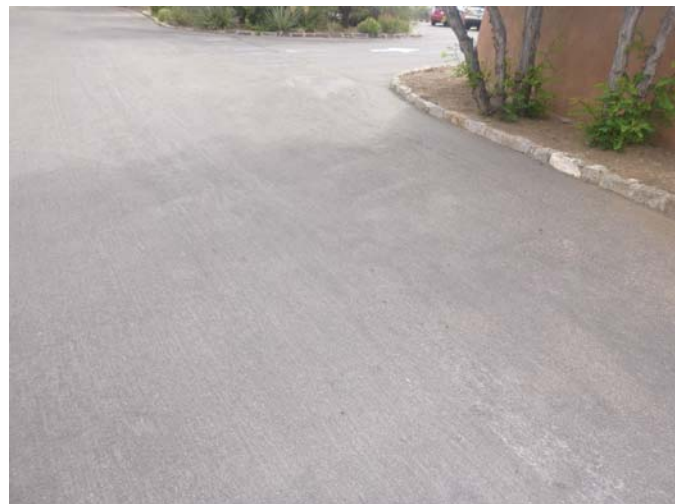
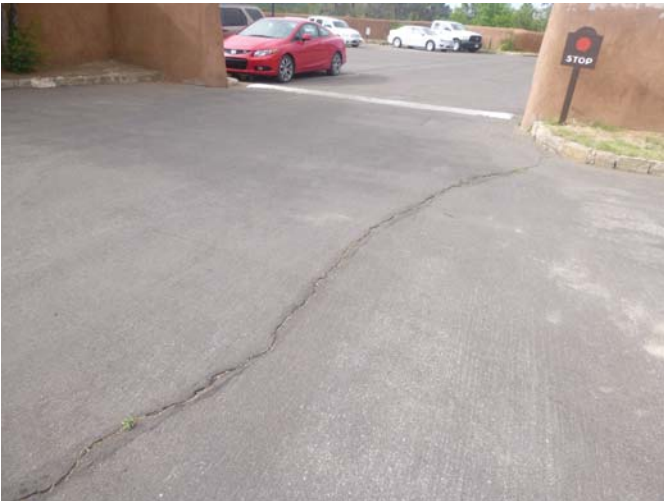
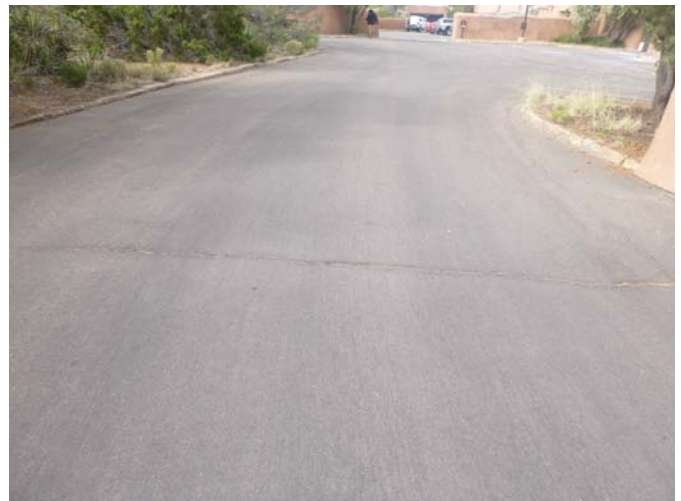
ROUTE 0900: VISITOR PARKING

Inspection Date	FMSS Number	User Access	Surface Type
6/1/2017	83290	PUBLIC	ASPHALT
Area (Sq. Ft.)	Lane Miles (11' Widths)	Curb Reveal (Inches)	Curb Recommendation
18,240	0.314	4	LIGHT REPAIR
Curb Type		Curb & Gutter Type	
STONE		NO CURB AND GUTTER	
Pavement Recommendation		Condition Rating / PCR	
PREVENTIVE MAINTENANCE		GOOD / 90

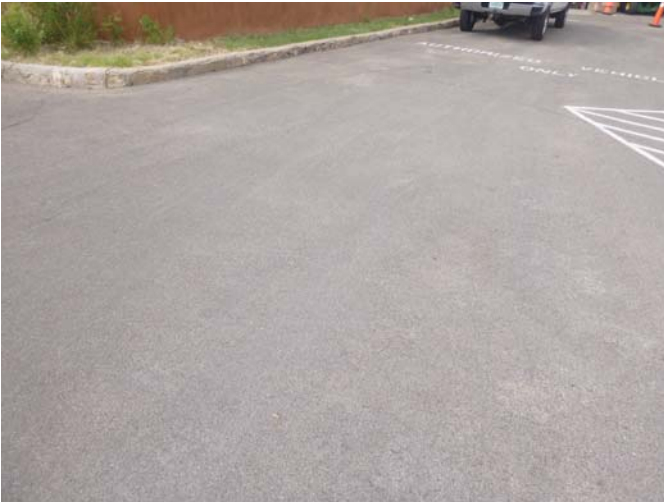
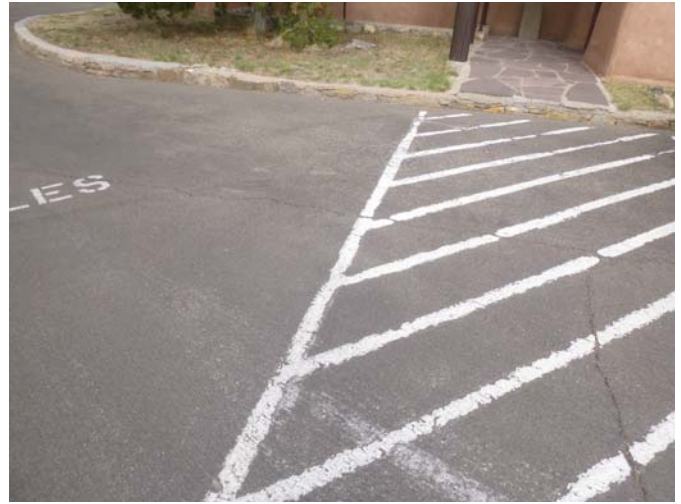
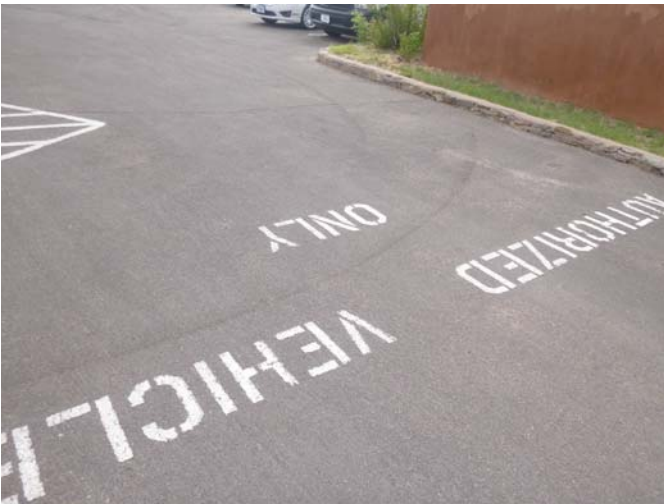
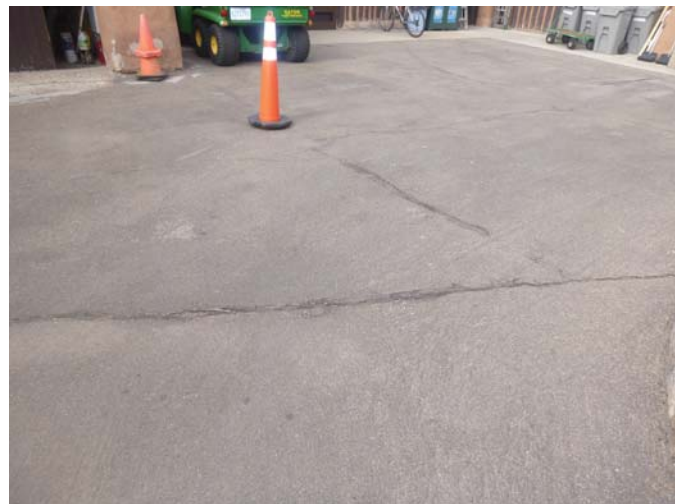
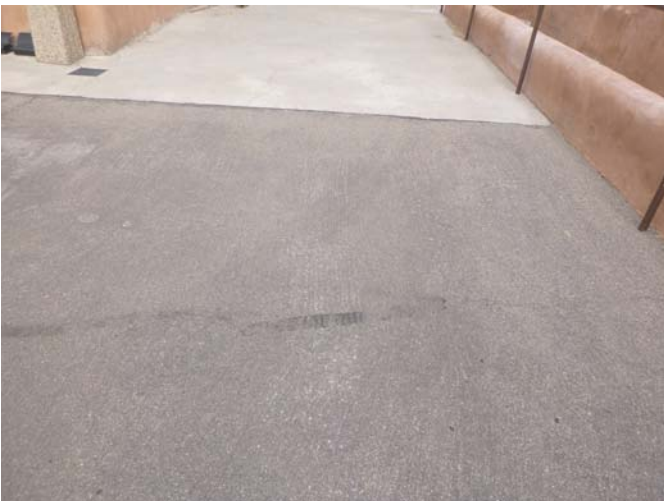
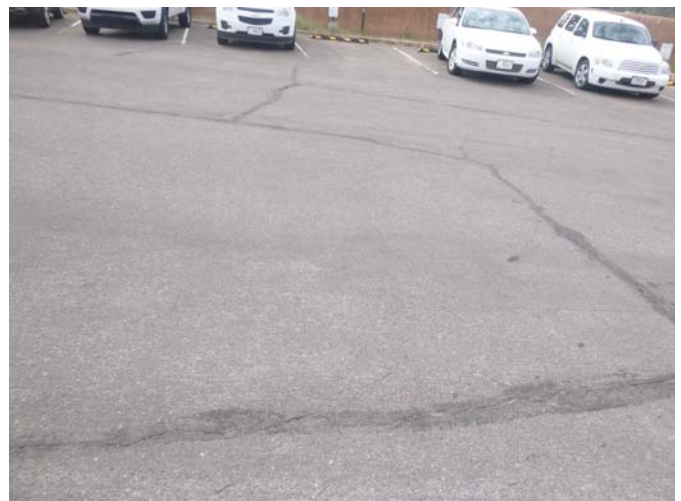
ROUTE 0901: ADMINISTRATIVE PARKING

Inspection Date	FMSS Number	User Access	Surface Type
6/1/2017	104968	NONPUBLIC	ASPHALT
Area (Sq. Ft.)	Lane Miles (11' Widths)	Curb Reveal (Inches)	Curb Recommendation
12,311	0.212	6	LIGHT REPAIR
Curb Type		Curb & Gutter Type	
STONE		NO CURB AND GUTTER	
Pavement Recommendation		Condition Rating / PCR	
PREVENTIVE MAINTENANCE		GOOD / 90

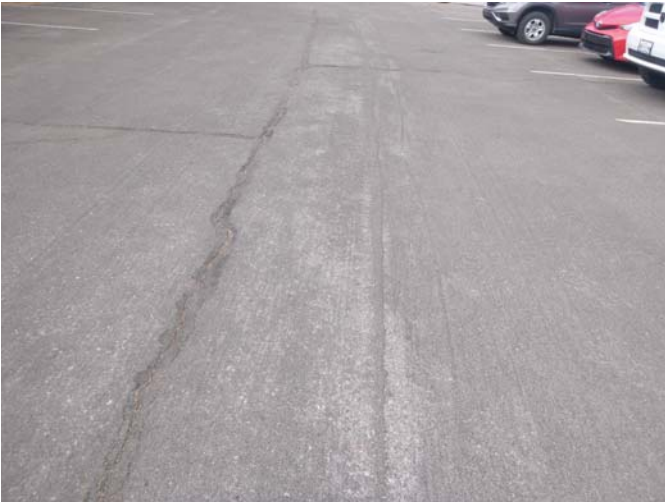
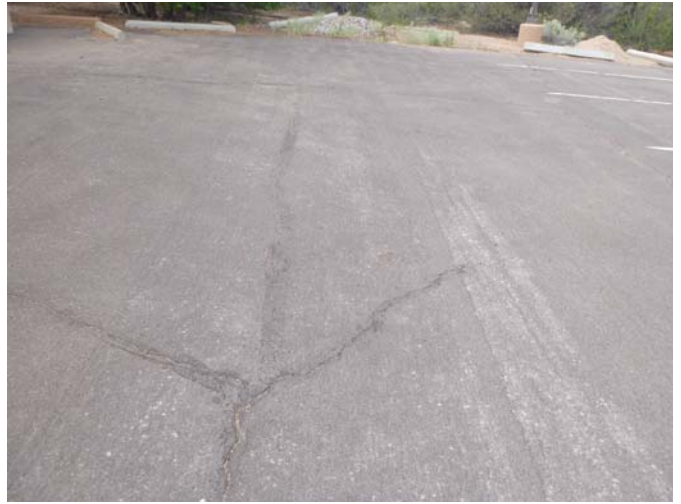
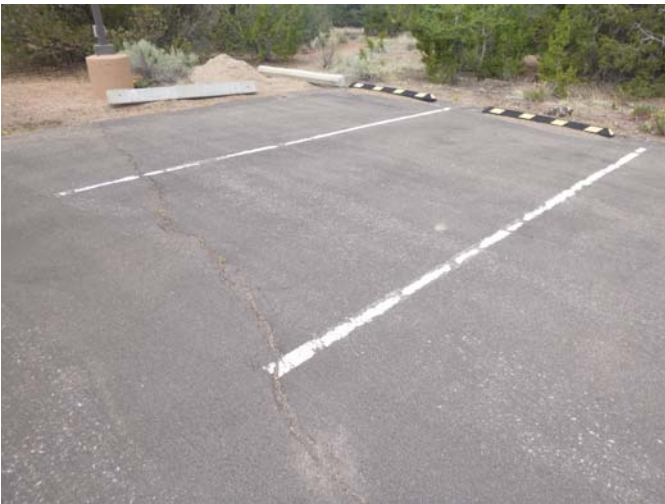
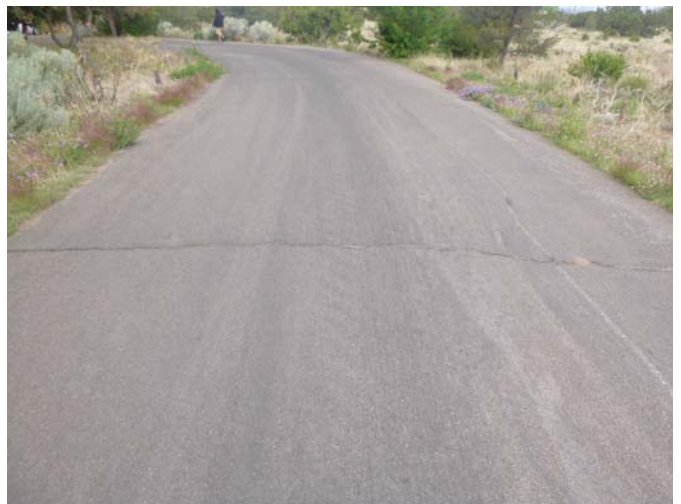
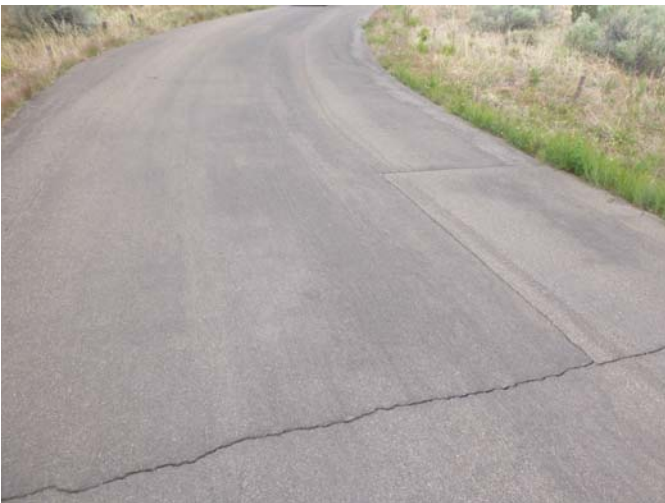
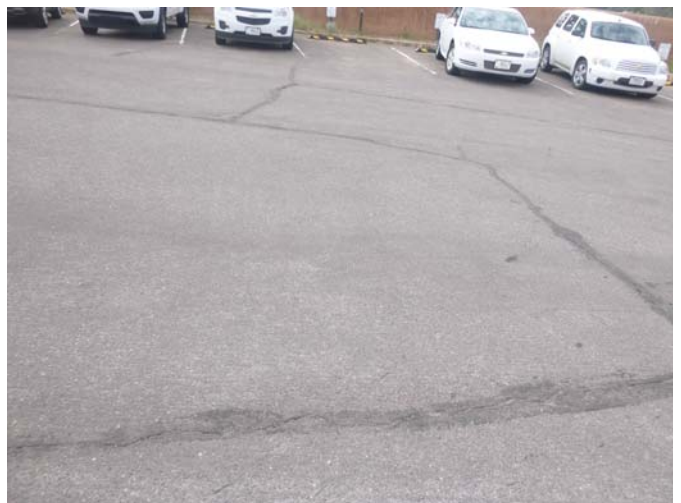
ROUTE 0902: REAR ADMINISTRATIVE PARKING

Inspection Date	FMSS Number	User Access	Surface Type
6/1/2017	104970	NONPUBLIC	ASPHALT
Area (Sq. Ft.)	Lane Miles (11' Widths)	Curb Reveal (Inches)	Curb Recommendation
16,714	0.288	NOT APPLICABLE	NOT APPLICABLE
Curb Type		Curb & Gutter Type	
NO CURB		NO CURB AND GUTTER	
Pavement Recommendation		Condition Rating / PCR	
PREVENTIVE MAINTENANCE		GOOD / 90
