# PAGR Cycle 6

## Final Report

### Road Inventory and Condition Assessment of Paved Routes Paterson Great Falls National Historical Park

**Report Date: February 2021**

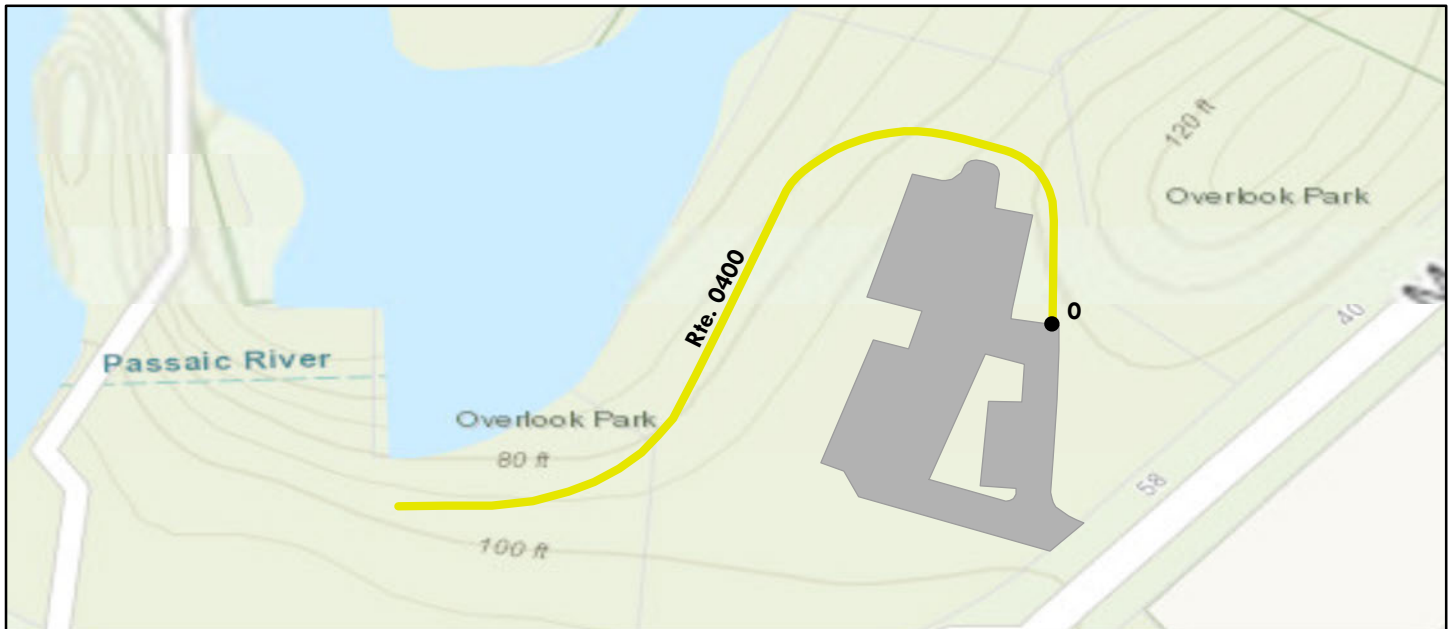
## ROUTE 0400: HYDROELECTRIC PLANT ACCESS ROAD

Route Condition Legend – Pavement Condition Rating (PCR)						
Poor (0 - 60)	Fair (61- 84)	Good (85 - 94)	Excellent (95 - 100)	Not Rated		
See Appendix for definitions and formulas						
<b>Inspection Date:</b> 10/7/2020	<b>Beginning Section MP</b>	0.00				
<b>Paved Length (Miles):</b> 0.11	<b>Section Length (MI)</b>	0.11				
<b>Surface Type:</b> ASPHALT	<b>Route Summary</b>					
<b>Roadway Condition Information</b>						
Pavement Condition Rating (PCR)	73	73				
Surface Condition Rating (SCR)	73	73				
Roughness Condition Index (RCI)	N/A	N/A				
<b>Distress Index Values</b>						
Structural Crack Index	N/A	N/A				
Alligator Crack Index	73	73				
Longitudinal Crack Index	90	90				
Transverse Cracking Index	90	90				
Patching Index	90	90				
Rutting Index	90	90				
International Roughness Index (IRI)	N/A	N/A				
<b>Lane &amp; Width Information</b>						
Number of Lanes	1	1				
Paved Width (ft)	14.2	14.2				
Lane Width (ft)	14.2	14.2
