PECO Cycle 6

Final Report

Road Inventory and Condition Assessment of Paved Routes Pecos National Historical Park

Report Date: June 2017

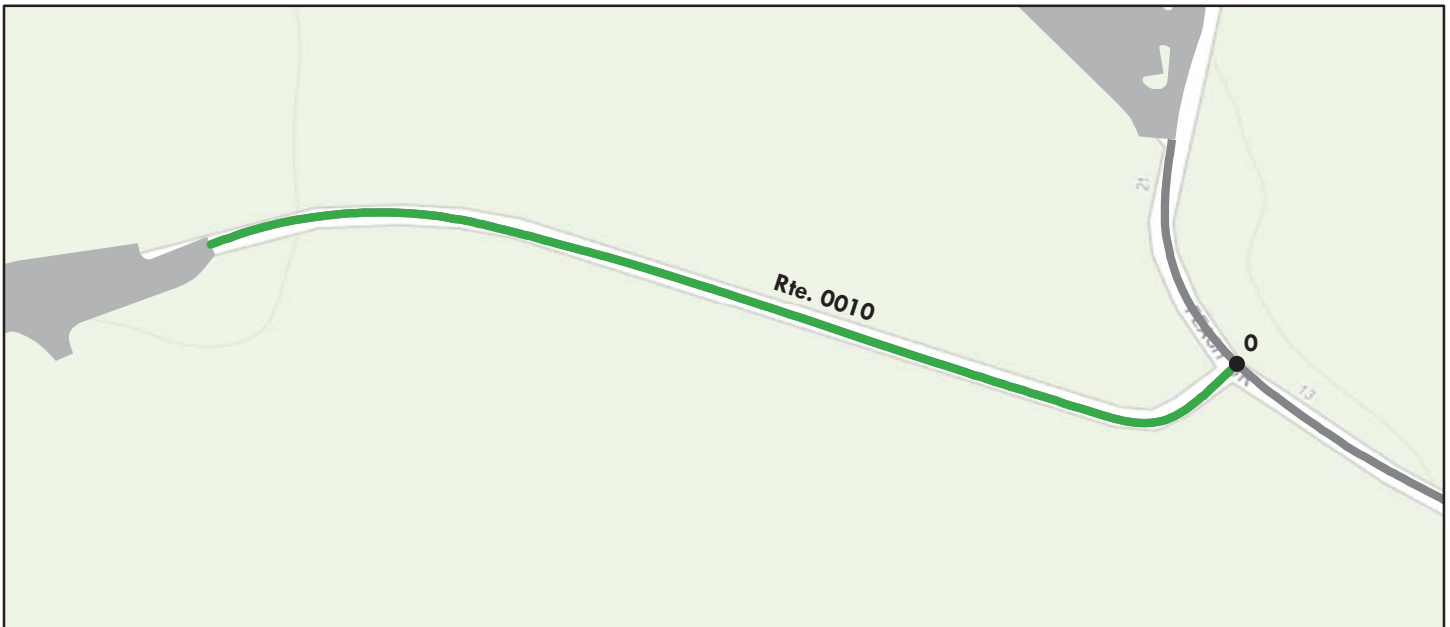
ROUTE 0010: PARK HEADQUARTERS ACCESS ROAD

Route Condition Legend – Pavement Condition Rating (PCR)						
Poor (0 - 60)	Fair (61- 84)	Good (85 - 94)	Excellent (95 - 100)	Not Rated		
See Appendix for definitions and formulas						
Inspection Date: 3/23/2017	Beginning Section MP	0				
Paved Length (Miles): 0.19	Section Length (MI)	0.19				
Surface Type: ASPHALT	Route Summary					
Roadway Condition Information						
Pavement Condition Rating (PCR)	91	91				
Surface Condition Rating (SCR)	91	91				
Roughness Condition Index (RCI)	N/A	N/A				
Distress Index Values						
Structural Crack Index	98	98				
Alligator Crack Index	100	100				
Longitudinal Crack Index	98	98				
Transverse Cracking Index	91	91				
Patching Index	100	100				
Rutting Index	96	96				
International Roughness Index (IRI)	N/A	N/A				
Lane & Width Information						
Number of Lanes	2	2				
Paved Width (ft)	21	21				
Lane Width (ft)	10.5	10.5

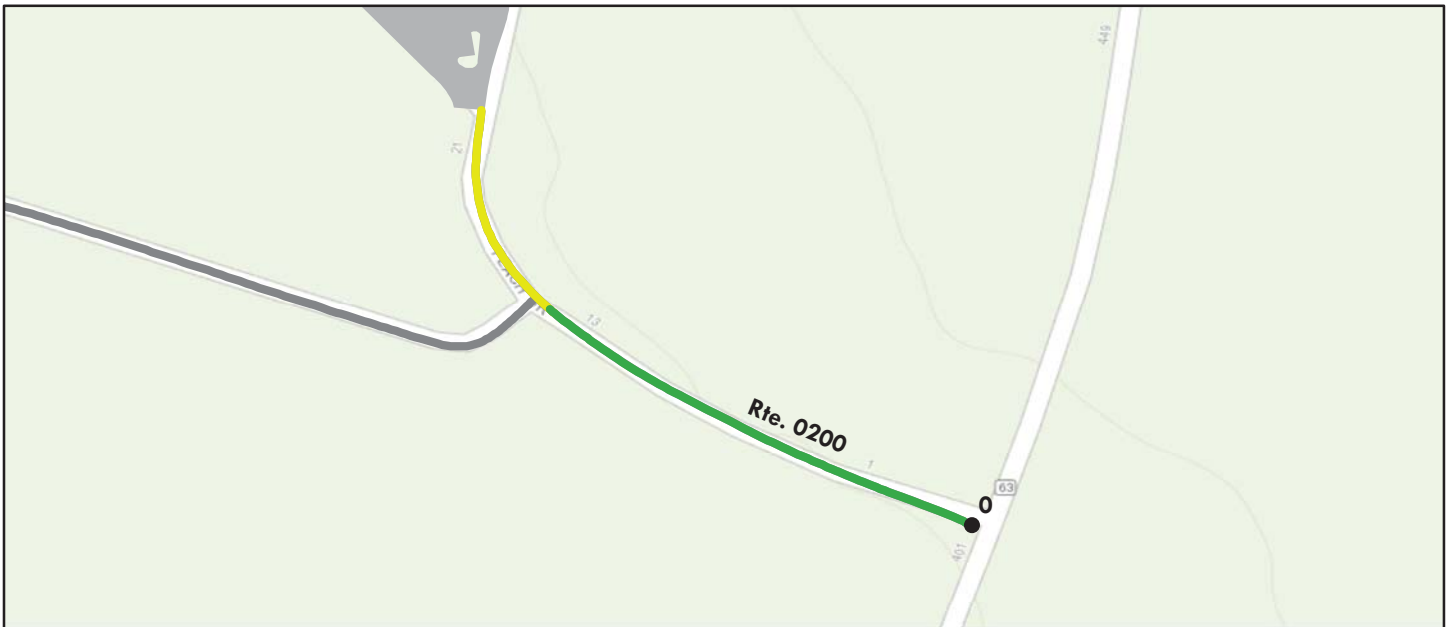
ROUTE 0200: VISITOR CENTER ROAD

Route Condition Legend – Pavement Condition Rating (PCR)						
Poor (0 - 60)	Fair (61- 84)	Good (85 - 94)	Excellent (95 - 100)	Not Rated		
See Appendix for definitions and formulas						
Inspection Date:	3/23/2017	Beginning Section MP	0			
Paved Length (Miles):	0.15	Section Length (MI)	0.15			
Surface Type:	ASPHALT	Route Summary				
Roadway Condition Information						
Pavement Condition Rating (PCR)	85	85				
Surface Condition Rating (SCR)	85	85				
Roughness Condition Index (RCI)	N/A	N/A				
Distress Index Values						
Structural Crack Index	85	85				
Alligator Crack Index	100	100				
Longitudinal Crack Index	85	85				
Transverse Cracking Index	97	97				
Patching Index	100	100				
Rutting Index	97	97				
International Roughness Index (IRI)	N/A	N/A				
Lane & Width Information						
Number of Lanes	2	2				
Paved Width (ft)	25.3	25.3				
Lane Width (ft)	13	13

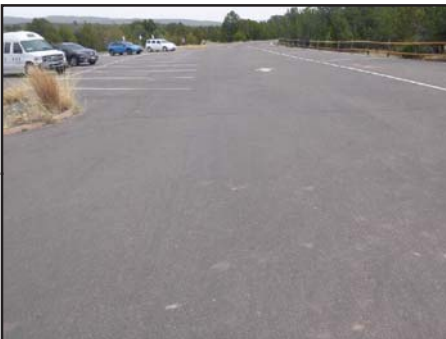
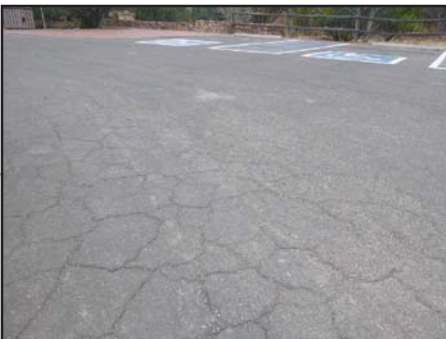
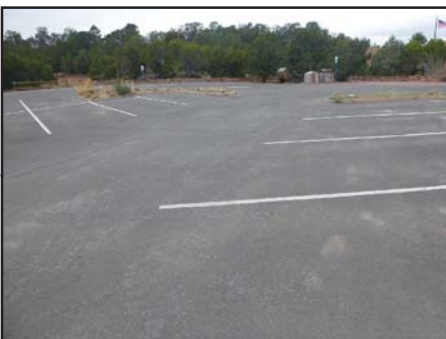
Inspection Date	FMSS Number	User Access	Surface Type
3/23/2017	69836	PUBLIC	ASPHALT
Area (Sq. Ft.)	Lane Miles (11' Widths)	Curb Reveal (Inches)	Curb Recommendation
29,529	0.508	5	LIGHT REPAIR
Curb Type		Curb & Gutter Type	
CONCRETE		NO CURB AND GUTTER	
Pavement Recommendation		Condition Rating / PCR	
HEAVY 3R TREATMENTS		POOR / 53

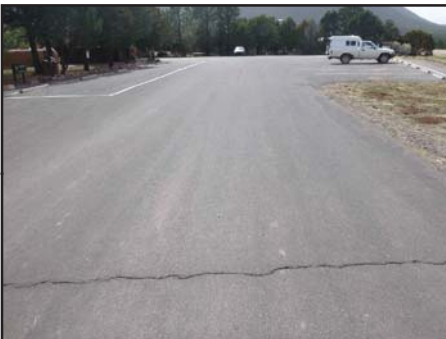
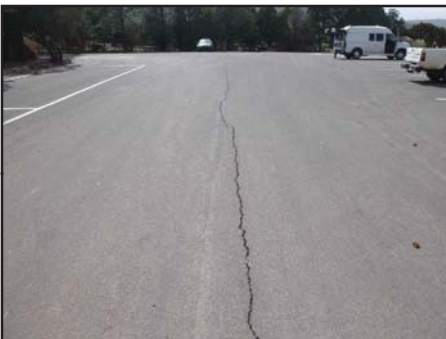
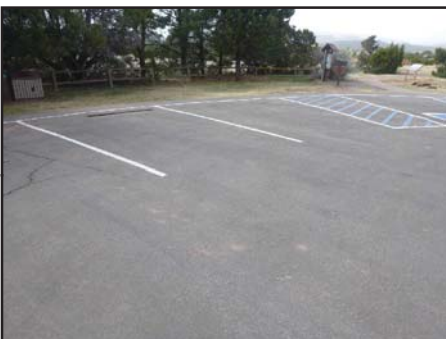
ROUTE 0901: HEADQUARTERS UPPER PARKING

Inspection Date	FMSS Number	User Access	Surface Type
3/23/2017	102950	PUBLIC	ASPHALT
Area (Sq. Ft.)	Lane Miles (11' Widths)	Curb Reveal (Inches)	Curb Recommendation
14,464	0.249	NOT APPLICABLE	NOT APPLICABLE
Curb Type		Curb & Gutter Type	
NO CURB		NO CURB AND GUTTER	
Pavement Recommendation		Condition Rating / PCR	
LIGHT 3R TREATMENTS		FAIR / 73
