# PEVI Cycle 6

## Final Report

### Road Inventory and Condition Assessment of Paved Routes Perry's Victory and International Peace Memorial

**Report Date: February 2020**

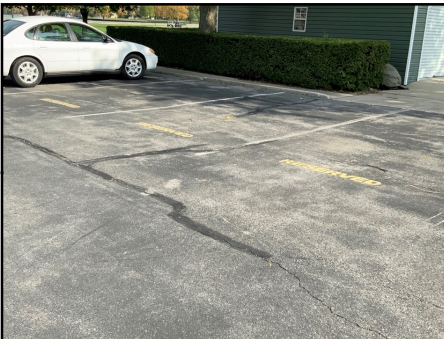
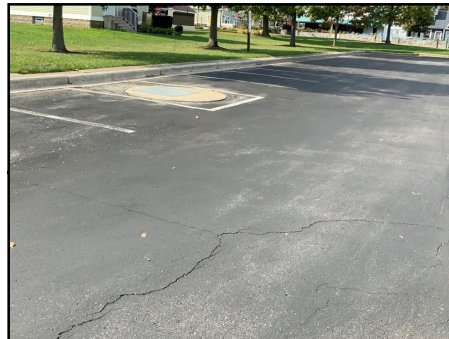
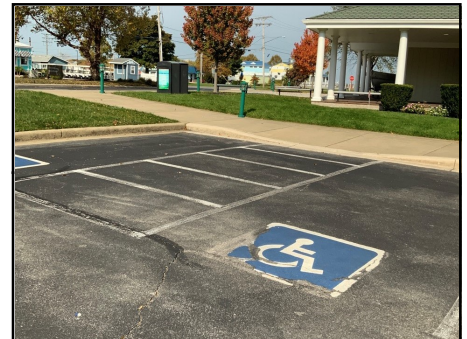
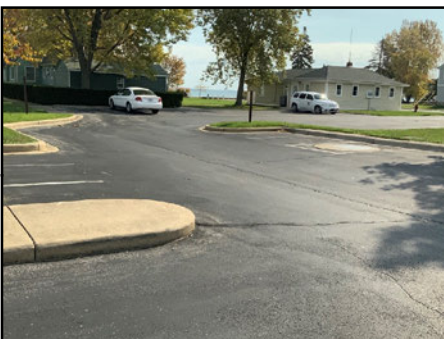
Inspection Date	FMSS Number	User Access	Surface Type
10/24/2019	73470	PUBLIC	ASPHALT
Area (Sq. Ft.)	Lane Miles (11' Widths)	Curb Reveal (Inches)	Curb Recommendation
8,663	0.149	6	DO NOTHING
Curb Type		Curb & Gutter Type	
CONCRETE		CONCRETE	
Pavement Recommendation		Condition Rating / PCR	
PREVENTIVE MAINTENANCE		GOOD / 90

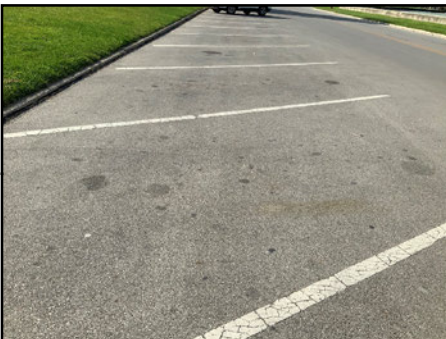
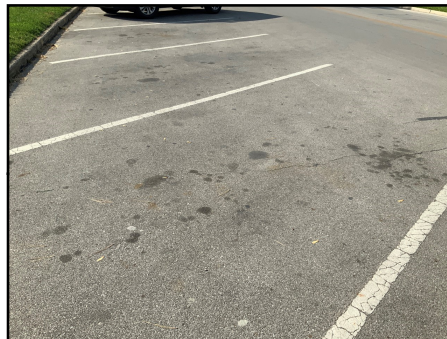
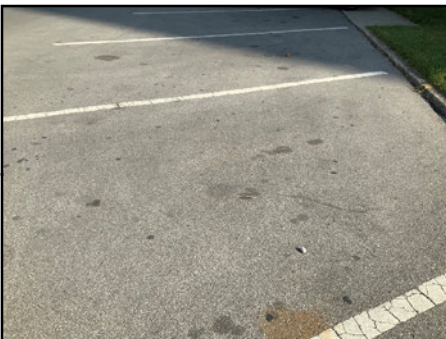
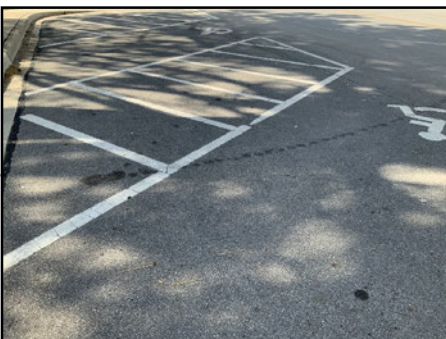
## ROUTE 0901: MONUMENT PARKING

Inspection Date	FMSS Number	User Access	Surface Type
10/24/2019	73455	PUBLIC	ASPHALT
Area (Sq. Ft.)	Lane Miles (11' Widths)	Curb Reveal (Inches)	Curb Recommendation
3,400	0.059	4	DO NOTHING
Curb Type		Curb & Gutter Type	
CONCRETE		CONCRETE	
Pavement Recommendation		Condition Rating / PCR	
PREVENTIVE MAINTENANCE		GOOD / 90

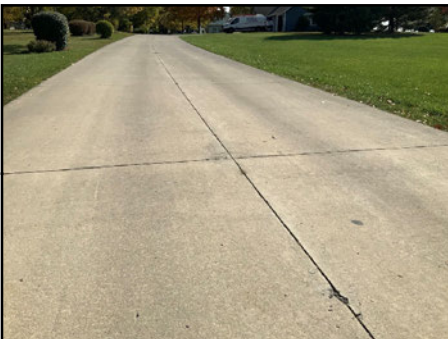
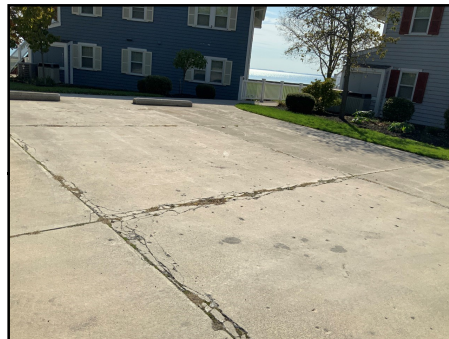
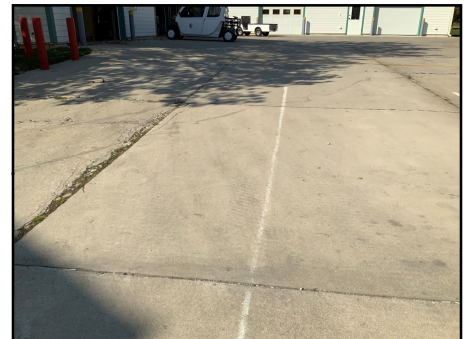
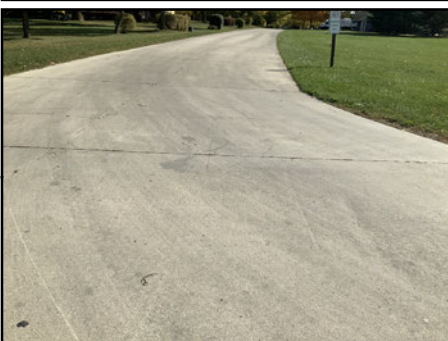
## ROUTE 0902: MAINTENANCE PARKING

Inspection Date	FMSS Number	User Access	Surface Type
10/24/2019	77498	NONPUBLIC	CONCRETE
Area (Sq. Ft.)	Lane Miles (11' Widths)	Curb Reveal (Inches)	Curb Recommendation
22,855	0.394	NOT APPLICABLE	NOT APPLICABLE
Curb Type		Curb & Gutter Type	
NO CURB		NO CURB AND GUTTER	
Pavement Recommendation		Condition Rating / PCR	
LIGHT 3R TREATMENTS		FAIR / 73

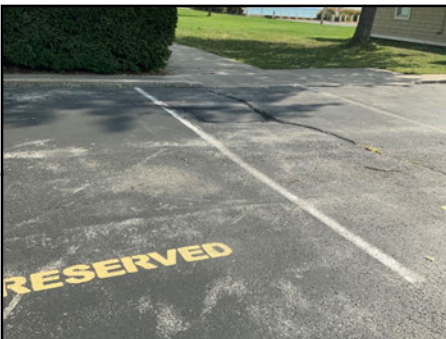
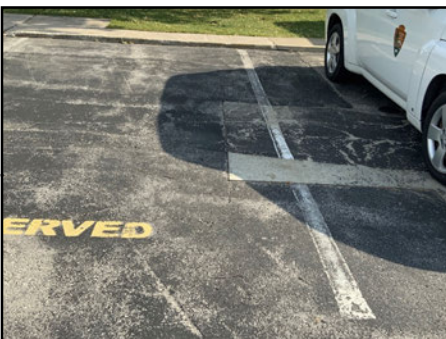
## ROUTE 0903: RANGER / RESIDENCE PARKING

Inspection Date	FMSS Number	User Access	Surface Type
10/24/2019	77496	NONPUBLIC	ASPHALT
Area (Sq. Ft.)	Lane Miles (11' Widths)	Curb Reveal (Inches)	Curb Recommendation
1,576	0.027	3	LIGHT REPAIR
Curb Type		Curb & Gutter Type	
CONCRETE		NO CURB AND GUTTER	
Pavement Recommendation		Condition Rating / PCR	
PREVENTIVE MAINTENANCE		GOOD / 90

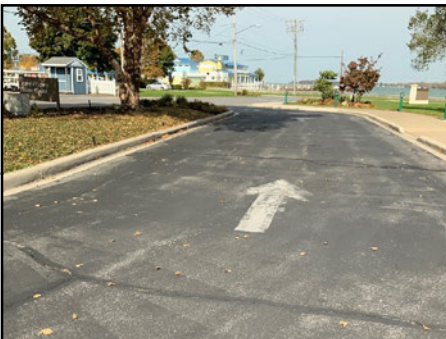
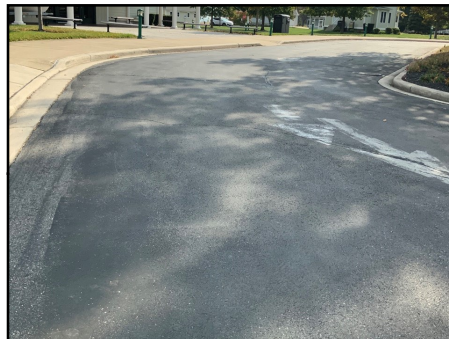
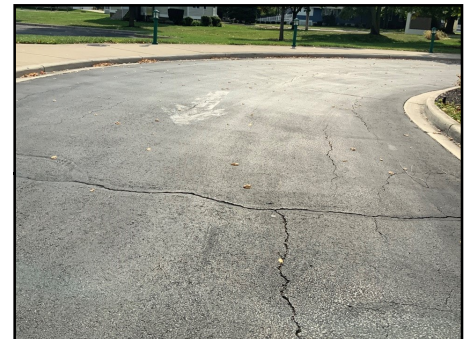
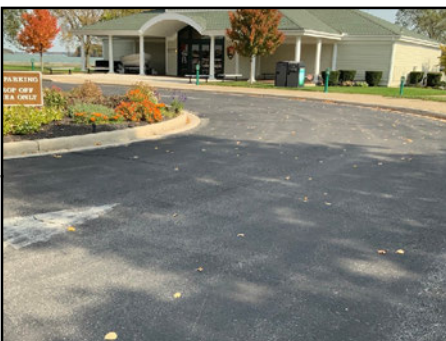
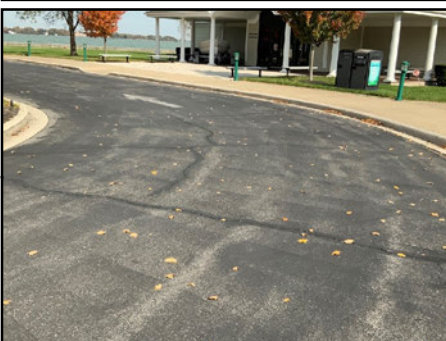
## ROUTE 0904: VISITOR CENTER DROP OFF AREA

Inspection Date	FMSS Number	User Access	Surface Type
10/24/2019	77481	PUBLIC	ASPHALT
Area (Sq. Ft.)	Lane Miles (11' Widths)	Curb Reveal (Inches)	Curb Recommendation
3,336	0.057	NOT APPLICABLE	DO NOTHING
Curb Type		Curb & Gutter Type	
NO CURB		CONCRETE	
Pavement Recommendation		Condition Rating / PCR	
LIGHT 3R TREATMENTS		FAIR / 73

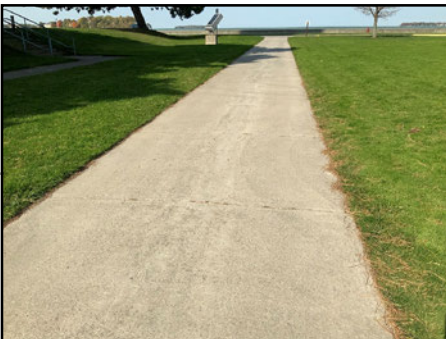
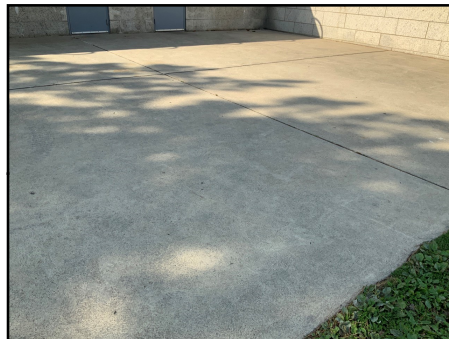
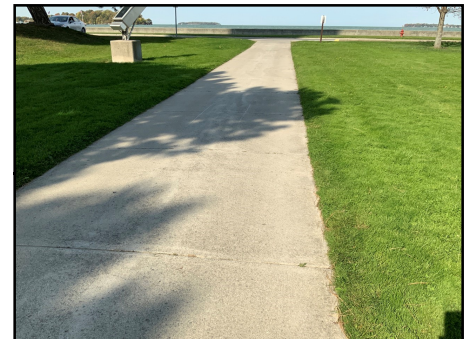
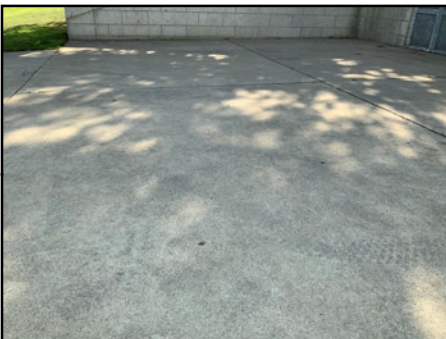
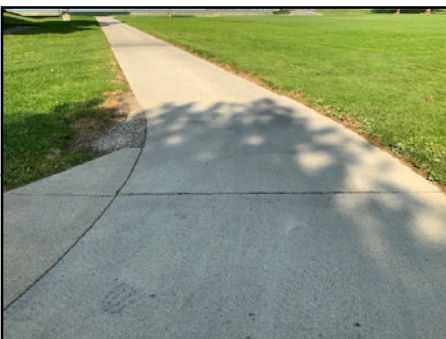
## ROUTE 0905: MONUMENT SERVICE AREA

Inspection Date	FMSS Number	User Access	Surface Type
10/24/2019	77489	NONPUBLIC	CONCRETE
Area (Sq. Ft.)	Lane Miles (11' Widths)	Curb Reveal (Inches)	Curb Recommendation
4,117	0.071	NOT APPLICABLE	NOT APPLICABLE
Curb Type		Curb & Gutter Type	
NO CURB		NO CURB AND GUTTER	
Pavement Recommendation		Condition Rating / PCR	
LIGHT 3R TREATMENTS		FAIR / 73
