PUHO Cycle 6

Final Report

Road Inventory and Condition Assessment of Paved Routes Pu'uhonua O Honaunau National Historical Park

Report Date: August 2022

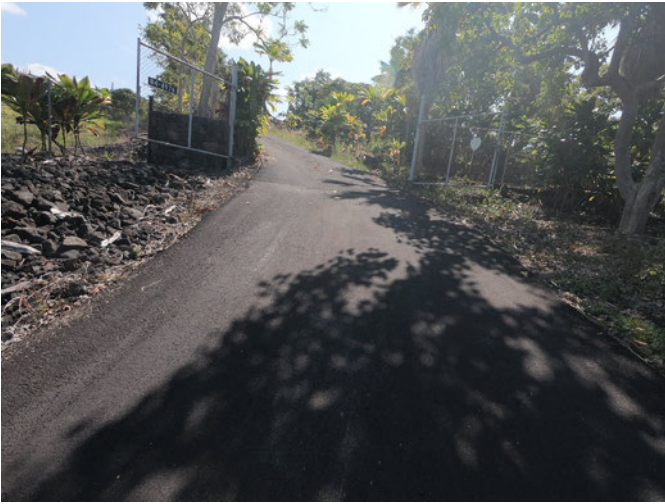
PUHO_0401_0.004.jpg

Inspection Date: 3/9/2022	Beginning Section MP	0.00				
Paved Length (Miles): 0.07	Section Length (MI)	0.07				
Surface Type: ASPHALT	Route Summary					
Roadway Condition Information						
Pavement Condition Rating (PCR)	97	97				
Surface Condition Rating (SCR)	97	97				
Roughness Condition Index (RCI)	N/A	N/A				
Distress Index Values						
Structural Crack Index	N/A	N/A				
Alligator Crack Index	97	97				
Longitudinal Crack Index	97	97				
Transverse Cracking Index	97	97				
Patching Index	97	97				
Rutting Index	97	97				
International Roughness Index (IRI)	N/A	N/A				
Lane & Width Information						
Number of Lanes	2	2				
Paved Width (ft)	16	16				
Lane Width (ft)	8	8

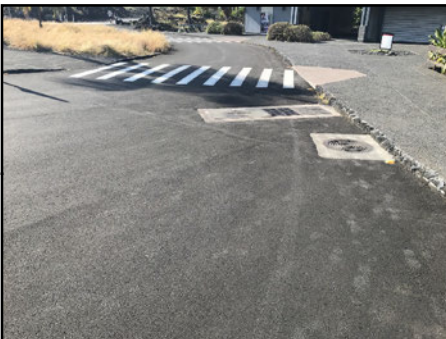
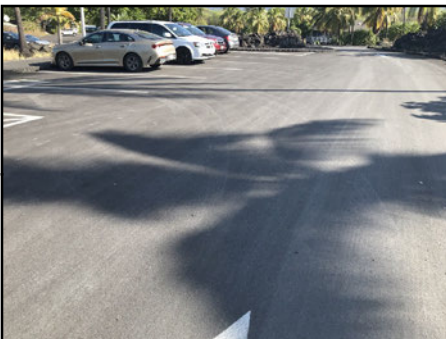
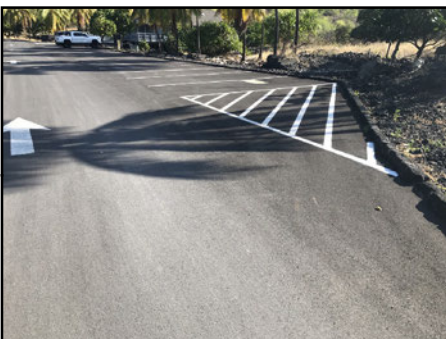
Inspection Date	FMSS Number	User Access	Surface Type
3/9/2022	50236	PUBLIC	ASPHALT
Area (Sq. Ft.)	Lane Miles (11' Widths)	Curb Reveal (Inches)	Curb Recommendation
50,549	0.87	3	LIGHT REPAIR
Curb Type		Curb & Gutter Type	
STONE		NO CURB AND GUTTER	
Pavement Recommendation		Condition Rating / PCR	
DO NOTHING		EXCELLENT / 97
