# REER Cycle 6

### Road Inventory and Condition Assessments for Reconstruction Era National Historical Park

**Federal Highway Administration  
Eastern Federal Lands Highway Division  
Road Inventory Program (RIP)**

**Report Date: April 2021**

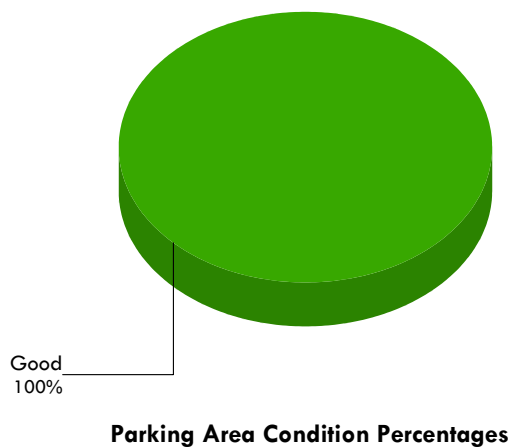
Figure 1: Pavement Condition Rating Breakdown for Paved Parking Areas

Cycle 6 Lane Miles and Overall Pavement Condition for PAVED Routes		
	Lanes Miles*	Pavement Condition Rating**
Data Collection Vehicle Routes	0	N/A
Manually Rated Roads	0	N/A
Parking Areas	0.23	90

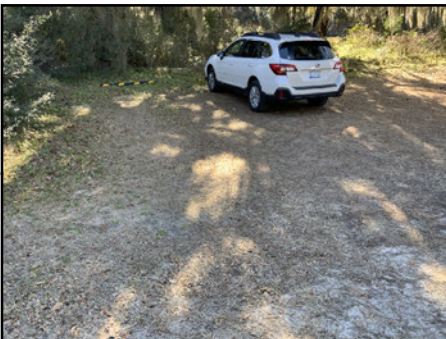
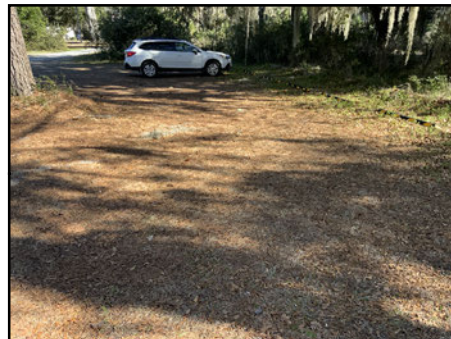
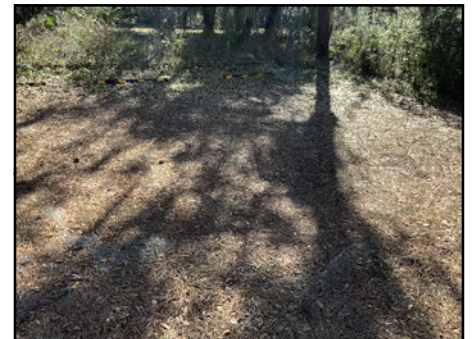
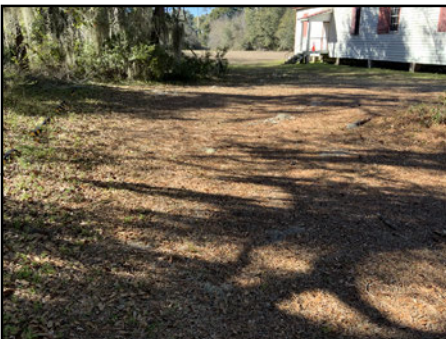
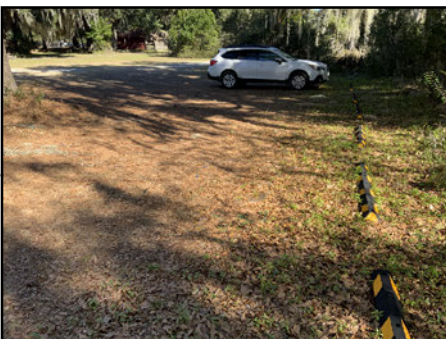
Inspection Date	FMSS Number	User Access	Surface Type
2/3/2021		PUBLIC	NATIVE
Area (Sq. Ft.)	Lane Miles (11' Widths)	Curb Reveal (Inches)	Curb Recommendation
3,299	0.057		NOT APPLICABLE
Curb Type		Curb & Gutter Type	
NO CURB		NO CURB AND GUTTER	
Treatment Recommendation		Condition Rating	
ROUTINE MAINTENANCE		3

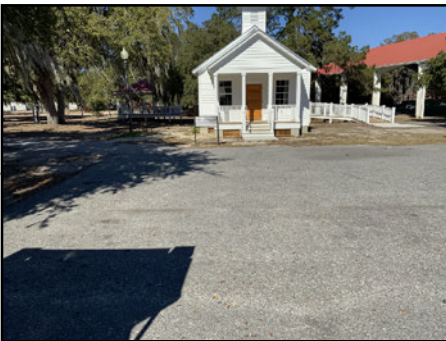
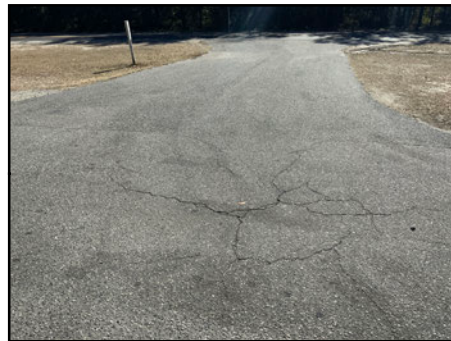
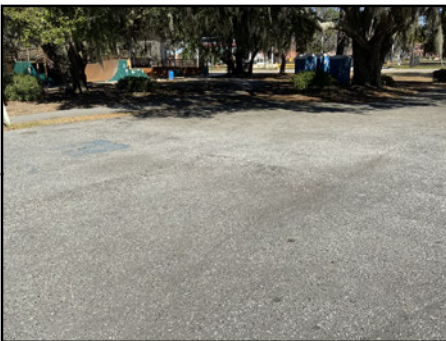
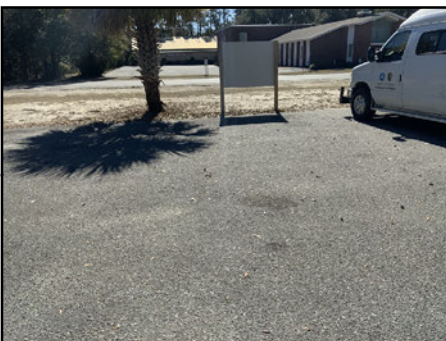
## ROUTE 0901: PORTER CHAPELS PARKING AREA

Inspection Date	FMSS Number	User Access	Surface Type
2/3/2021		PUBLIC	ASPHALT
Area (Sq. Ft.)	Lane Miles (11' Widths)	Curb Reveal (Inches)	Curb Recommendation
11,779	0.203	NOT APPLICABLE	NOT APPLICABLE
Curb Type		Curb & Gutter Type	
NO CURB		NO CURB AND GUTTER	
Pavement Recommendation		Condition Rating / PCR	
PREVENTIVE MAINTENANCE		GOOD / 90

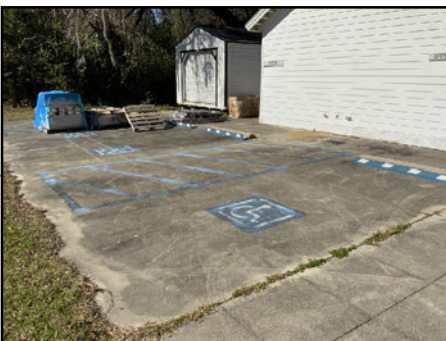
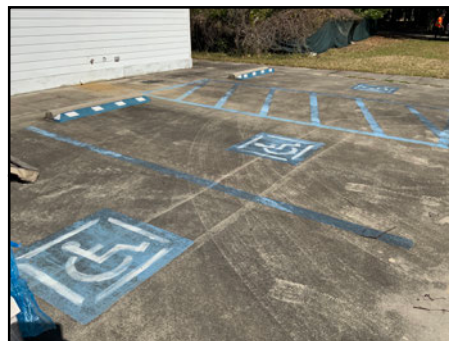
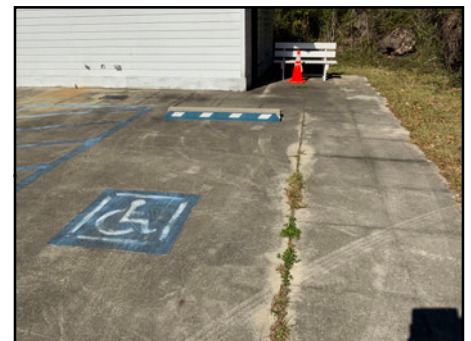
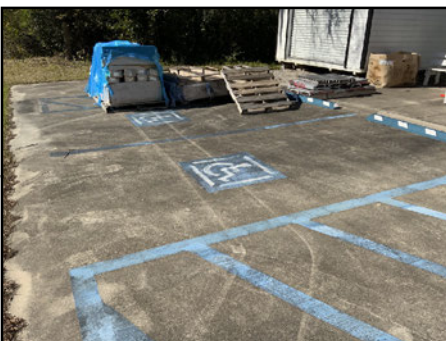
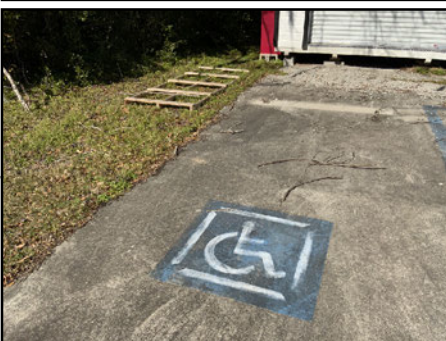
## ROUTE 0902: DARRAH HALL ACCESSIBLE PARKING

Inspection Date	FMSS Number	User Access	Surface Type
2/3/2021		PUBLIC	CONCRETE
Area (Sq. Ft.)	Lane Miles (11' Widths)	Curb Reveal (Inches)	Curb Recommendation
1,469	0.025	NOT APPLICABLE	NOT APPLICABLE
Curb Type		Curb & Gutter Type	
NO CURB		NO CURB AND GUTTER	
Pavement Recommendation		Condition Rating / PCR	
PREVENTIVE MAINTENANCE		GOOD / 90

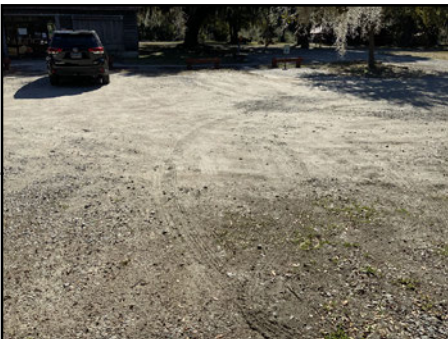
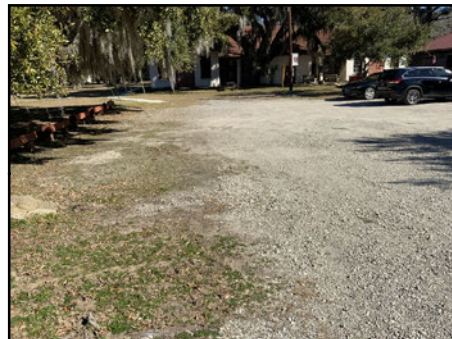
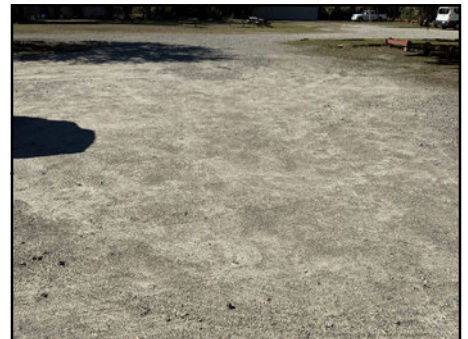
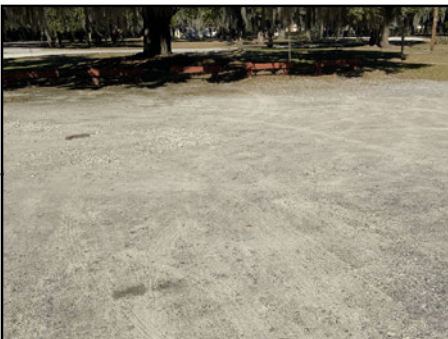
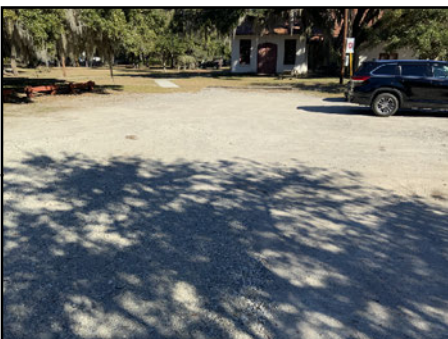
## ROUTE 0903: MUSEUM PARKING

Inspection Date	FMSS Number	User Access	Surface Type
2/3/2021		PUBLIC	GRAVEL
Area (Sq. Ft.)	Lane Miles (11' Widths)	Curb Reveal (Inches)	Curb Recommendation
6,065	0.104		NOT APPLICABLE
Curb Type		Curb & Gutter Type	
NO CURB		NO CURB AND GUTTER	
Treatment Recommendation		Condition Rating	
LIGHT REHABILITATION		3

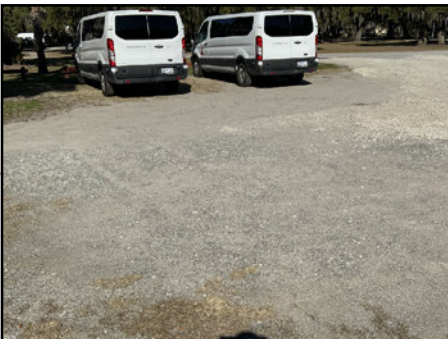
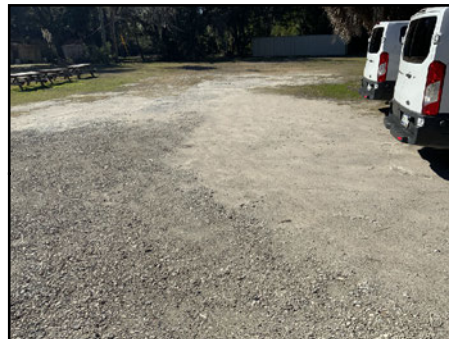
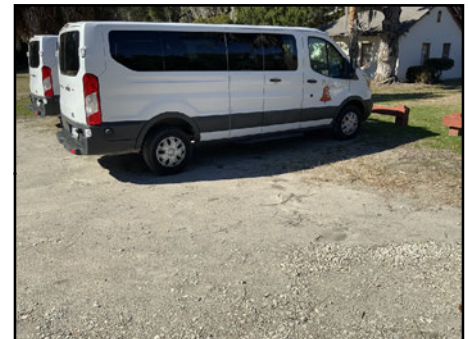
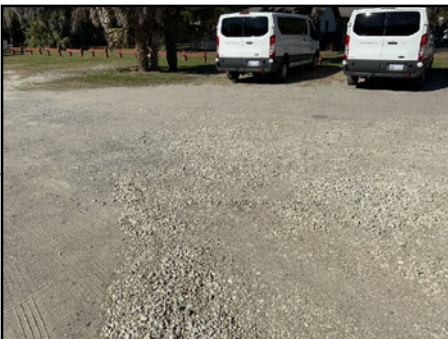
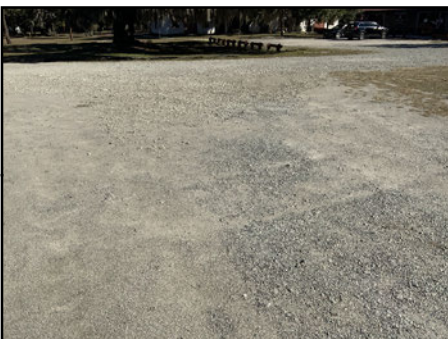
## ROUTE 0904: LATHERS ADMIN PARKING

Inspection Date	FMSS Number	User Access	Surface Type
2/3/2021		PUBLIC	GRAVEL
Area (Sq. Ft.)	Lane Miles (11' Widths)	Curb Reveal (Inches)	Curb Recommendation
3,396	0.058		NOT APPLICABLE
Curb Type		Curb & Gutter Type	
NO CURB		NO CURB AND GUTTER	
Treatment Recommendation		Condition Rating	
LIGHT REHABILITATION		3
