RICH Cycle 6

Road Inventory and Condition Assessment of Paved Routes Richmond National Battlefield Park

**Federal Lands Highway
Road Inventory Program**

**Federal Highway Administration
Eastern Federal Lands Highway Division
Road Inventory Program (RIP)**

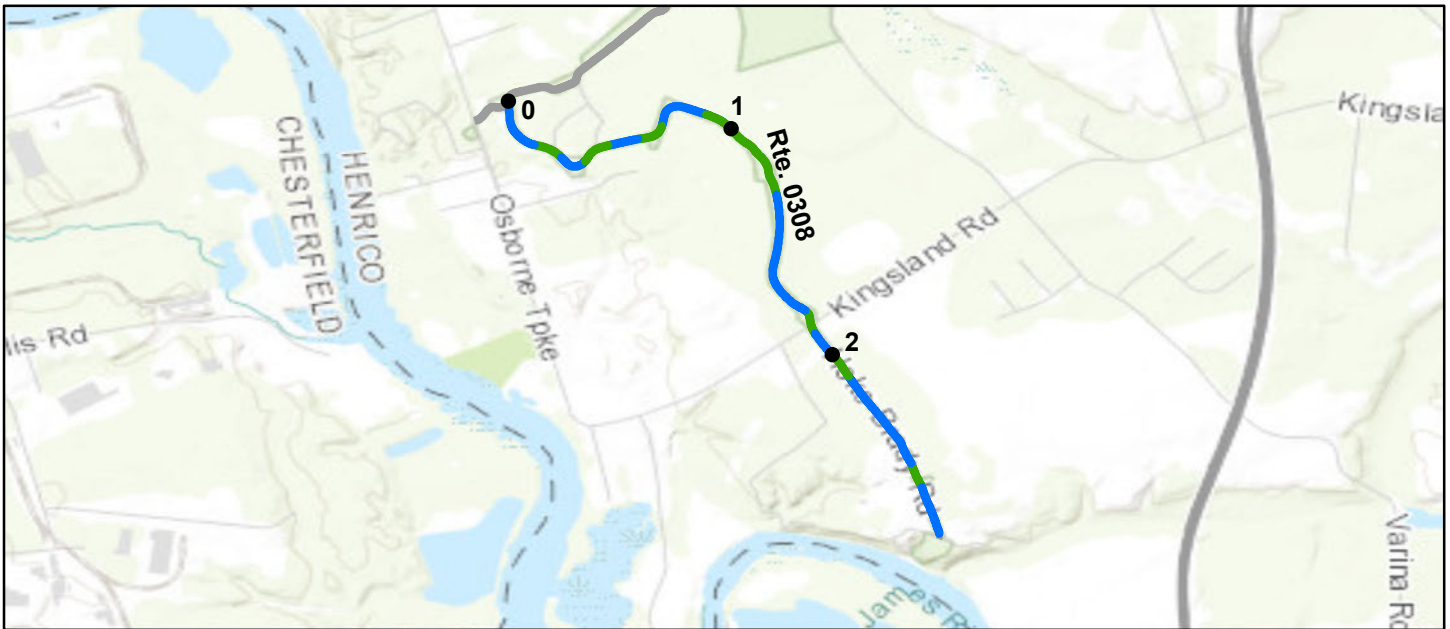
Route Condition Legend – Pavement Condition Rating (PCR)									
Poor (0 - 60)		Fair (61- 84)		Good (85 - 94)		Excellent (95 - 100)		Not Rated	
Colors on map represent condition scores at 0.10-mile intervals. See Appendix for definitions and formulas.									
Inspection Date:	12/10/2020	Beginning Section MP	0	1	2				
Paved Length (Miles):	2.79	Section Length (MI)	1	1	0.79				
Surface Type:	ASPHALT	Route Summary							
Roadway Condition Information									
Pavement Condition Rating (PCR)	95	95	95	96					
Surface Condition Rating (SCR)	99	99	99	99					
Roughness Condition Index (RCI)	90	90	88	92					
Distress Index Values									
Structural Crack Index	99	99	99	99					
Alligator Crack Index	100	100	100	100					
Longitudinal Crack Index	99	99	99	99					
Transverse Cracking Index	99	99	100	100					
Patching Index	100	100	100	100					
Rutting Index	99	99	100	99					
International Roughness Index (IRI)	140	139	145	135

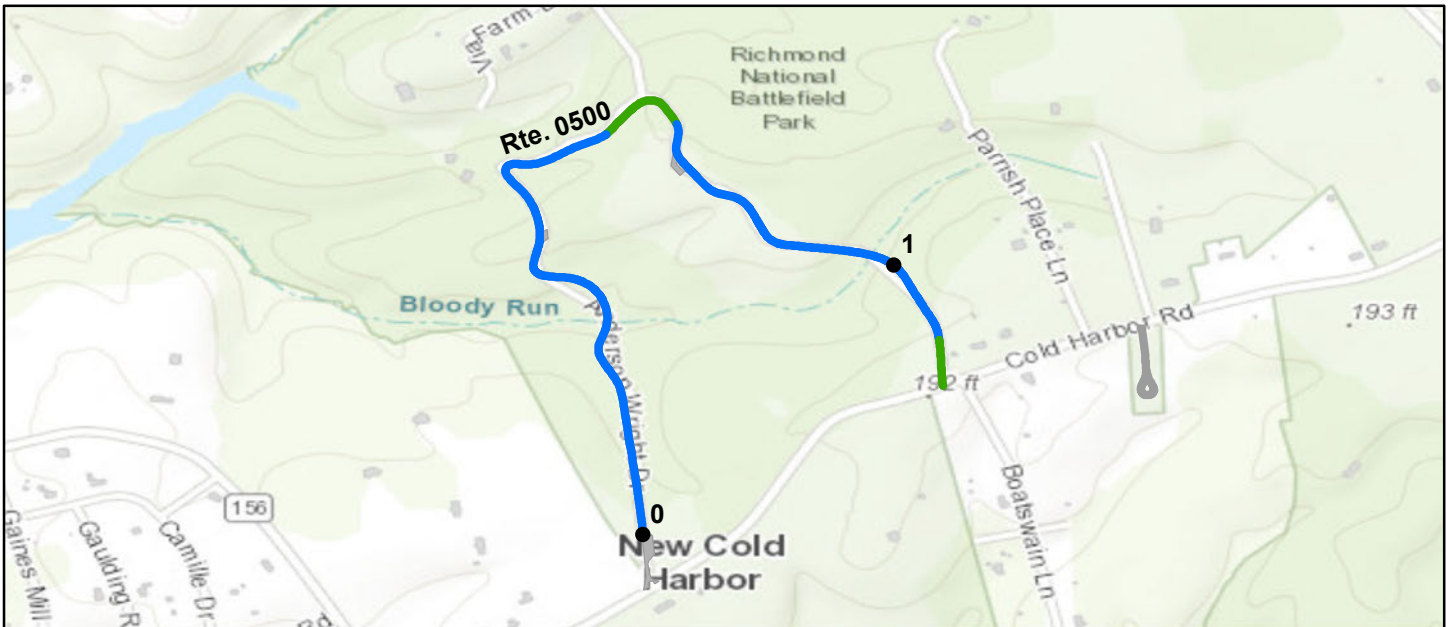
Inspection Date:	12/10/2020	Beginning Section MP	0	1			
Paved Length (Miles):	1.15	Section Length (MI)	1	0.15			
Surface Type:	ASPHALT	Route Summary					
Roadway Condition Information							
Pavement Condition Rating (PCR)	97	97	96				
Surface Condition Rating (SCR)	97	97	96				
Roughness Condition Index (RCI)	N/A	N/A	N/A				
Distress Index Values							
Structural Crack Index	100	100	100				
Alligator Crack Index	100	100	100				
Longitudinal Crack Index	100	100	100				
Transverse Cracking Index	100	100	100				
Patching Index	100	100	100				
Rutting Index	97	97	96				
International Roughness Index (IRI)	N/A	N/A	N/A				
Lane & Width Information							
Number of Lanes	1	1	1				
Paved Width (ft)	10.8	10.8	10.5				
Lane Width (ft)	10.8	10.8	10.5

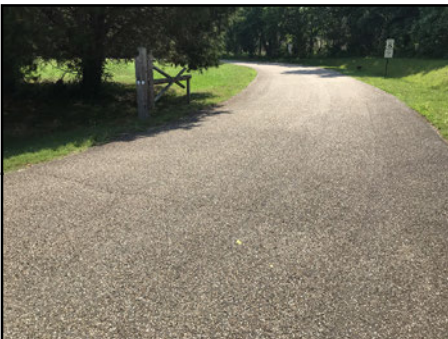
Inspection Date	FMSS Number	User Access	Surface Type
6/22/2020	79993	PUBLIC	ASPHALT
Area (Sq. Ft.)	Lane Miles (11' Widths)	Curb Reveal (Inches)	Curb Recommendation
27,771	0.478	4	LIGHT REPAIR
Curb Type		Curb & Gutter Type	
CONCRETE		NO CURB AND GUTTER	
Pavement Recommendation		Condition Rating / PCR	
LIGHT 3R TREATMENTS		FAIR / 73

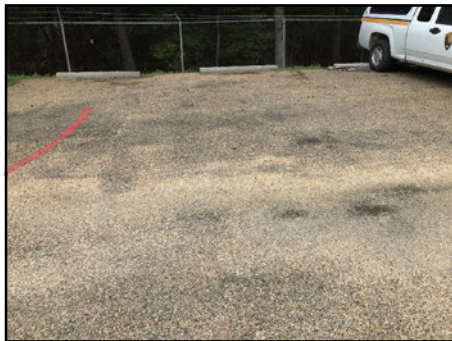
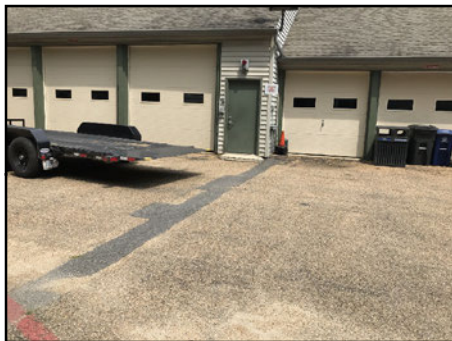
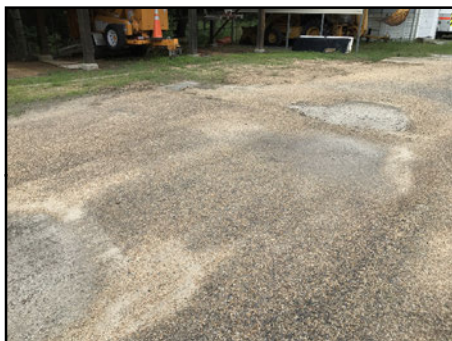
ROUTE 0913: MAINTENANCE AREA

Note: Parking area consists of multiple surface types: 1 part Asphalt at 17,698 square feet; 1 part Concrete at 1,102 square feet.
