RUCA Cycle 6

Final Report

Road Inventory and Condition Assessment of Paved Routes Russell Cave National Monument

Report Date: July 2021

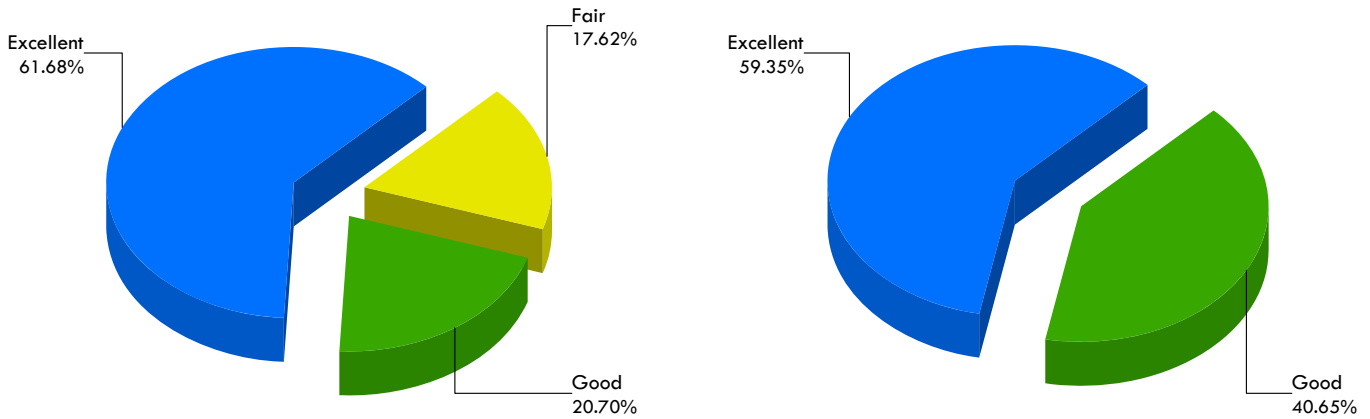
Figure 1: Pavement Condition Rating Breakdown for Paved Roads and Parking Areas

Road Condition Percentages

Parking Area Condition Percentages

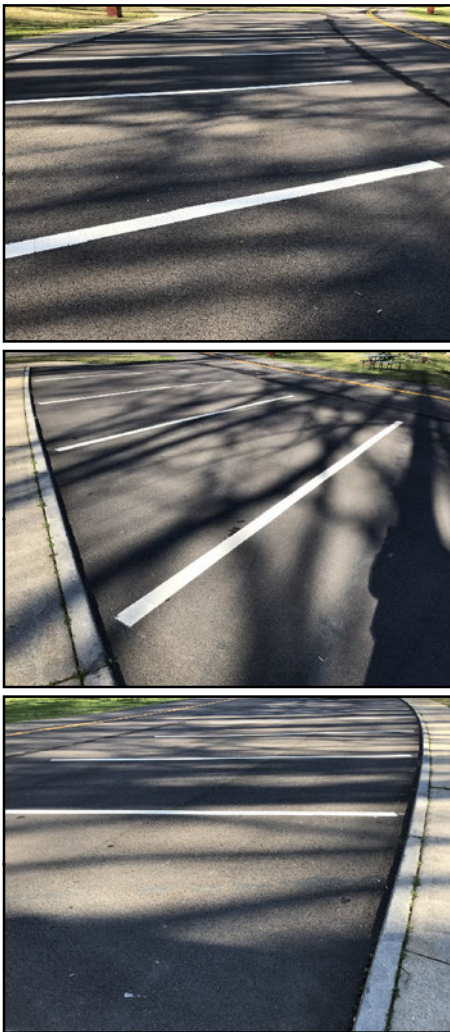
Inspection Date	FMSS Number	User Access	Surface Type
2/21/2020	66376	PUBLIC	ASPHALT
Area (Sq. Ft.)	Lane Miles (11' Widths)	Curb Reveal (Inches)	Curb Recommendation
7,209	0.124	2	LIGHT REPAIR
Curb Type		Curb & Gutter Type	
CONCRETE		NO CURB AND GUTTER	
Pavement Recommendation		Condition Rating / PCR	
DO NOTHING		EXCELLENT / 97

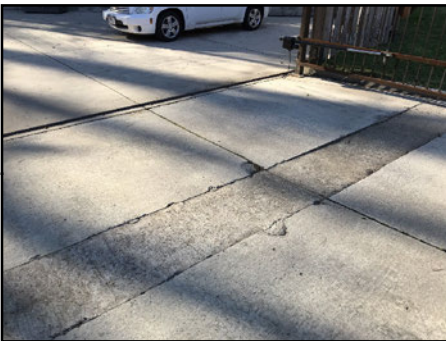
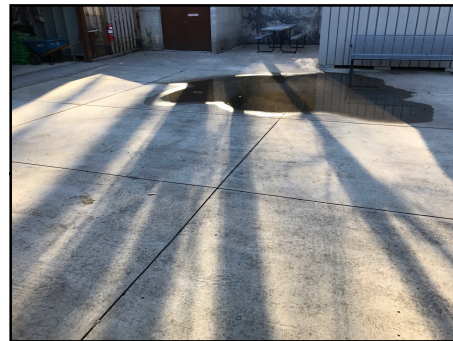
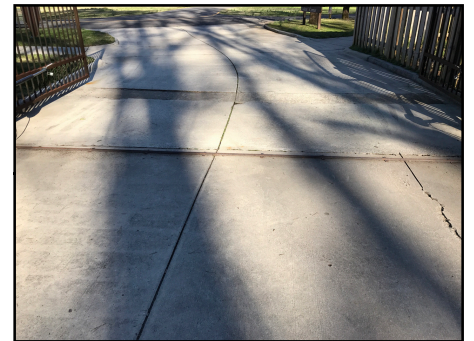
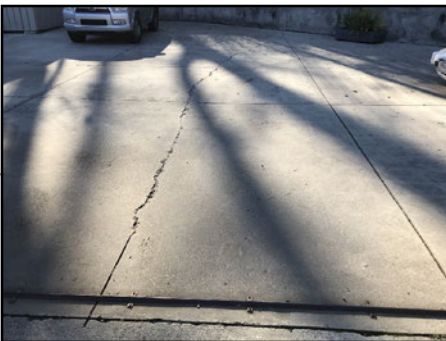
ROUTE 0902: MAINTENANCE YARD

Inspection Date	FMSS Number	User Access	Surface Type
2/21/2020	66374	NONPUBLIC	CONCRETE
Area (Sq. Ft.)	Lane Miles (11' Widths)	Curb Reveal (Inches)	Curb Recommendation
4,937	0.085	3	DO NOTHING
Curb Type		Curb & Gutter Type	
CONCRETE		NO CURB AND GUTTER	
Pavement Recommendation		Condition Rating / PCR	
PREVENTIVE MAINTENANCE		GOOD / 90
