SAIR Cycle 6

Final Report

Road Inventory and Condition Assessment of Paved Routes Saugus Iron Works National Historic Site

Report Date: April 2020

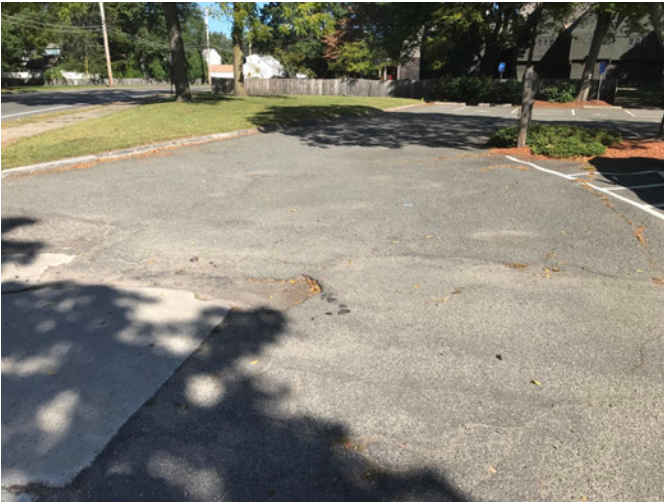
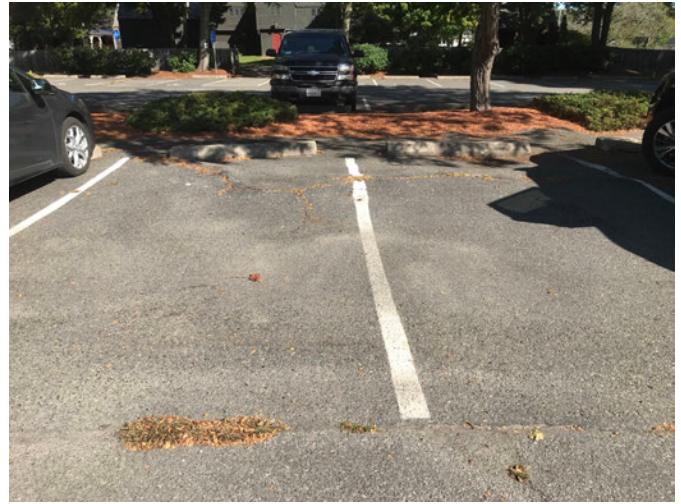
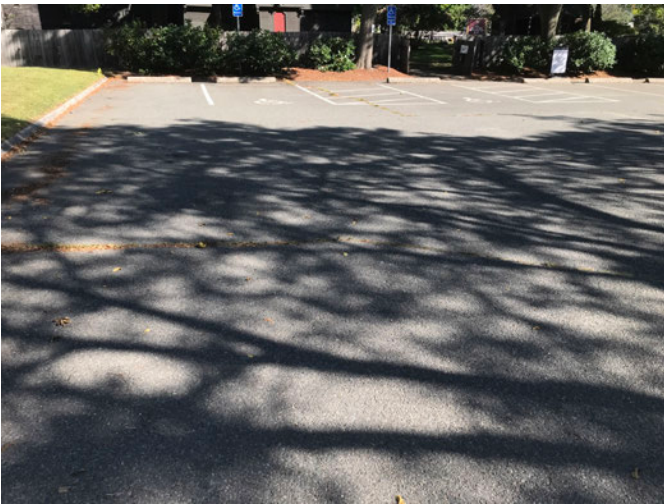
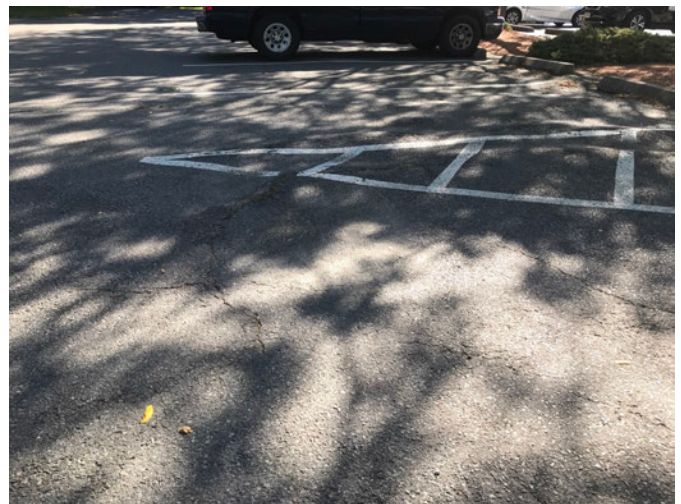
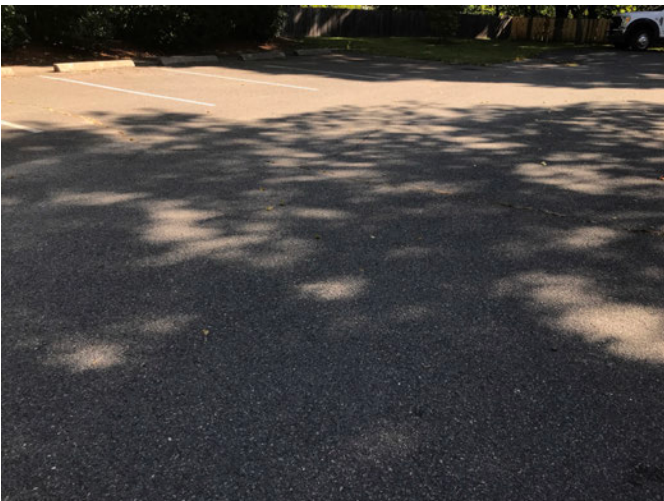
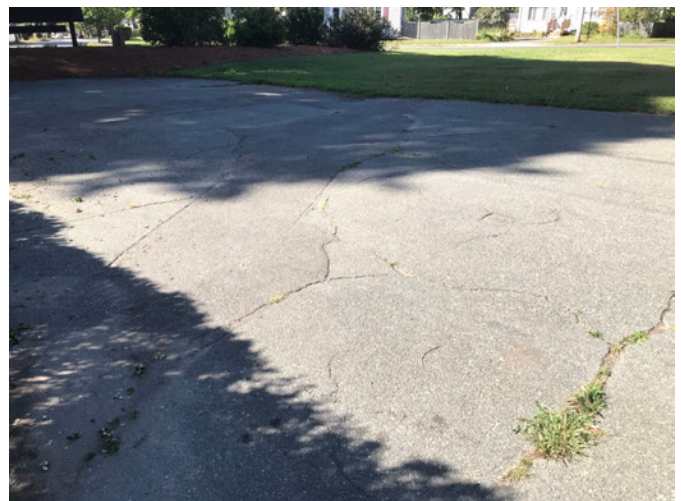
ROUTE 0900: VISITOR CENTER PARKING

Inspection Date	FMSS Number	User Access	Surface Type
9/17/2019	65448	PUBLIC	ASPHALT
Area (Sq. Ft.)	Lane Miles (11' Widths)	Curb Reveal (Inches)	Curb Recommendation
16,462	0.283	3	DO NOTHING
Curb Type		Curb & Gutter Type	
STONE		NO CURB AND GUTTER	
Pavement Recommendation		Condition Rating / PCR	
RECONSTRUCTION		POOR / 30

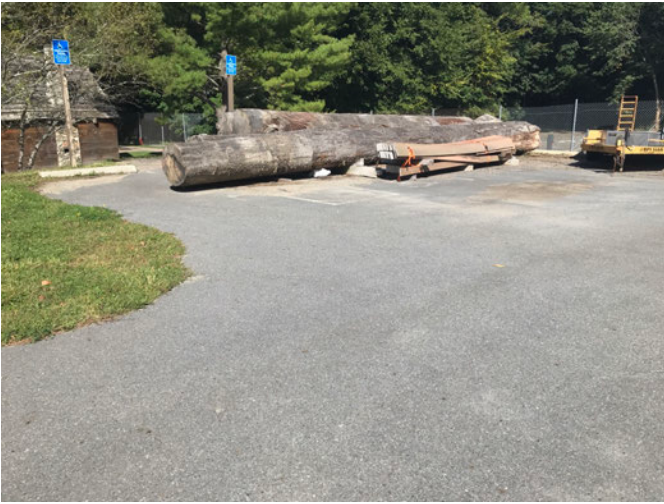
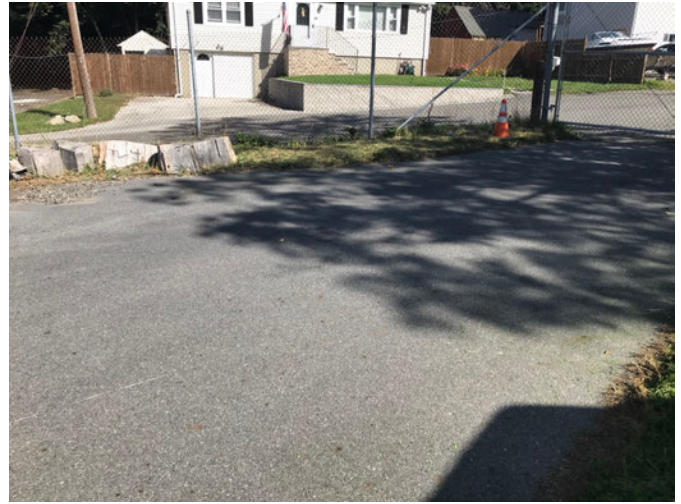
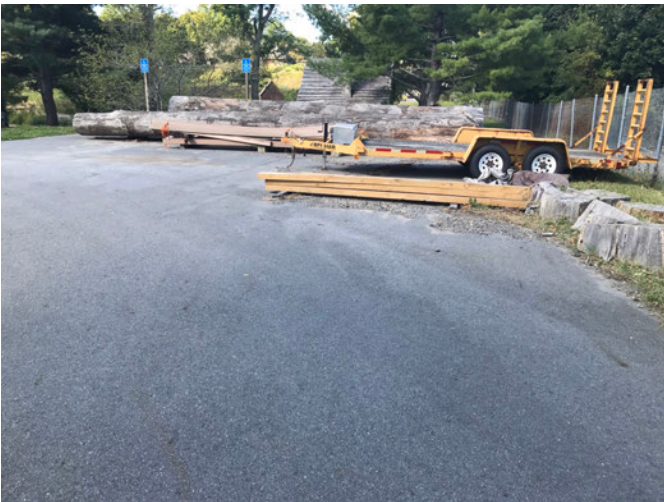
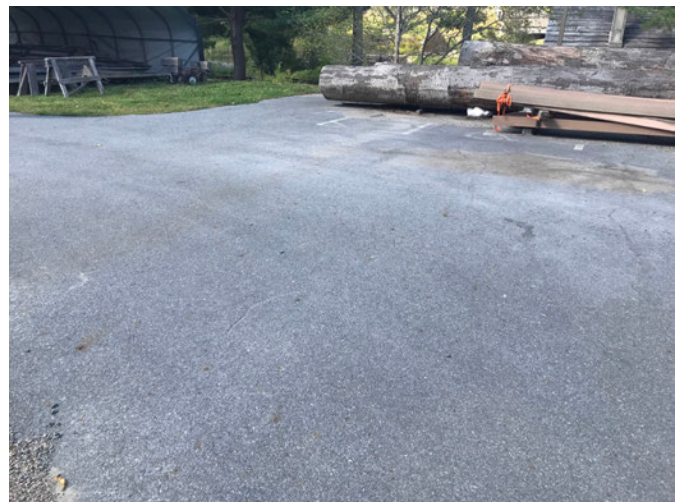
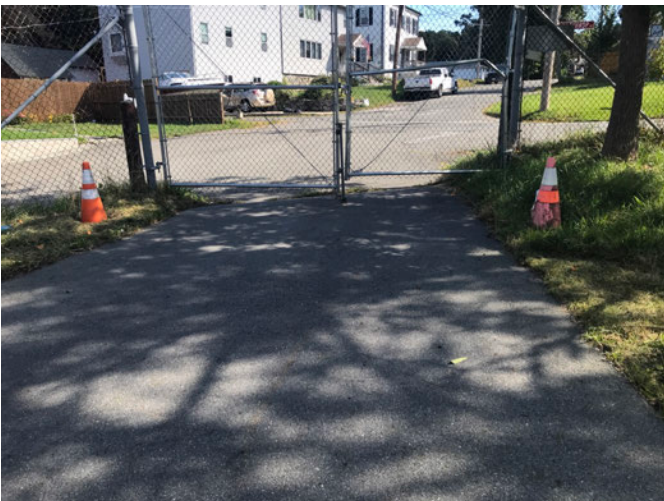
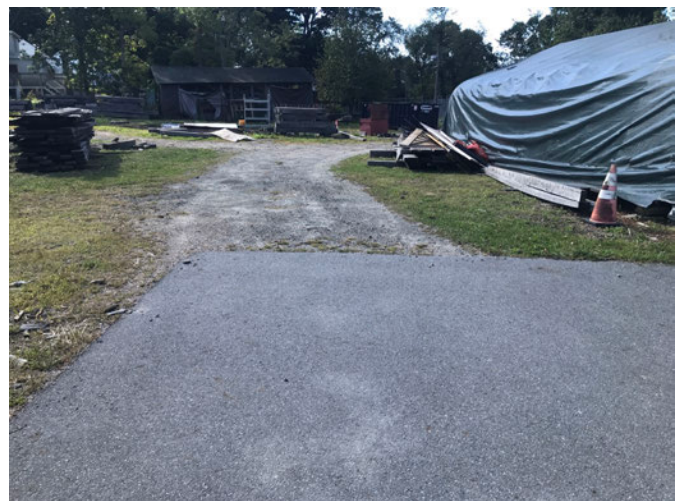
ROUTE 0902: LOWER ACCESSIBLE PARKING

Inspection Date	FMSS Number	User Access	Surface Type
9/17/2019	242660	PUBLIC	ASPHALT
Area (Sq. Ft.)	Lane Miles (11' Widths)	Curb Reveal (Inches)	Curb Recommendation
2,822	0.049	NOT APPLICABLE	NOT APPLICABLE
Curb Type		Curb & Gutter Type	
NO CURB		NO CURB AND GUTTER	
Pavement Recommendation		Condition Rating / PCR	
PREVENTIVE MAINTENANCE		GOOD / 90
