Road Inventory and Condition Assessment of Paved Routes Saint Paul's Church National Historic Site

**Federal Lands Highway
Road Inventory Program**

Report Date: January 2021

Saint Paul's Church National Historic Site in New York

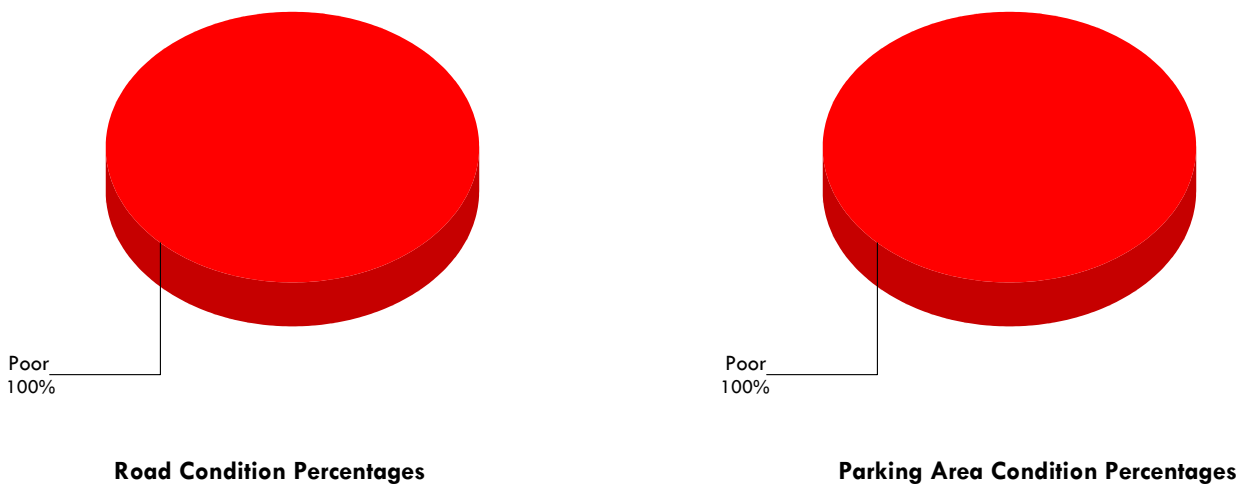
Figure 1: Pavement Condition Rating Breakdown for Paved Roads and Parking Areas

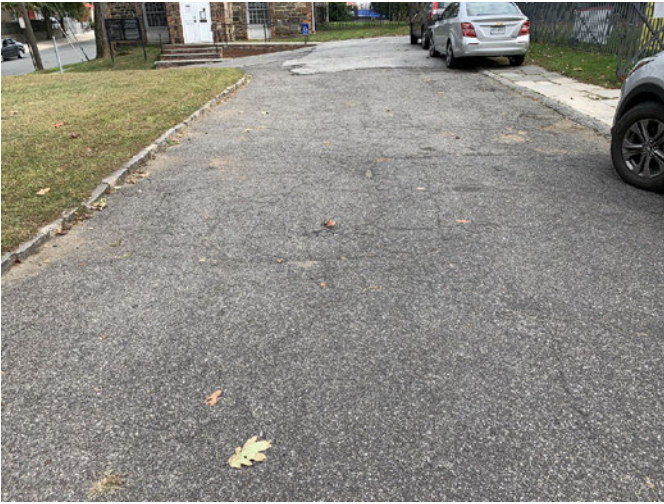
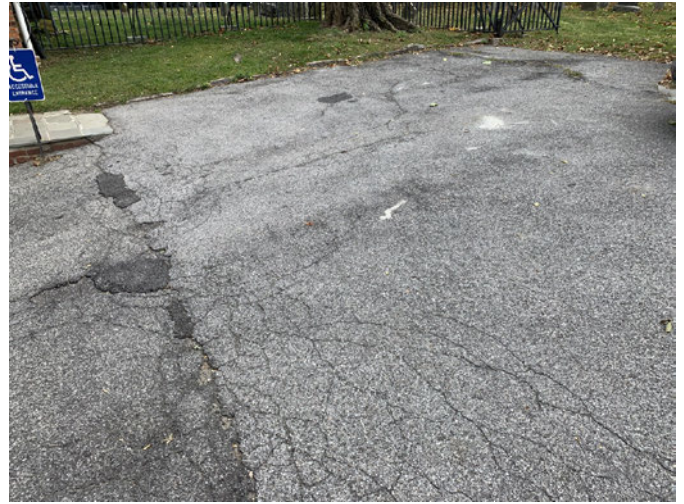
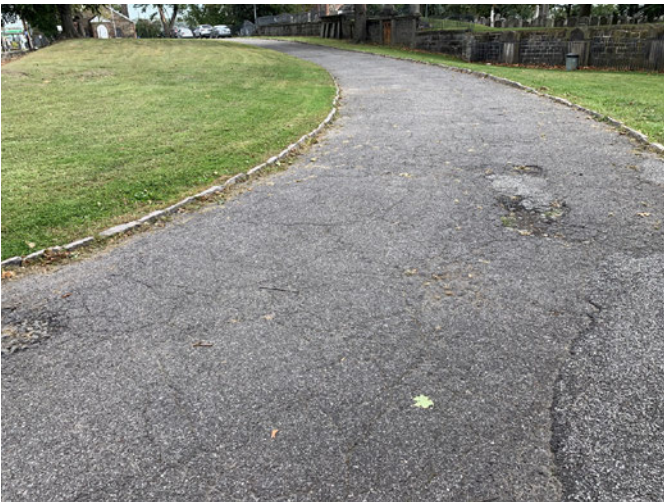
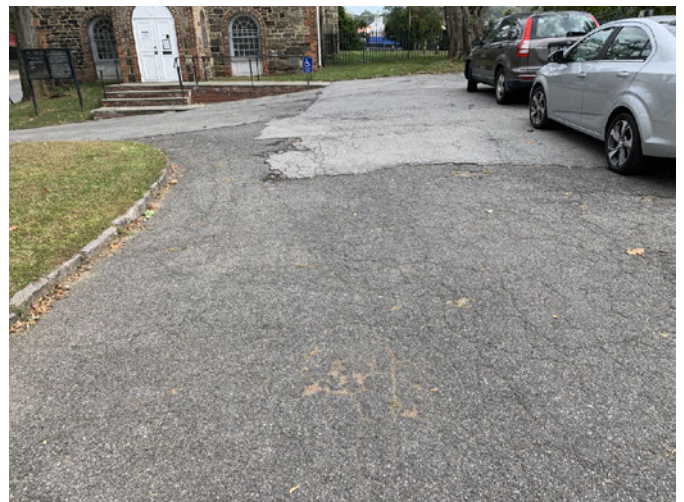
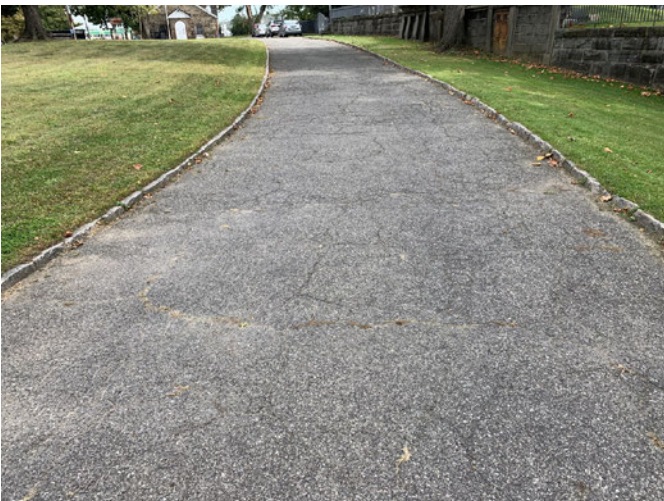
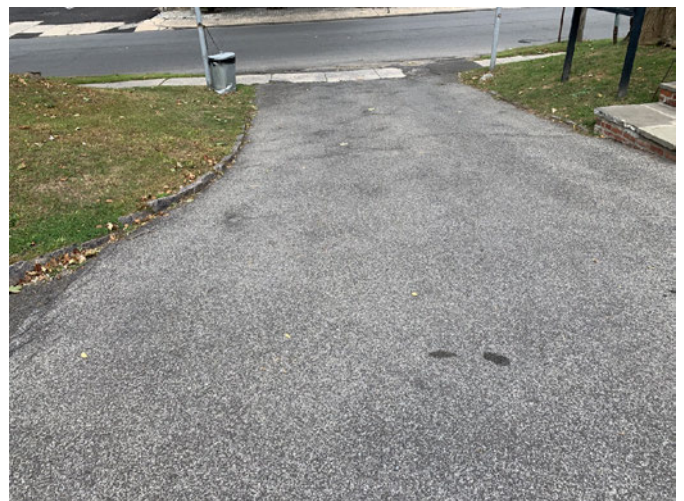
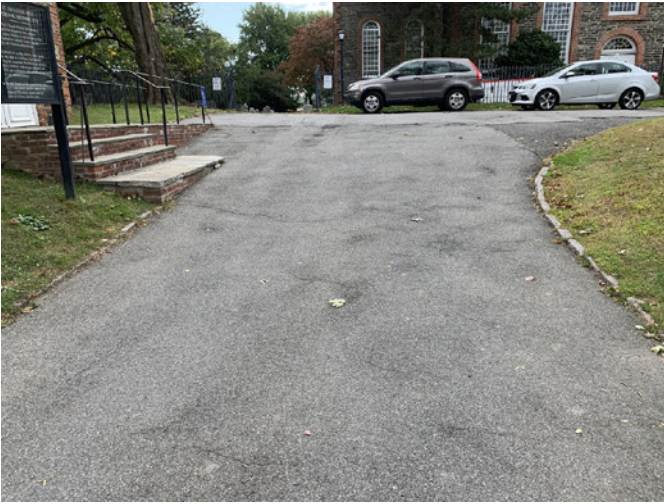
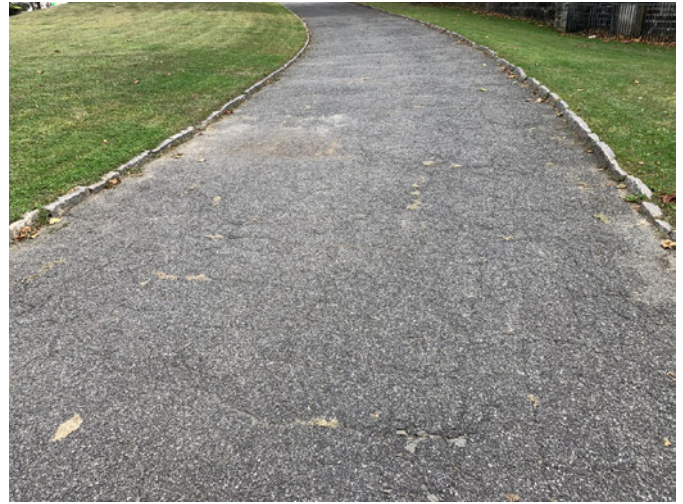
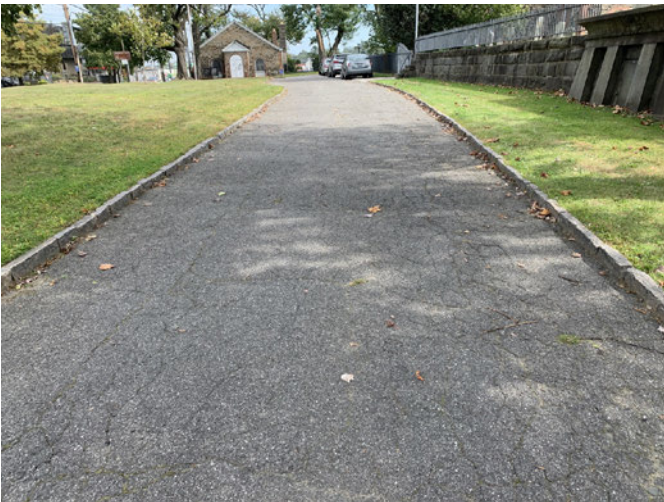
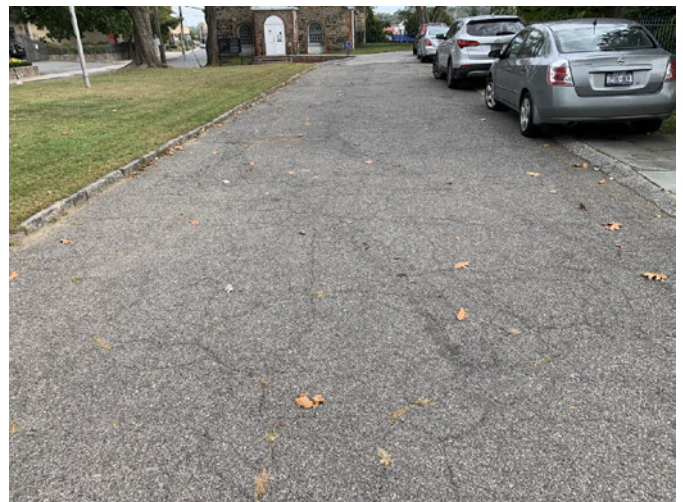
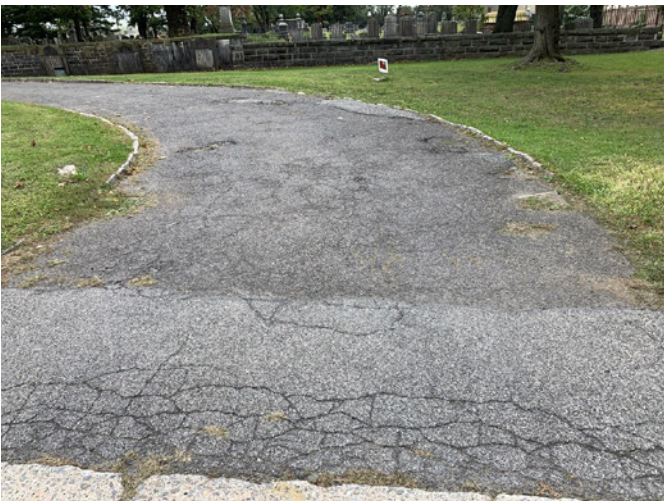
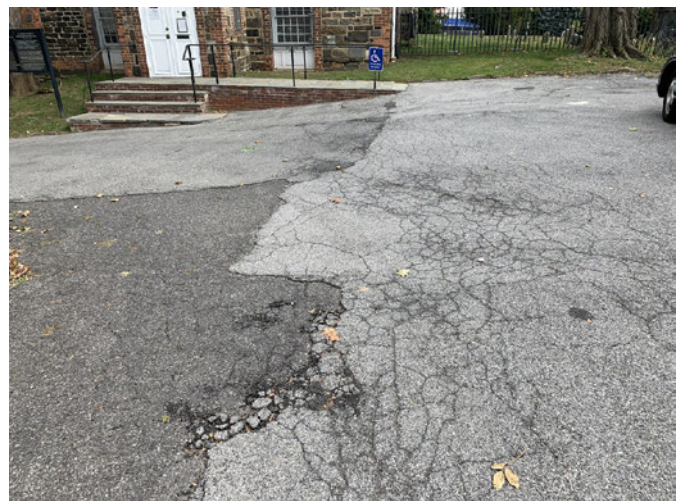
Inspection Date	FMSS Number	User Access	Surface Type
10/7/2020	240525	PUBLIC	ASPHALT
Area (Sq. Ft.)	Lane Miles (11' Widths)	Curb Reveal (Inches)	Curb Recommendation
5,745	0.099	4	MODERATE REPAIR
Curb Type		Curb & Gutter Type	
STONE		NO CURB AND GUTTER	
Pavement Recommendation		Condition Rating / PCR	
RECONSTRUCTION		POOR / 30
