# SARI Cycle 6

## Final Report

### Road Inventory and Condition Assessment of Paved Routes Salt River Bay National Historical Park and Ecological Preserve

**Report Date: September 2022**

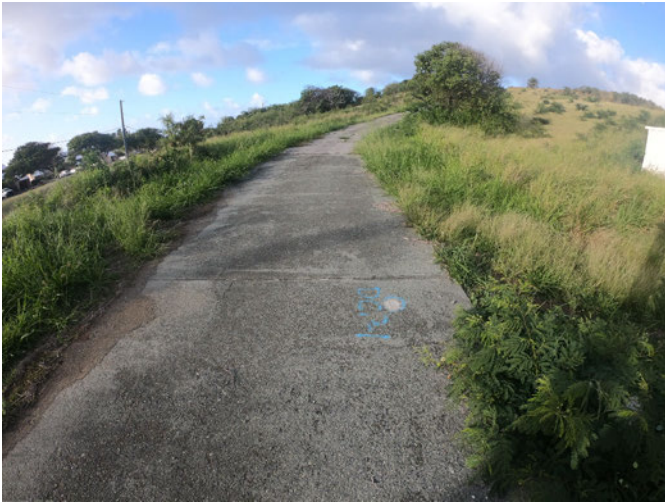
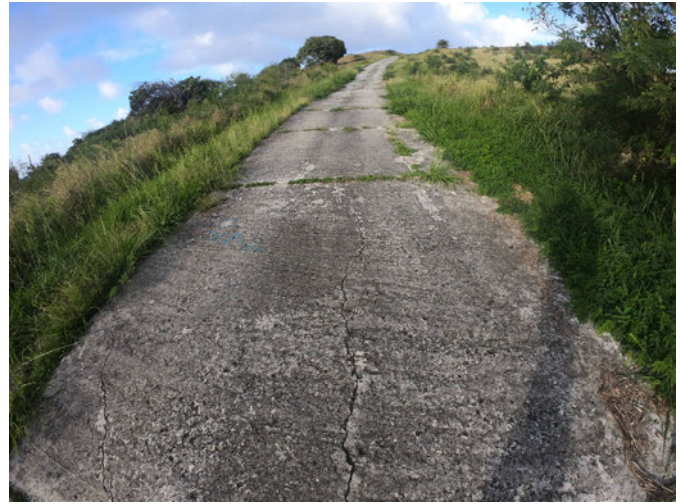
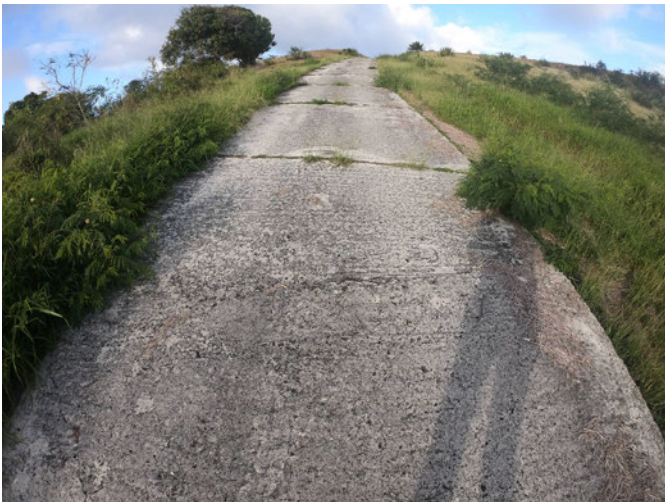
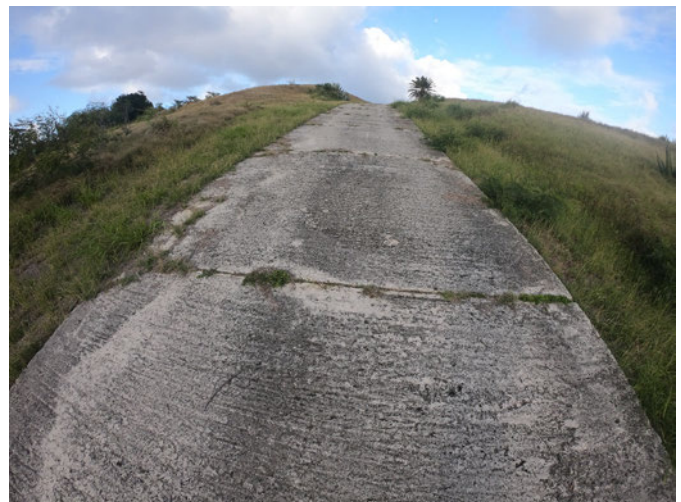
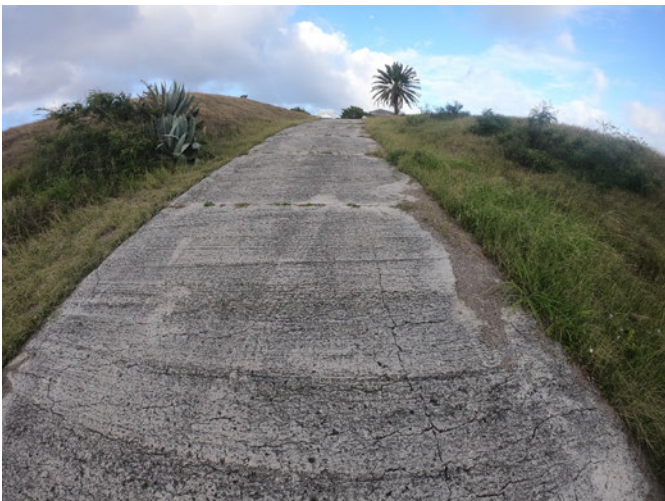
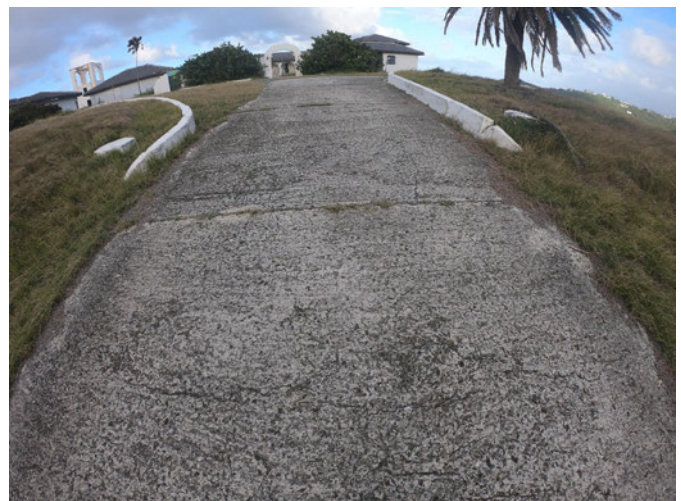
## ROUTE 0011: SALT RIVER VISITOR STATION DRIVEWAY

SURFACE DELAMINATION/POPOUTS AND SLAB CRACKING RATED 'GOOD'.

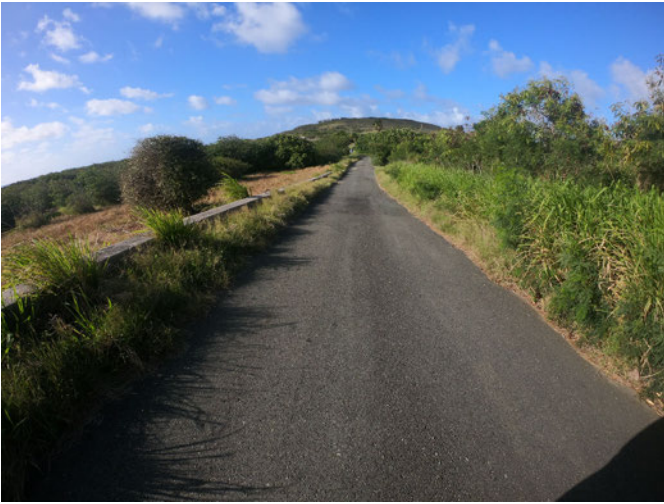
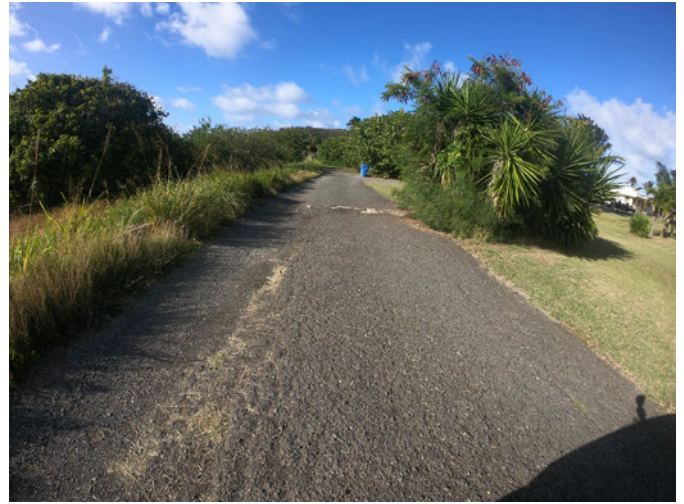
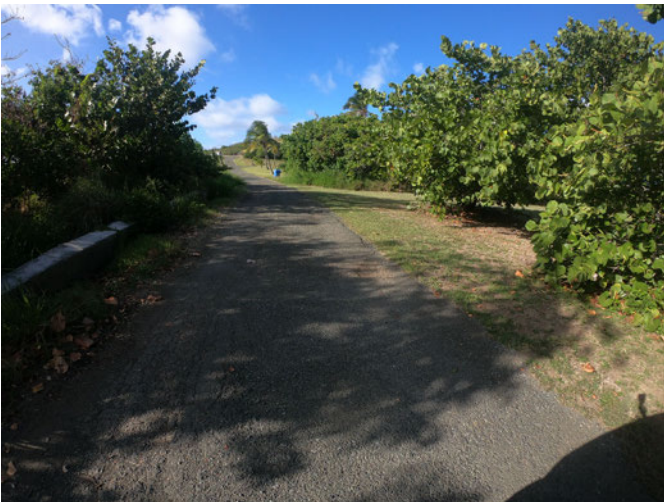
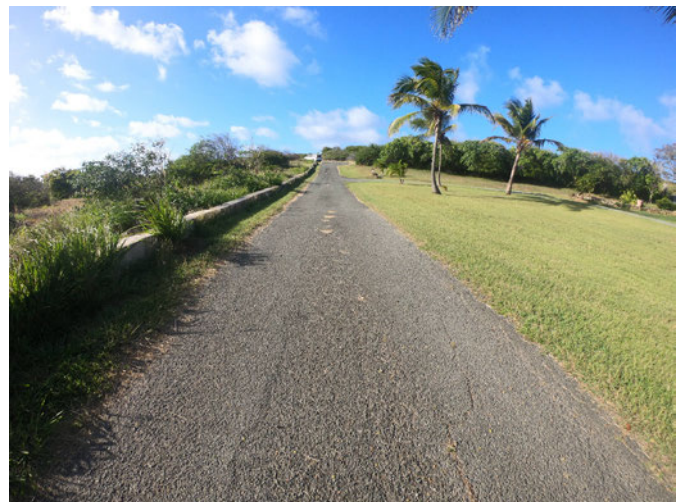
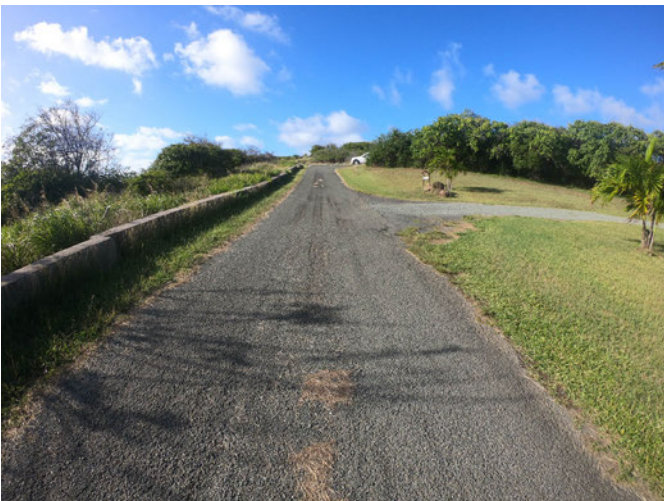
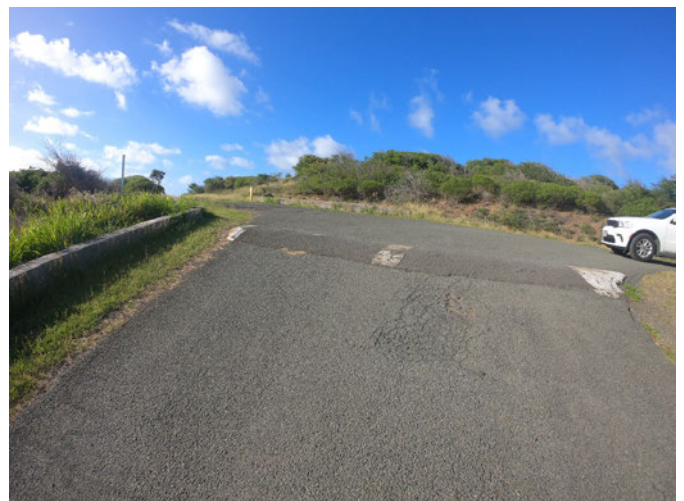
## ROUTE 0200: GRAPETREE ROAD

Route No.	FMSS No.	Route Name	Functional Class	Surf. Type	Paved Length (Miles)	Pavement Condition Rating (PCR)	Roughness Condition Index (RCI)	Surface Condition Rating (SCR)	Structural Crack Index	Alligator Crack Index	Longitudinal Cracking Index	Transverse Cracking Index	Patch / Pothole Index	Rutting Index
SARI-0011	114025	SALT RIVER VISITOR STATION DRIVEWAY	1	CO	0.10	90	NR	90	NR	NR	NR	NR	NR	NR
SARI-0200	242796	GRAPETREE ROAD	4	AS	0.13	73	NR	73	NR	73	90	90	73	73

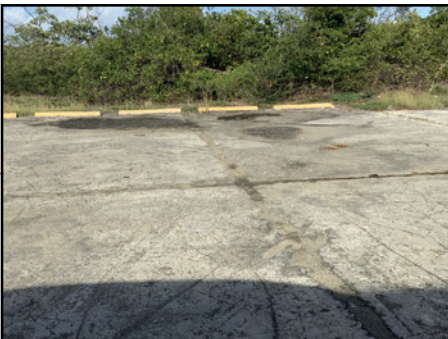
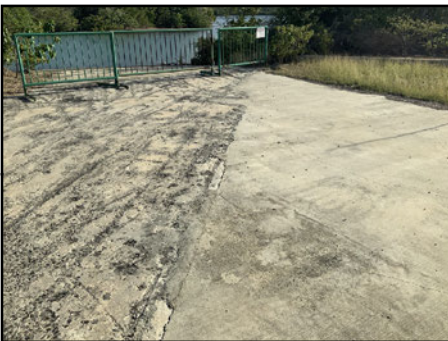
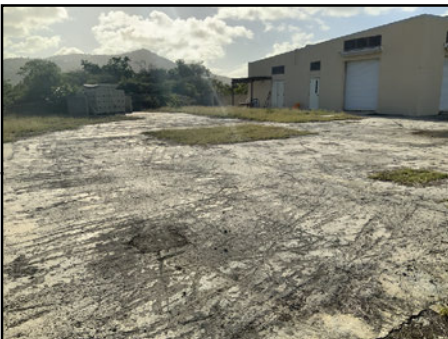
Inspection Date	FMSS Number	User Access	Surface Type
3/14/2022	242795	NONPUBLIC	CONCRETE
Area (Sq. Ft.)	Lane Miles (11' Widths)	Curb Reveal (Inches)	Curb Recommendation
10,887	0.187	NOT APPLICABLE	NOT APPLICABLE
Curb Type		Curb & Gutter Type	
NO CURB		NO CURB AND GUTTER	
Pavement Recommendation		Condition Rating / PCR	
HEAVY 3R TREATMENTS		POOR / 53
