SCBL Cycle 6

Final Report

Road Inventory and Condition Assessment of Paved Routes Scotts Bluff National Monument

Report Date: April 2018

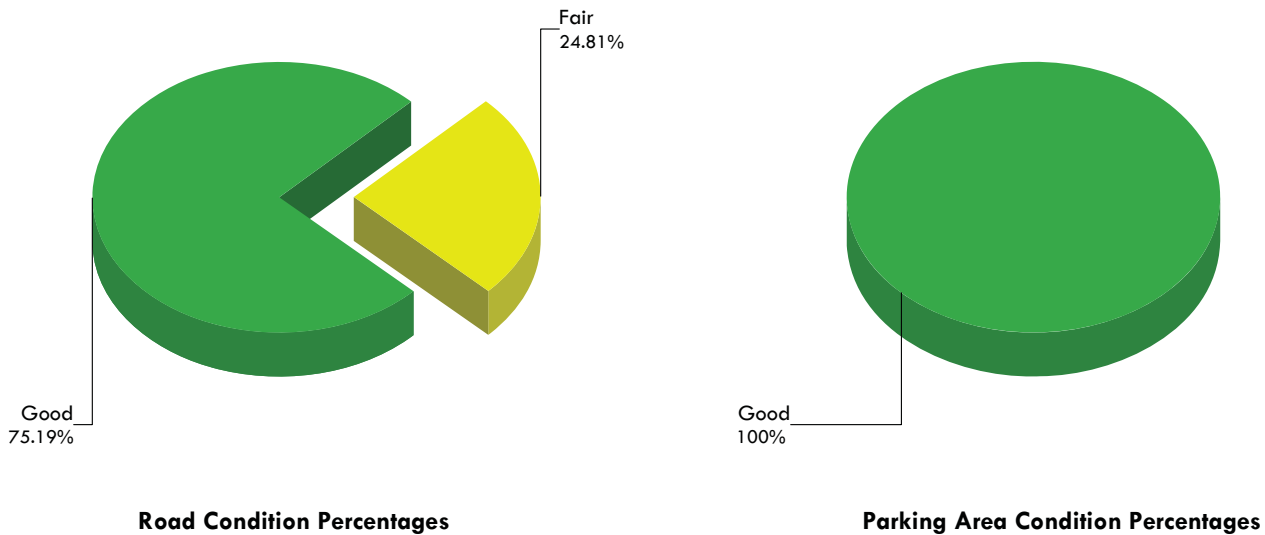
Figure 1: Pavement Condition Rating Breakdown for Paved Roads and Parking Areas

Cycle 6 Lane Miles and Overall Pavement Condition		
	Lanes Miles*	Pavement Condition Rating**
Data Collection Vehicle Routes	2.73	86
Manually Rated Roads	0	N/A
Parking Areas	1.40	90

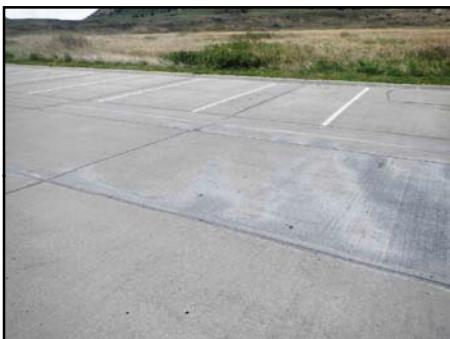
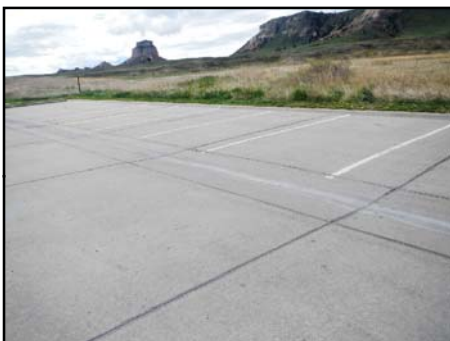
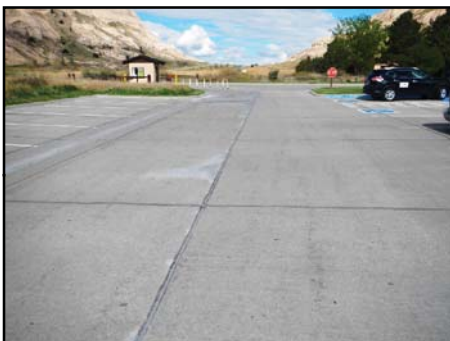
Inspection Date	FMSS Number	User Access	Surface Type
4/25/2017	30343	PUBLIC	CONCRETE
Area (Sq. Ft.)	Lane Miles (11' Widths)	Curb Reveal (Inches)	Curb Recommendation
12,117	0.209	7	DO NOTHING
Curb Type		Curb & Gutter Type	
CONCRETE		NO CURB AND GUTTER	
Pavement Recommendation		Condition Rating / PCR	
PREVENTIVE MAINTENANCE		GOOD / 90

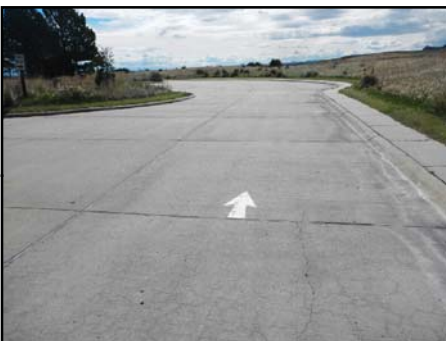
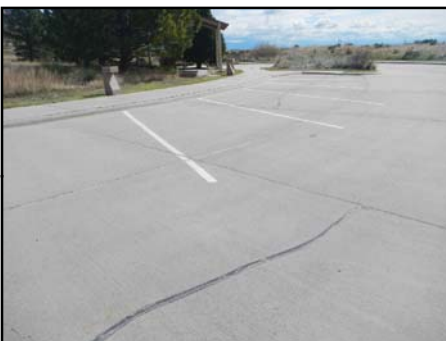
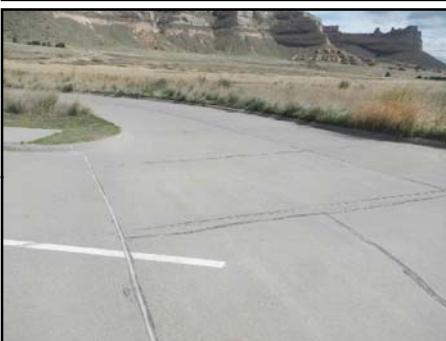
ROUTE 0901: VISITOR CENTER BUS PARKING

Inspection Date	FMSS Number	User Access	Surface Type
4/25/2017	52838	PUBLIC	CONCRETE
Area (Sq. Ft.)	Lane Miles (11' Widths)	Curb Reveal (Inches)	Curb Recommendation
27,014	0.465	7	DO NOTHING
Curb Type		Curb & Gutter Type	
CONCRETE		NO CURB AND GUTTER	
Pavement Recommendation		Condition Rating / PCR	
PREVENTIVE MAINTENANCE		GOOD / 90

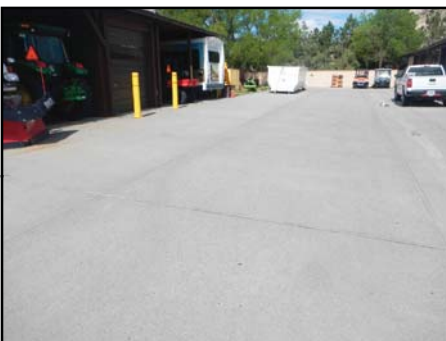
ROUTE 0902: MAINTENANCE YARD

Inspection Date	FMSS Number	User Access	Surface Type
4/25/2017	51529	NONPUBLIC	CONCRETE
Area (Sq. Ft.)	Lane Miles (11' Widths)	Curb Reveal (Inches)	Curb Recommendation
8,449	0.145	7	DO NOTHING
Curb Type		Curb & Gutter Type	
CONCRETE		NO CURB AND GUTTER	
Pavement Recommendation		Condition Rating / PCR	
PREVENTIVE MAINTENANCE		GOOD / 90

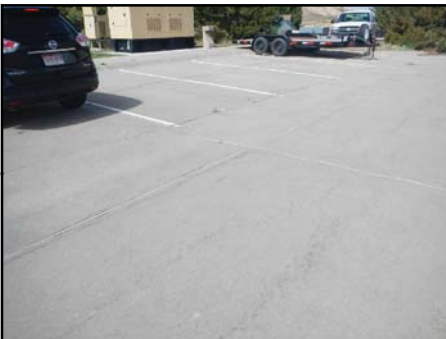
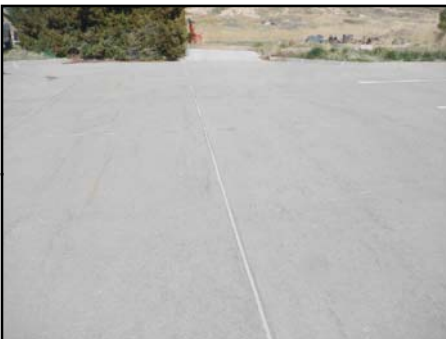
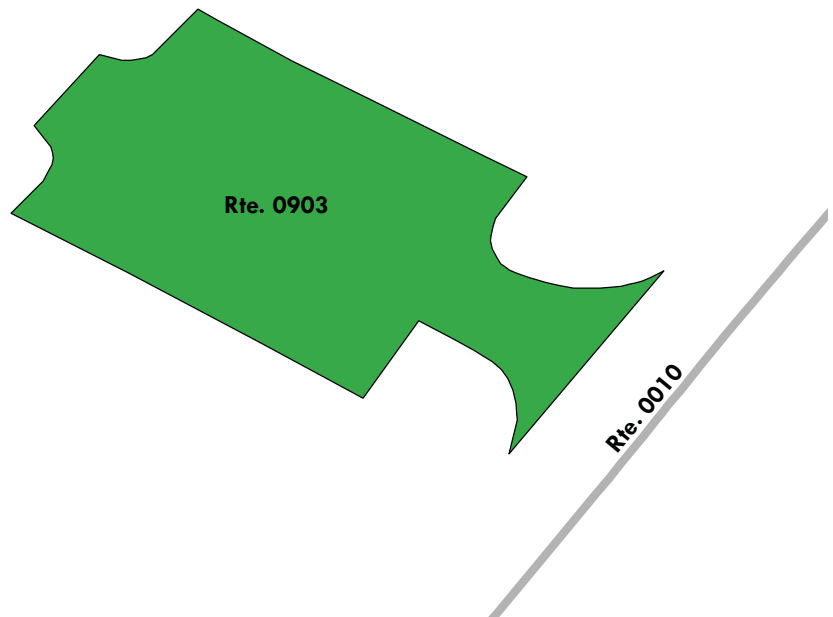
ROUTE 0903: EMPLOYEE PARKING

Inspection Date	FMSS Number	User Access	Surface Type
4/25/2017	51528	NONPUBLIC	CONCRETE
Area (Sq. Ft.)	Lane Miles (11' Widths)	Curb Reveal (Inches)	Curb Recommendation
6,670	0.115	7	DO NOTHING
Curb Type		Curb & Gutter Type	
CONCRETE		NO CURB AND GUTTER	
Pavement Recommendation		Condition Rating / PCR	
PREVENTIVE MAINTENANCE		GOOD / 90

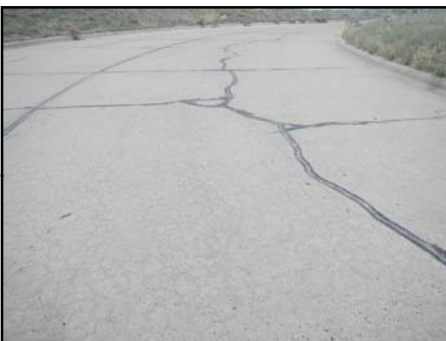
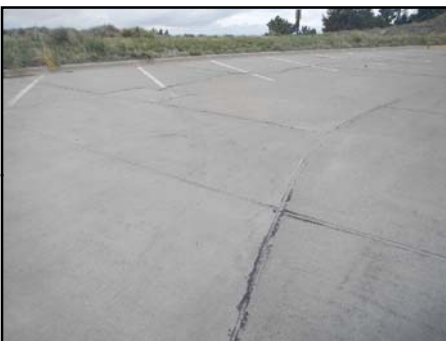
ROUTE 0904: SUMMIT PARKING

Inspection Date	FMSS Number	User Access	Surface Type
4/25/2017	30364	PUBLIC	CONCRETE
Area (Sq. Ft.)	Lane Miles (11' Widths)	Curb Reveal (Inches)	Curb Recommendation
26,941	0.464	7	DO NOTHING
Curb Type		Curb & Gutter Type	
CONCRETE		NO CURB AND GUTTER	
Pavement Recommendation		Condition Rating / PCR	
PREVENTIVE MAINTENANCE		GOOD / 90
