SITK Cycle 6

Final Report

Road Inventory and Condition Assessment for Sitka National Historical Park

**Federal Highway Administration
Eastern Federal Lands Highway Division
Road Inventory Program (RIP)**

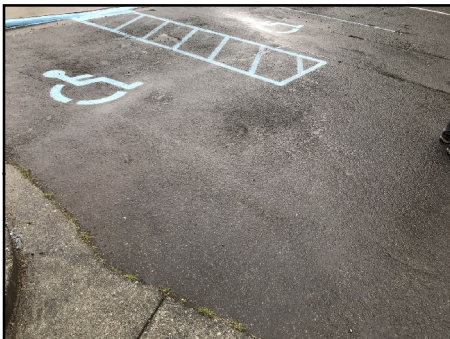
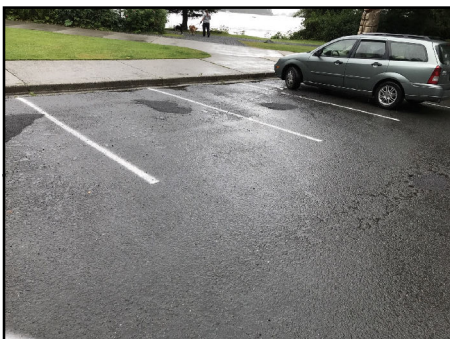
Inspection Date	FMSS Number	User Access	Surface Type
7/18/2019	64371	PUBLIC	ASPHALT
Area (Sq. Ft.)	Lane Miles (11' Widths)	Curb Reveal (Inches)	Curb Recommendation
6,793	0.117	NOT APPLICABLE	LIGHT REPAIR
Curb Type		Curb & Gutter Type	
NO CURB		CONCRETE	
Pavement Recommendation		Condition Rating / PCR	
LIGHT 3R TREATMENTS		FAIR / 73

Parking area consists of multiple surface types:
1 part Asphalt at 5,661 sq ft; 1 part concrete at 1,132 sq ft.

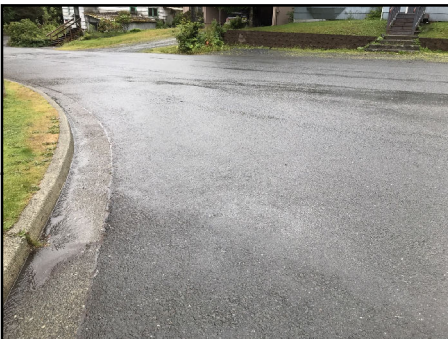
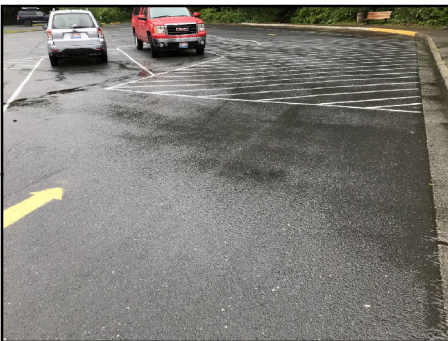
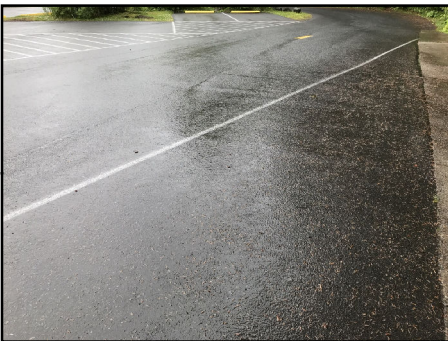
ROUTE 0901: VISITOR CENTER UPPER PARKING

Inspection Date	FMSS Number	User Access	Surface Type
7/18/2019	64369	PUBLIC	ASPHALT
Area (Sq. Ft.)	Lane Miles (11' Widths)	Curb Reveal (Inches)	Curb Recommendation
15,749	0.271	NOT APPLICABLE	DO NOTHING
Curb Type		Curb & Gutter Type	
NO CURB		CONCRETE	
Pavement Recommendation		Condition Rating / PCR	
LIGHT 3R TREATMENTS		FAIR / 73

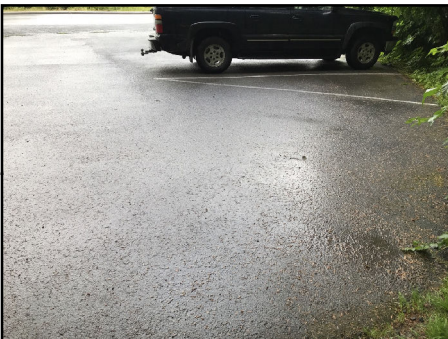
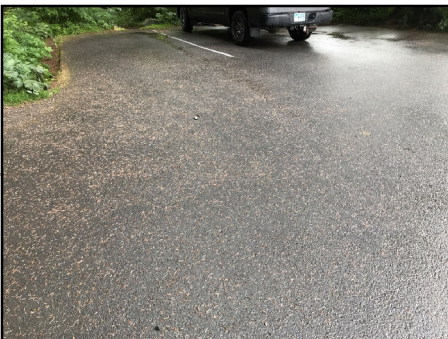
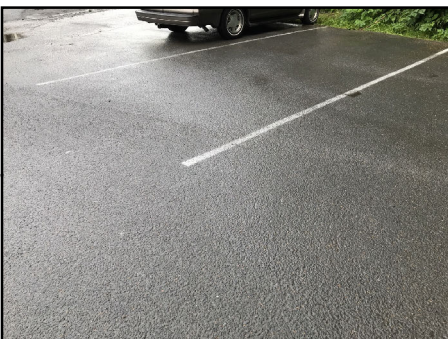
ROUTE 0902: EAST ENTRANCE PARKING

Inspection Date	FMSS Number	User Access	Surface Type
7/18/2019	89278	PUBLIC	ASPHALT
Area (Sq. Ft.)	Lane Miles (11' Widths)	Curb Reveal (Inches)	Curb Recommendation
3,358	0.058	NOT APPLICABLE	NOT APPLICABLE
Curb Type		Curb & Gutter Type	
NO CURB		NO CURB AND GUTTER	
Pavement Recommendation		Condition Rating / PCR	
LIGHT 3R TREATMENTS		FAIR / 73

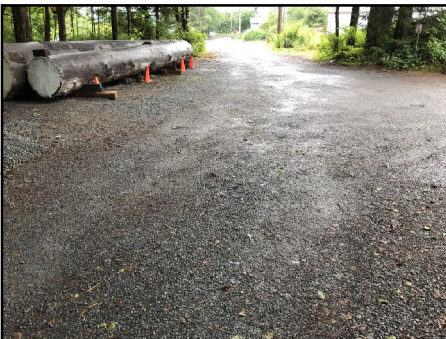
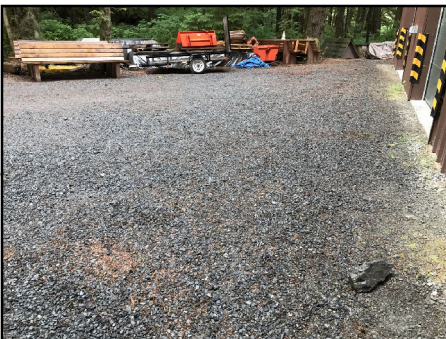
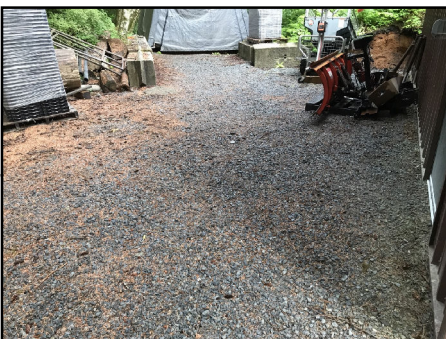
ROUTE 0903: BPR PARKING

Inspection Date	FMSS Number	User Access	Surface Type
7/18/2019	236453	NONPUBLIC	GRAVEL
Area (Sq. Ft.)	Lane Miles (11' Widths)	Curb Reveal (Inches)	Curb Recommendation
4,270	0.074	NOT APPLICABLE	NOT APPLICABLE
Curb Type		Curb & Gutter Type	
NO CURB		NO CURB AND GUTTER	
Treatment Recommendation		Condition Rating	
HEAVY REHABILITATION		2
