STLI Cycle 6

Final Report

Road Inventory and Condition Assessment for Statue of Liberty National Monument

Statue of Liberty National Monument in New York

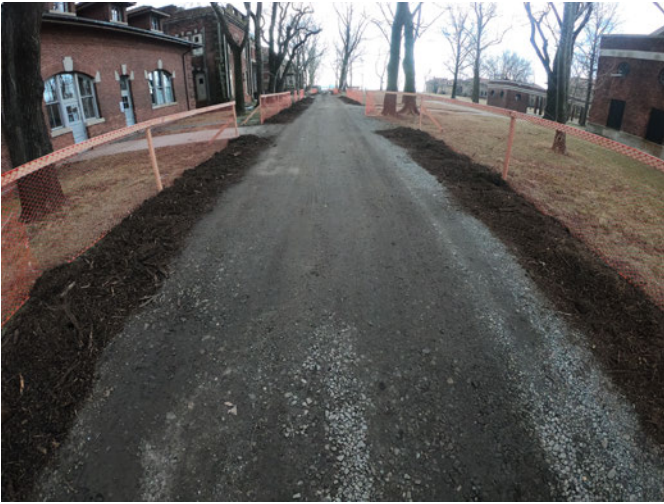
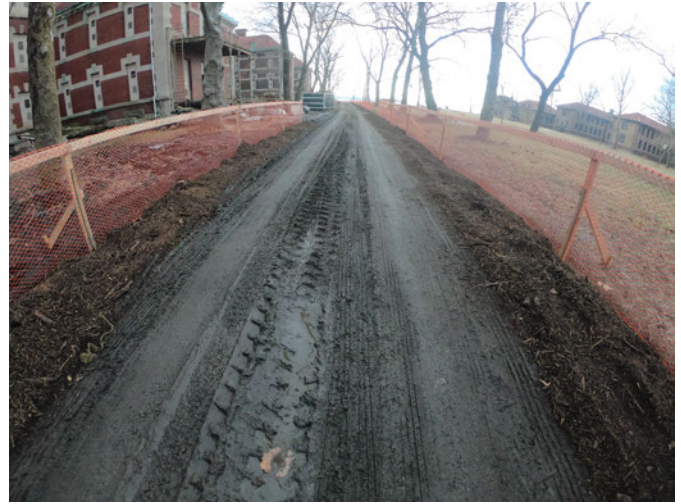
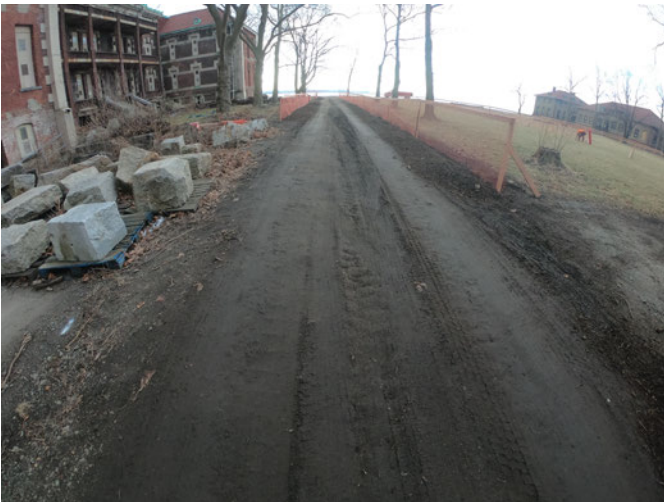
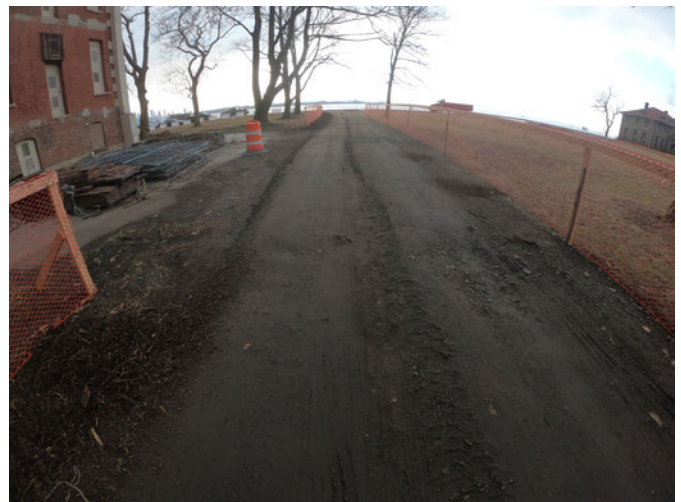
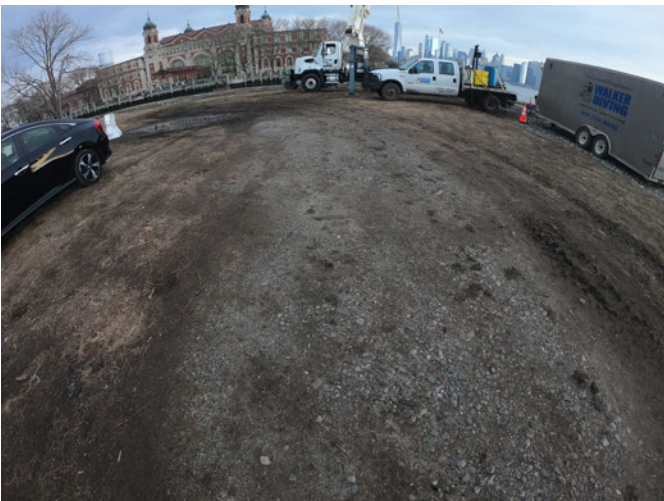
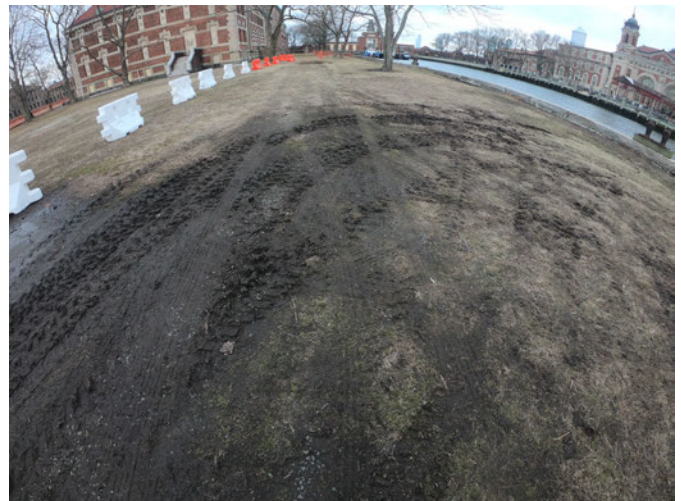
ROUTE 0400AZ: ISLAND 2 ROAD A

Begin MP	End MP	Section Length	# of Lanes	Lane Width	Road Width	Treatment Recommendation	Treatment Cost	Unpaved Rating (Paser +)	Crown Severity	Drainage Severity	Rutting, Washboard Severity	Potholes / Loose Aggregate Severity
0.00	0.18	0.18	1	10.0	10.0	Heavy Rehabilitation	\$19,840	2	Med	Med	Med	Med
Route Level Data:		0.18	1	10.0	10.0	Heavy Rehabilitation	\$19,840	2	Med	Med	Med	Med

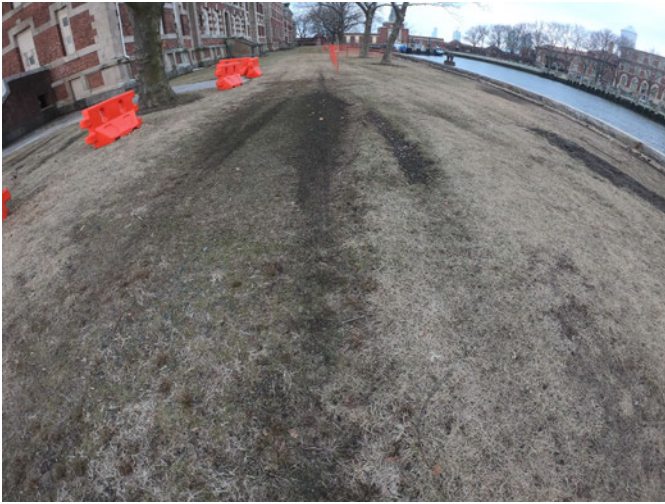
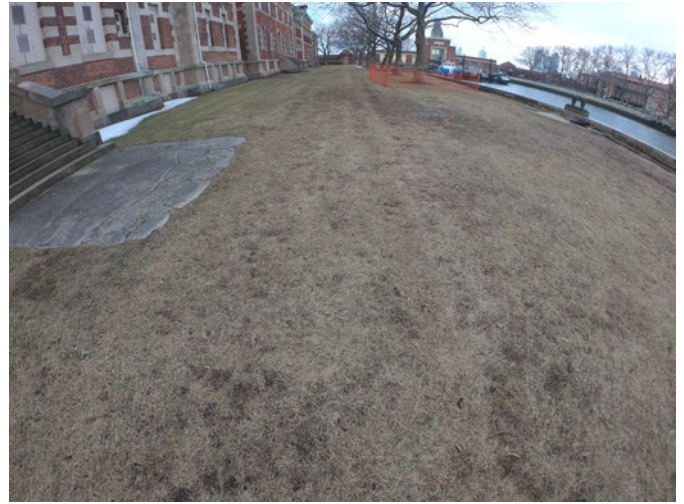
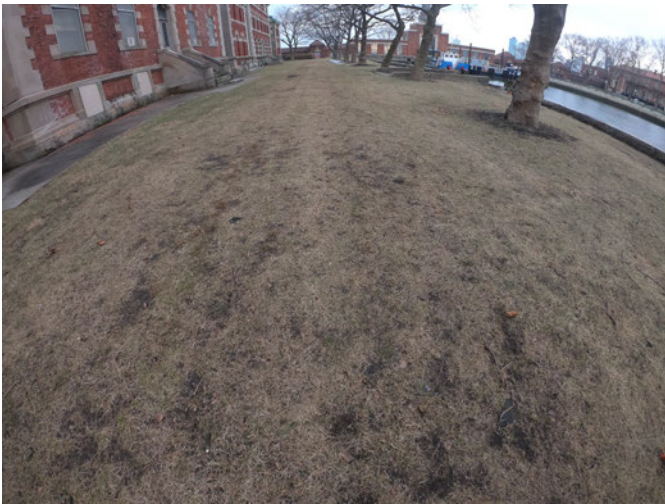
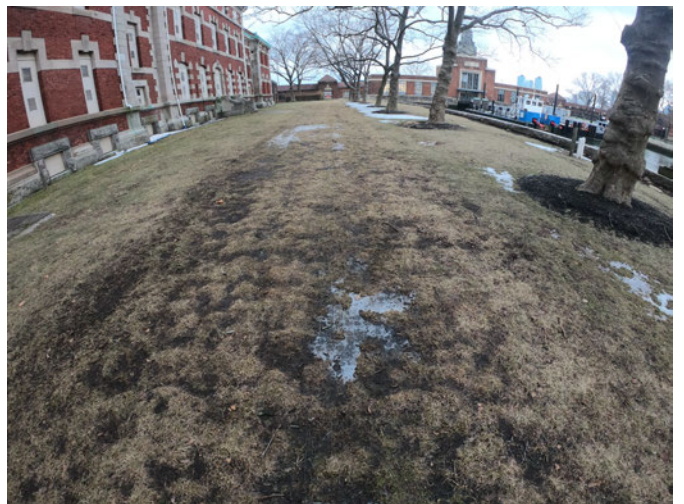
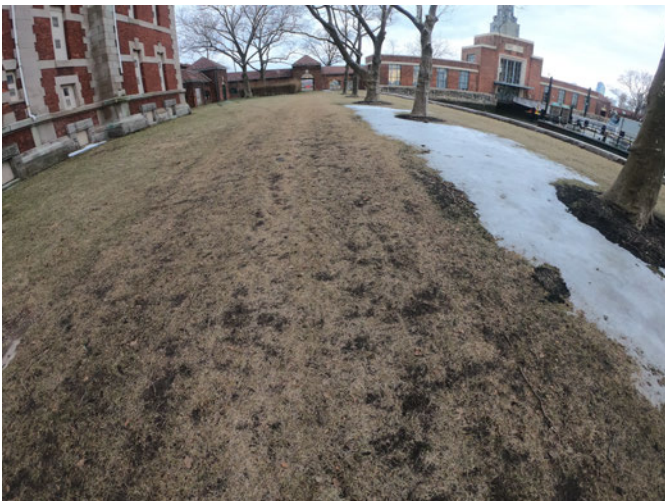
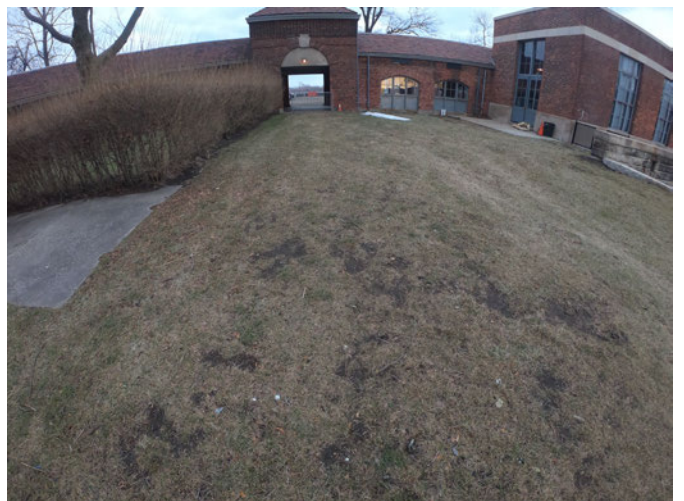
ROUTE 0400BZ: ISLAND 2 ROAD B

Begin MP	End MP	Section Length	# of Lanes	Lane Width	Road Width	Treatment Recommendation	Treatment Cost	Unpaved Rating (Paser +)	Crown Severity	Drainage Severity	Rutting, Washboard Severity	Potholes / Loose Aggregate Severity
0.00	0.12	0.12	1	12.0	12.0	Routine Maintenance	\$364	3	Med	Med	Low	Low
Route Level Data:		0.12	1	12.0	12.0	Routine Maintenance	\$364	3	Med	Med	Low	Low

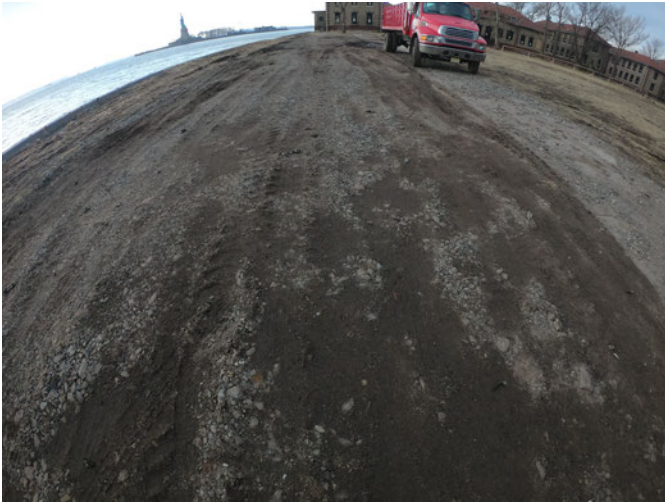
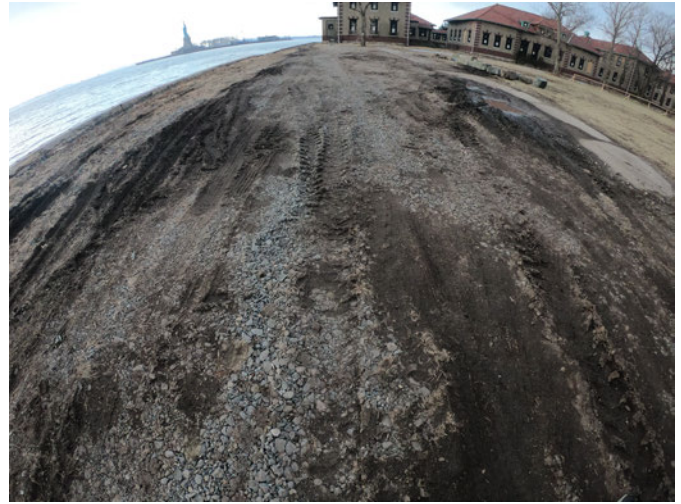
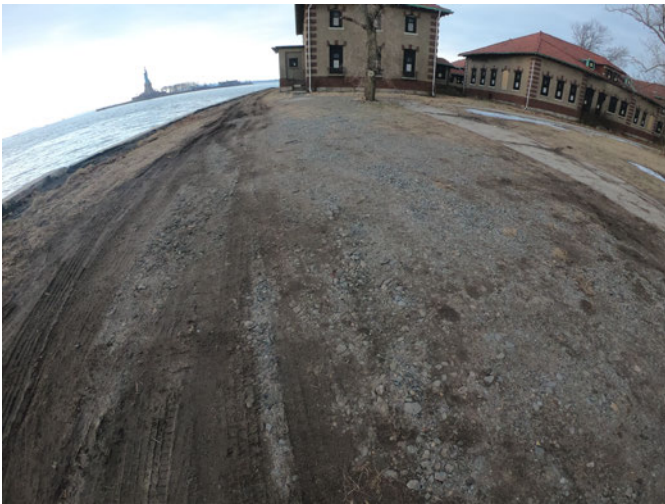
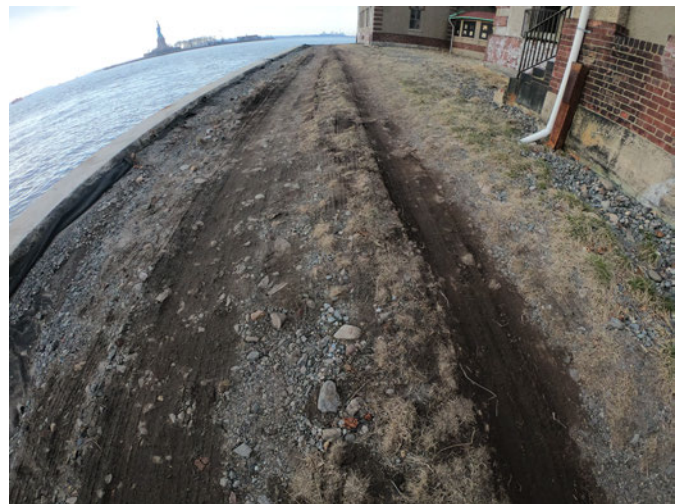
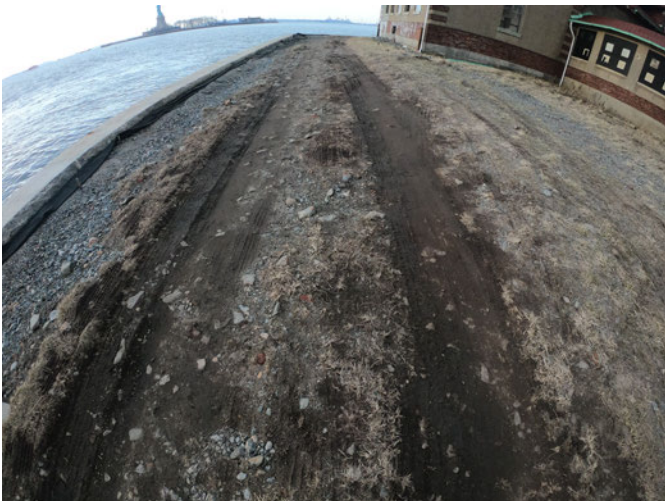
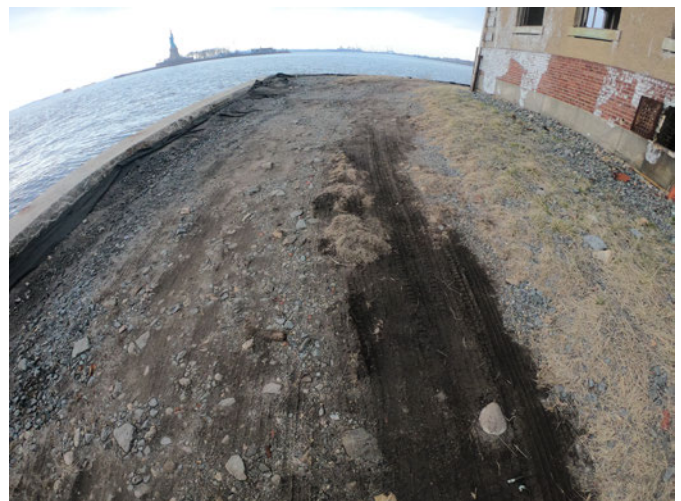
ROUTE 0400CZ: ISLAND 2 ROAD C

Begin MP	End MP	Section Length	# of Lanes	Lane Width	Road Width	Treatment Recommendation	Treatment Cost	Unpaved Rating (Paser +)	Crown Severity	Drainage Severity	Rutting, Washboard Severity	Potholes / Loose Aggregate Severity
0.00	0.09	0.09	1	12.0	12.0	Heavy Rehabilitation	\$14,880	2	Med	Med	Med	Med
Route Level Data:		0.09	1	12.0	12.0	Heavy Rehabilitation	\$14,880	2	Med	Med	Med	Med

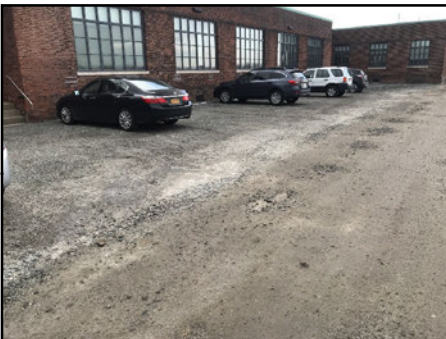
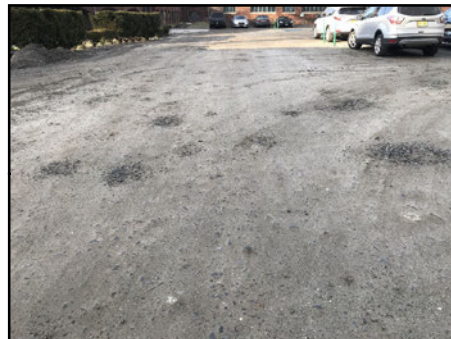
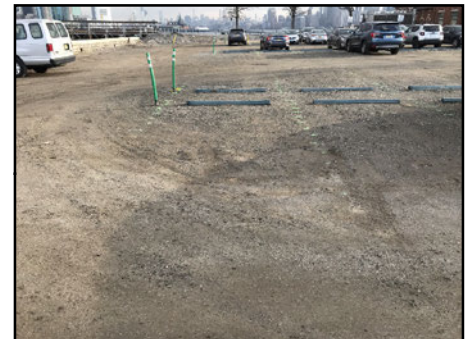
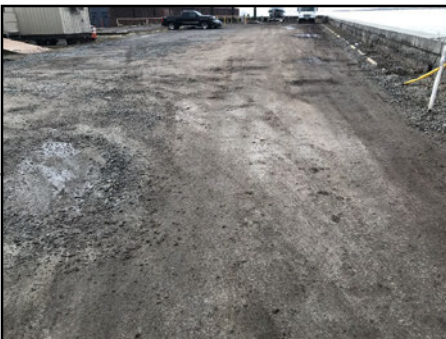
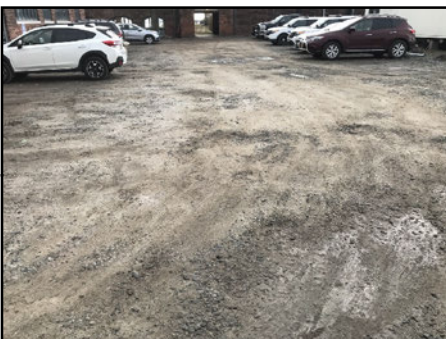
Inspection Date	FMSS Number	User Access	Surface Type
3/4/2021	60105	NONPUBLIC	GRAVEL
Area (Sq. Ft.)	Lane Miles (11' Widths)	Curb Reveal (Inches)	Curb Recommendation
67,575	1.163	NOT APPLICABLE	NOT APPLICABLE
Curb Type		Curb & Gutter Type	
NO CURB		NO CURB AND GUTTER	
Treatment Recommendation		Condition Rating	
Light Rehabilitation		3

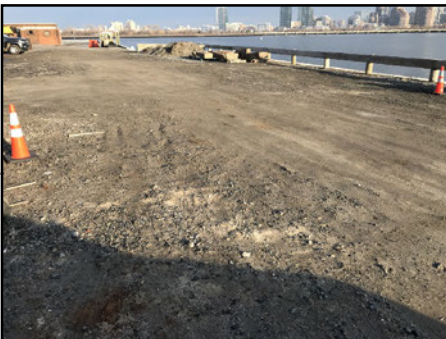
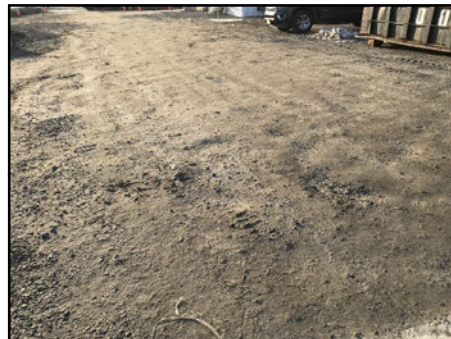
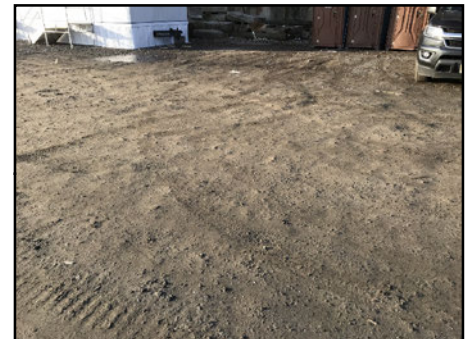
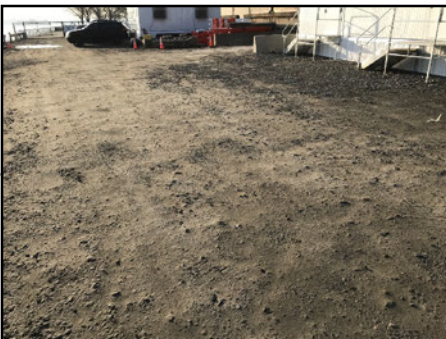
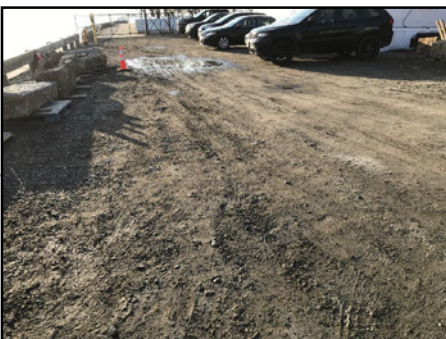
ROUTE 0901: UNPAVED OVERFLOW PARKING

Inspection Date	FMSS Number	User Access	Surface Type
3/4/2021	60106	NONPUBLIC	GRAVEL
Area (Sq. Ft.)	Lane Miles (11' Widths)	Curb Reveal (Inches)	Curb Recommendation
19,638	0.338	NOT APPLICABLE	NOT APPLICABLE
Curb Type		Curb & Gutter Type	
NO CURB		NO CURB AND GUTTER	
Treatment Recommendation		Condition Rating	
Light Rehabilitation		3

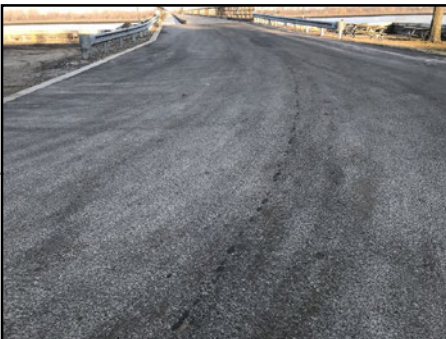
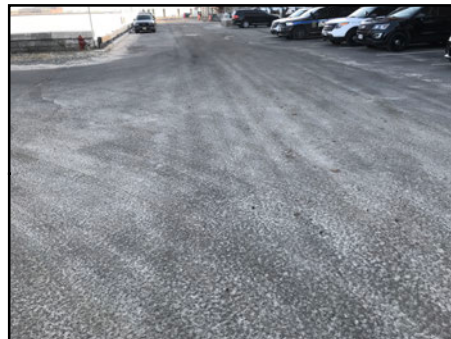
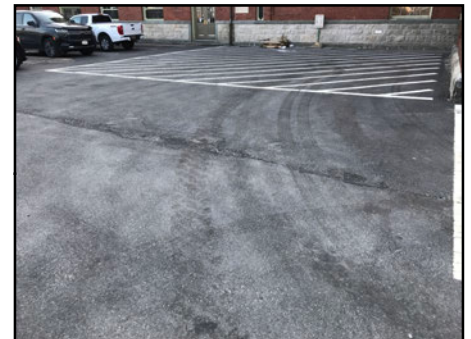
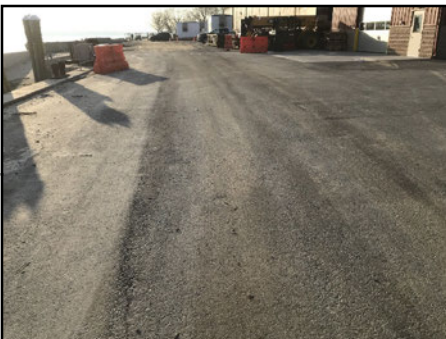
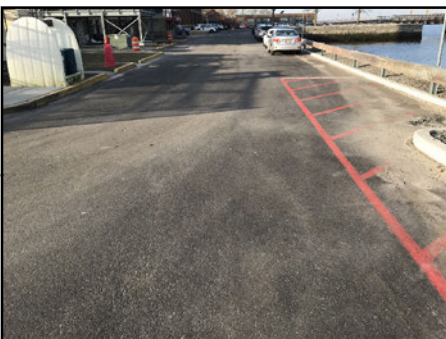
ROUTE 0902: POWER HOUSE PARKING

Inspection Date	FMSS Number	User Access	Surface Type
3/4/2021	254579	NONPUBLIC	ASPHALT
Area (Sq. Ft.)	Lane Miles (11' Widths)	Curb Reveal (Inches)	Curb Recommendation
37,851	0.652	6	DO NOTHING
Curb Type		Curb & Gutter Type	
CONCRETE		NO CURB AND GUTTER	
Pavement Recommendation		Condition Rating / PCR	
PREVENTIVE MAINTENANCE		GOOD / 90

Multiple Surface Types:
 ASPHALT = 36,571 sq ft
 CONCRETE = 1,280 sq ft
