TAPR Cycle 6

Road Inventory and Condition Assessment for Tallgrass Prairie National Preserve

**Federal Highway Administration
Eastern Federal Lands Highway Division
Road Inventory Program (RIP)**

Report Date: August 2021

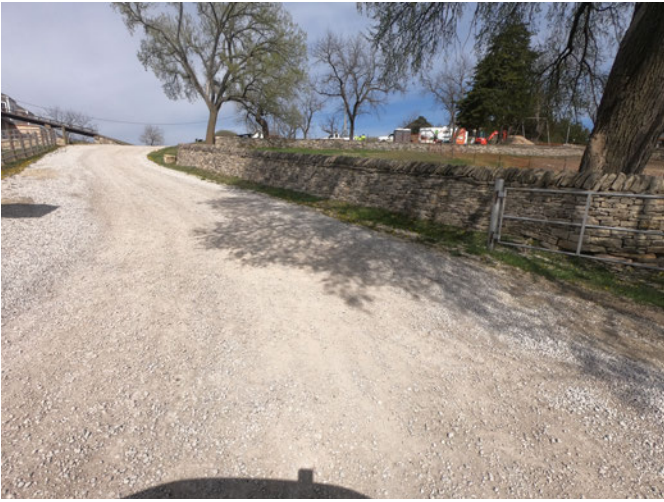
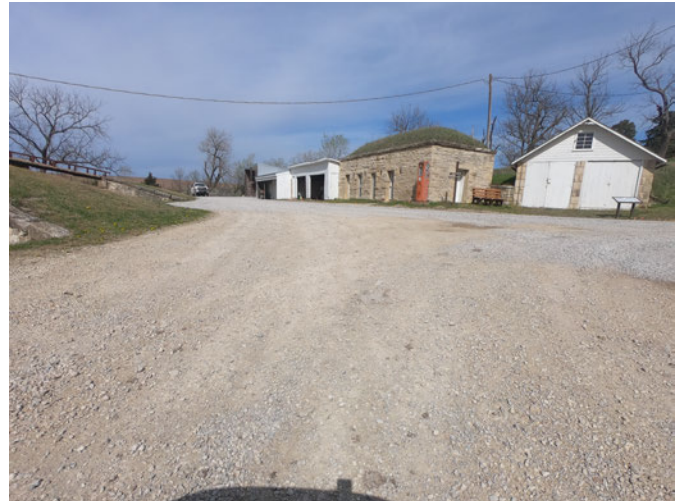
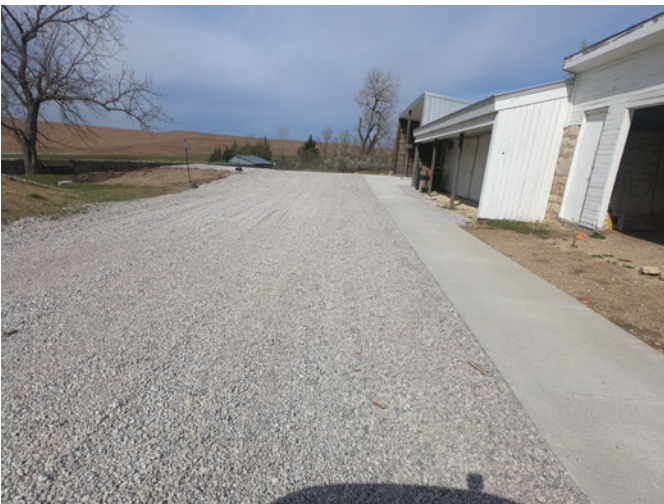
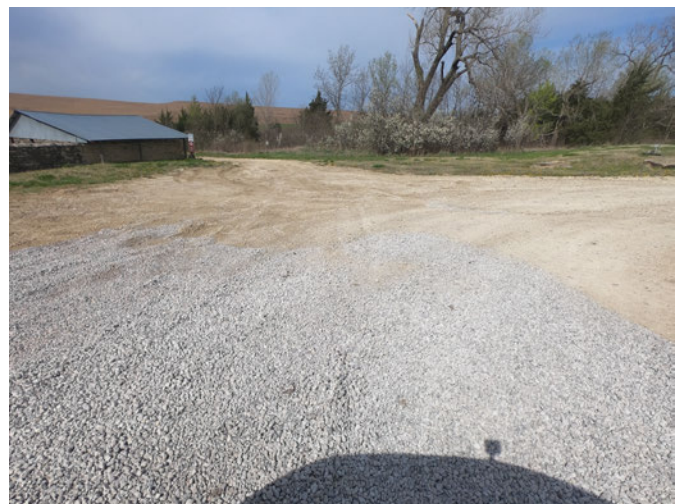
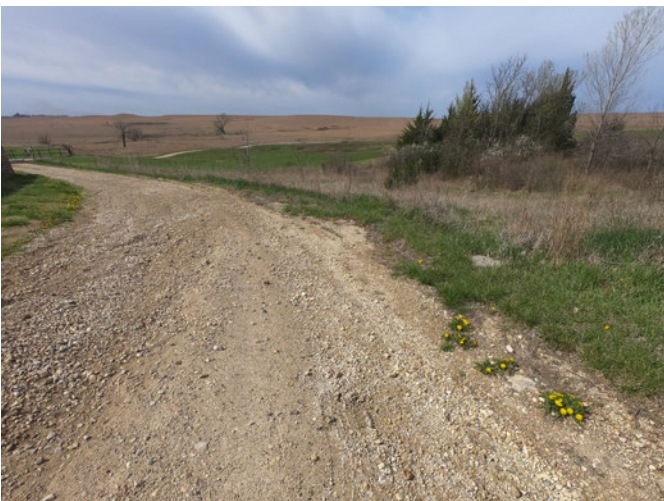
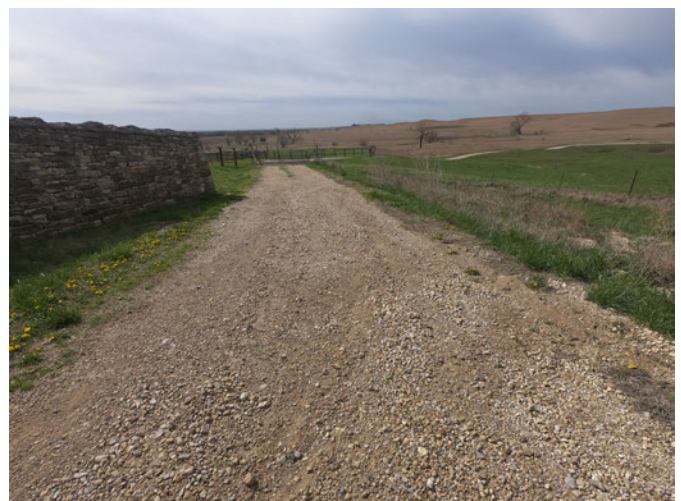
Begin MP	End MP	Section Length	# of Lanes	Lane Width	Road Width	Treatment Recommendation	Treatment Cost	Unpaved Rating (Paser +)	Crown Severity	Drainage Severity	Rutting, Washboard Severity	Potholes / Loose Aggregate Severity
0.00	0.13	0.13	2	12.0	21.6	Limited Local Maintenance	\$0	5	Low	Low	Low	Med
Route Level Data:		0.13	2	12.0	21.6	Limited Local Maintenance	\$0	5	Low	Low	Low	Med

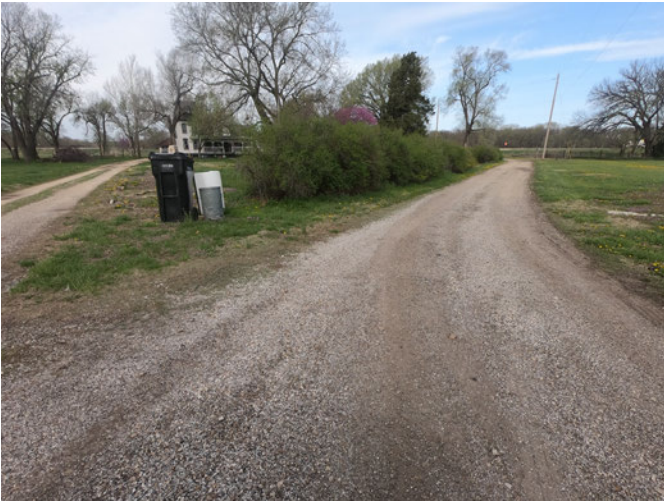
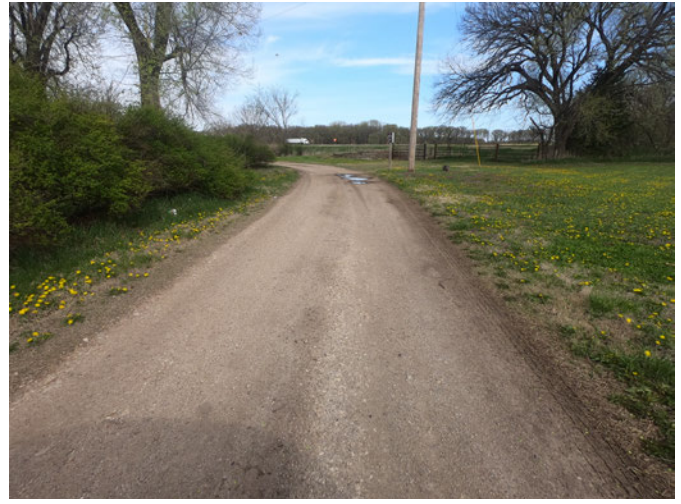
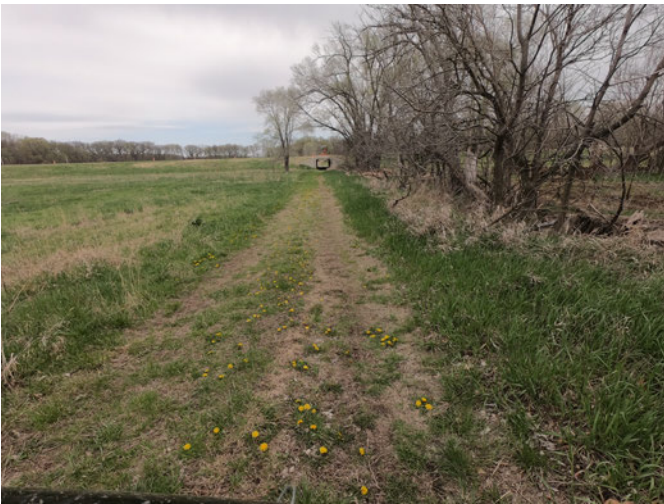
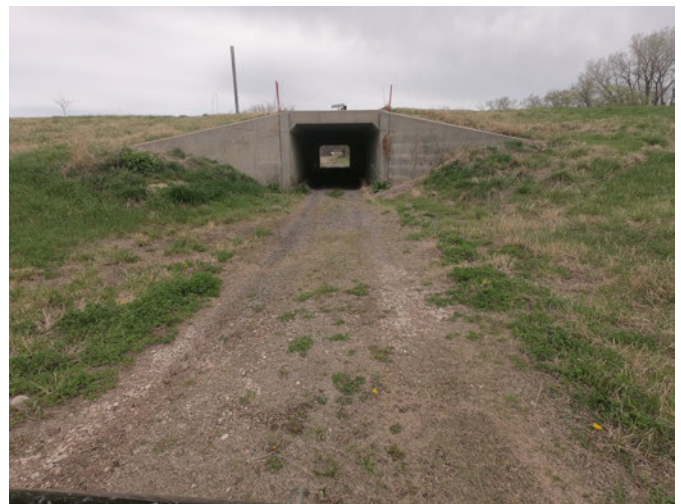
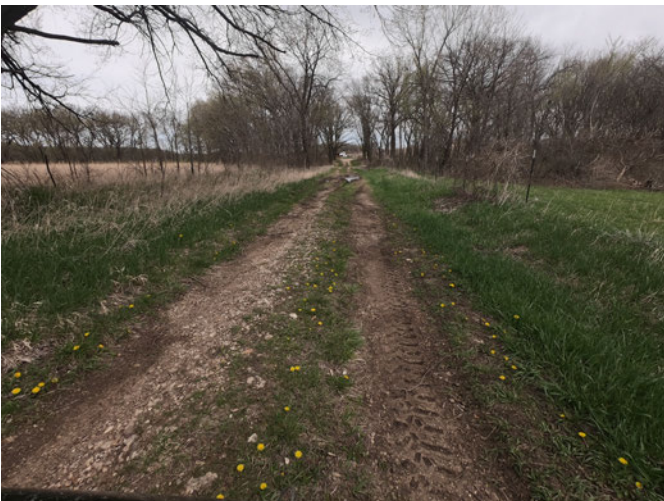
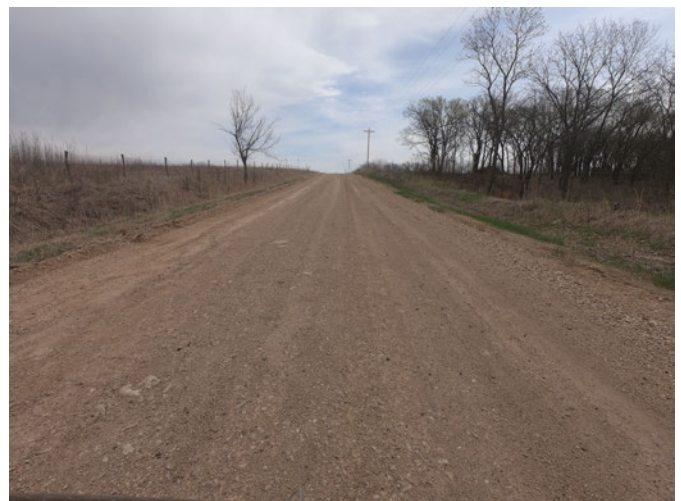
Begin MP	End MP	Section Length	# of Lanes	Lane Width	Road Width	Treatment Recommendation	Treatment Cost	Unpaved Rating (Paser +)	Crown Severity	Drainage Severity	Rutting, Washboard Severity	Potholes / Loose Aggregate Severity
0.00	0.29	0.29	1	10.0	10.0	Heavy Rehabilitation	\$47,040	2	Med	Med	Med	High
Route Level Data:		0.29	1	10.0	10.0	Heavy Rehabilitation	\$47,040	2	Med	Med	Med	High

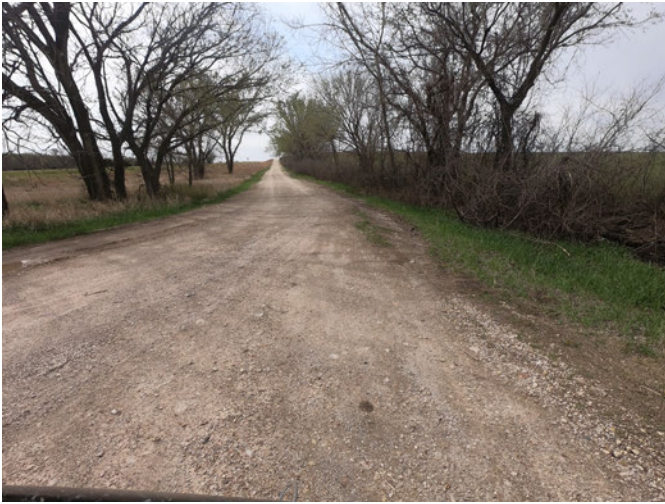
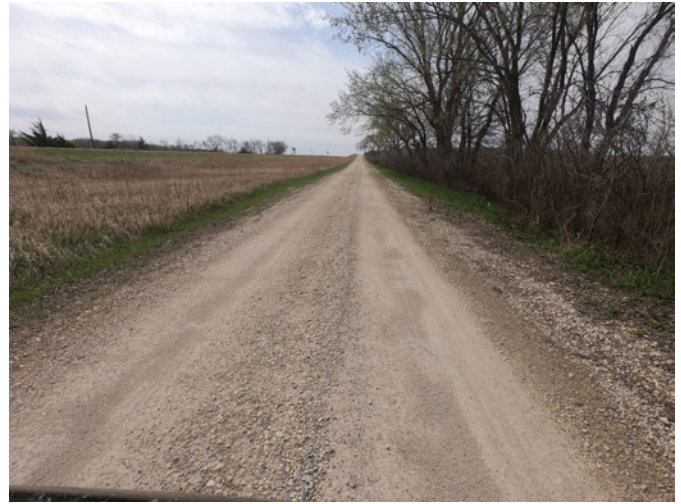
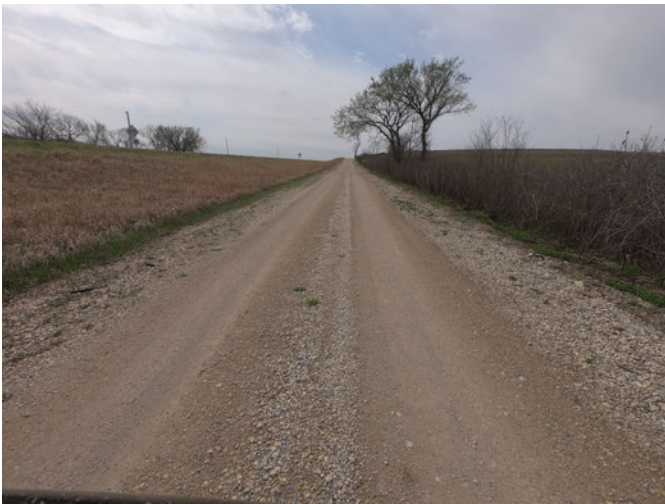
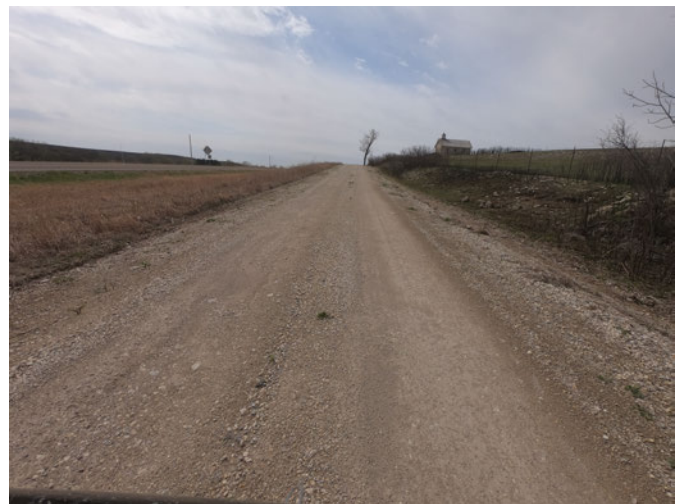
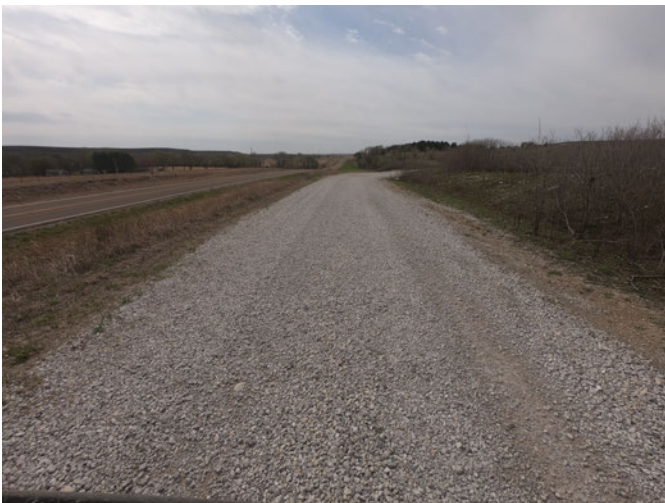
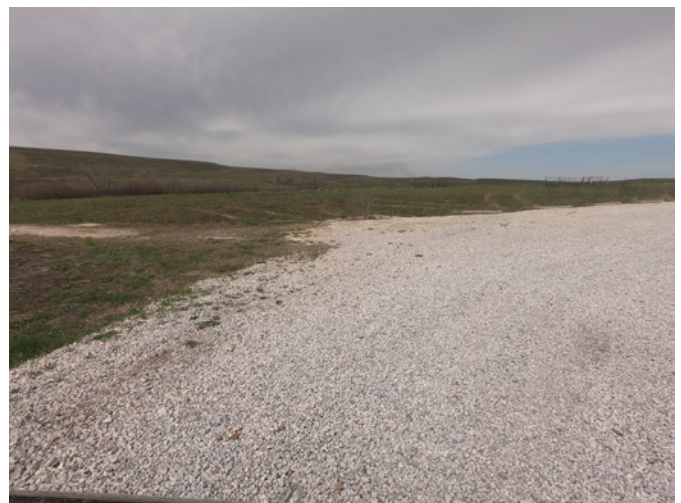
Begin MP	End MP	Section Length	# of Lanes	Lane Width	Road Width	Treatment Recommendation	Treatment Cost	Unpaved Rating (Paser +)	Crown Severity	Drainage Severity	Rutting, Washboard Severity	Potholes / Loose Aggregate Severity
0.00	0.30	0.30	2	8.0	16.0	Limited Local Maintenance	\$0	5	Low	Low	Low	Med
Route Level Data:		0.30	2	8.0	16.0	Limited Local Maintenance	\$0	5	Low	Low	Low	Med

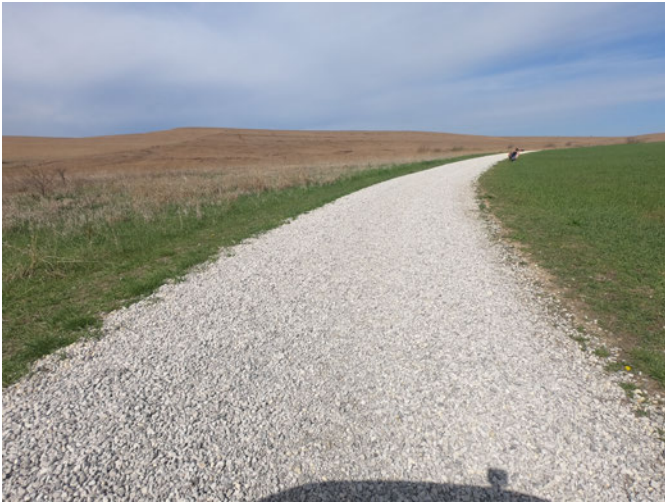
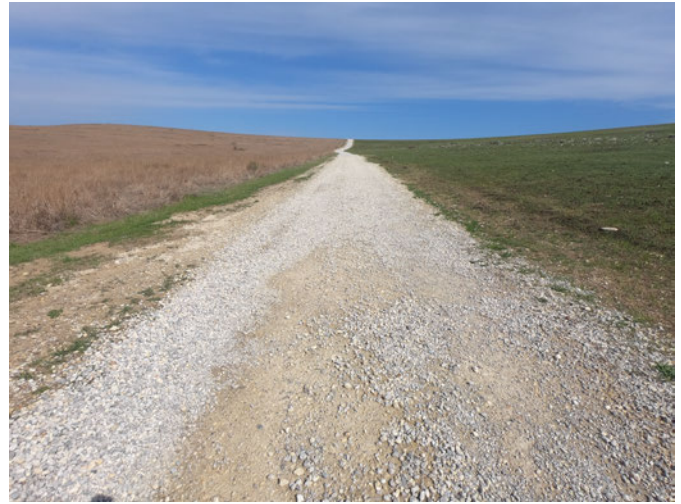
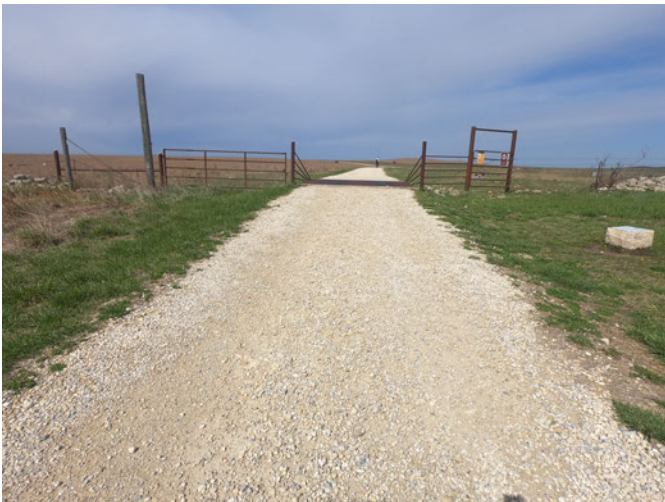
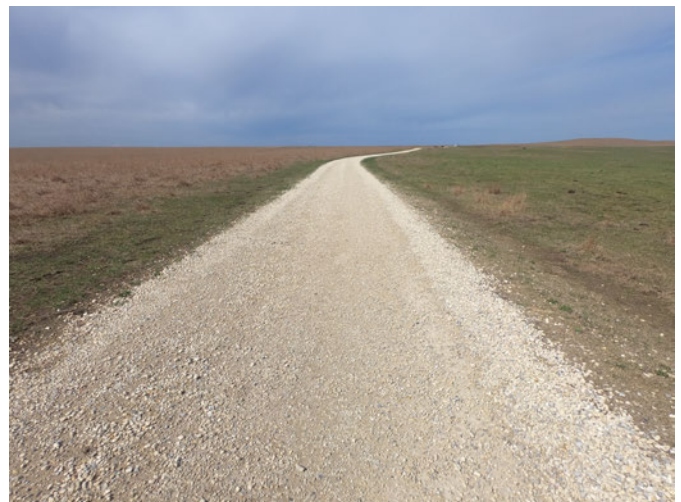
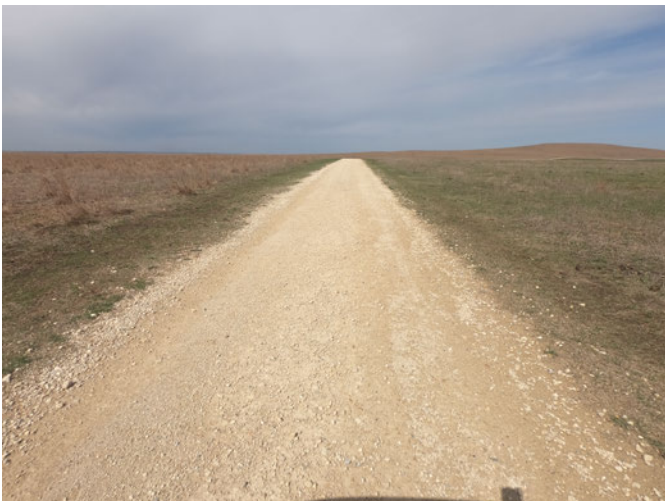
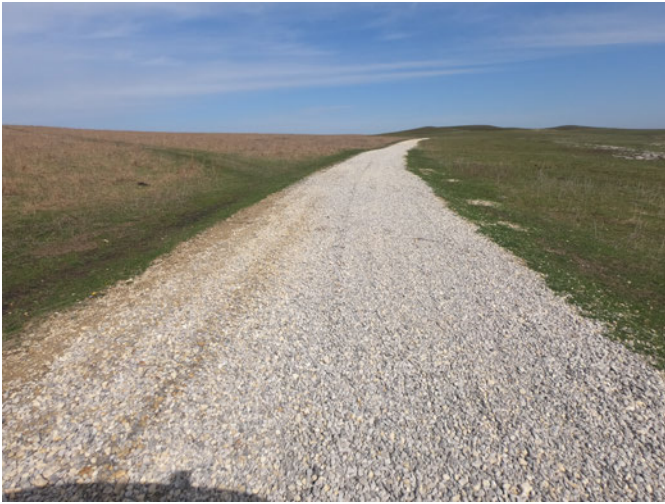
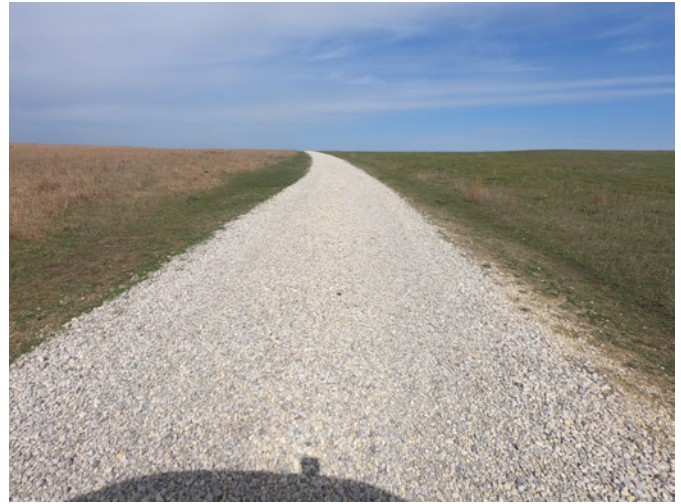
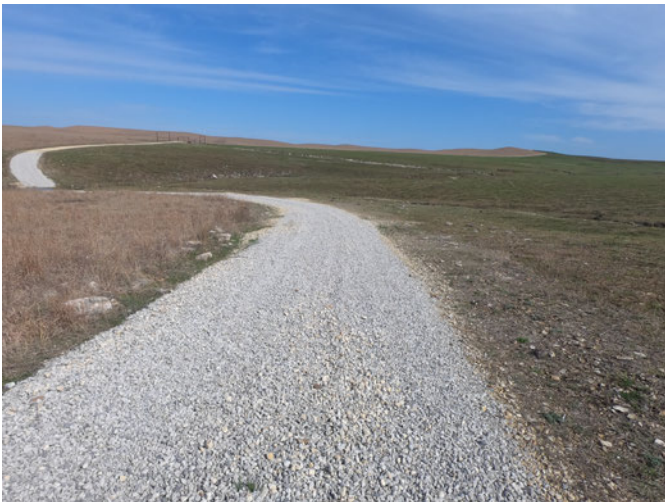
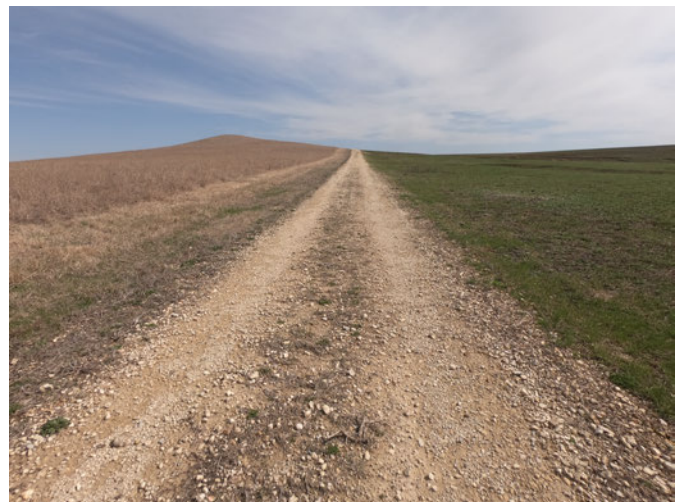
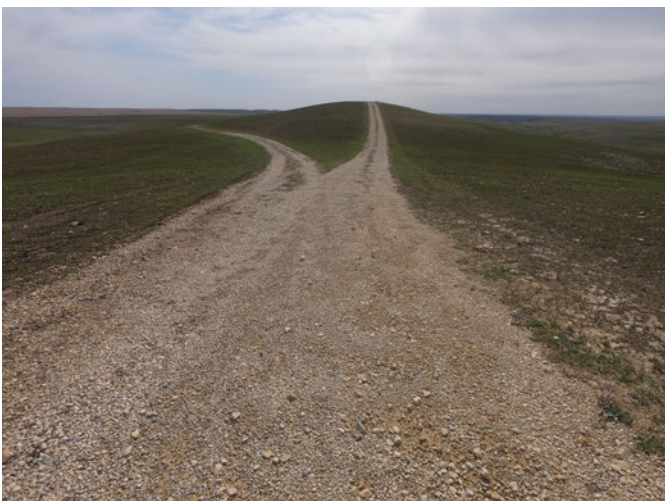
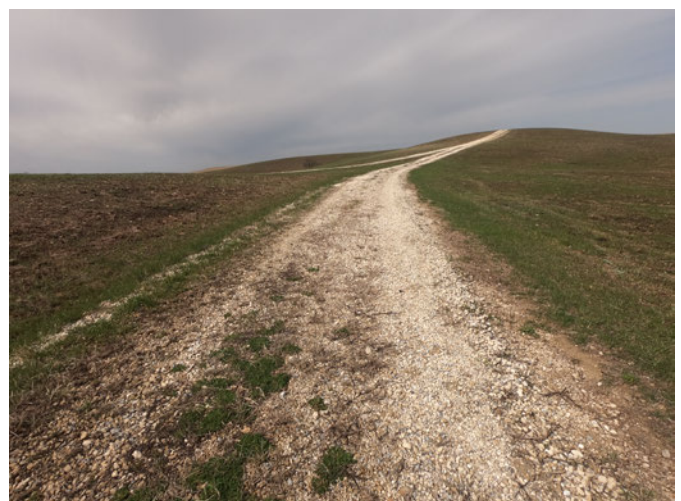
Begin MP	End MP	Section Length	# of Lanes	Lane Width	Road Width	Treatment Recommendation	Treatment Cost	Unpaved Rating (Paser +)	Crown Severity	Drainage Severity	Rutting, Washboard Severity	Potholes / Loose Aggregate Severity
0.00	1.00	1.00	1	11.0	11.0	Light Rehabilitation	\$100,000	3	Med	Med	Low	Med
1.00	2.00	1.00	1	10.8	10.8	Light Rehabilitation	\$100,000	3	Med	Med	Low	Med
2.00	3.00	1.00	1	12.0	12.0	Light Rehabilitation	\$100,000	3	Med	Med	Low	Med
3.00	3.41	0.41	1	12.0	12.0	Heavy Rehabilitation	\$66,080	2	Med	Med	Med	Med
Route Level Data:		3.41	1	11.4	11.4	Light Rehabilitation	\$366,080	3	Med	Med	Low	Med

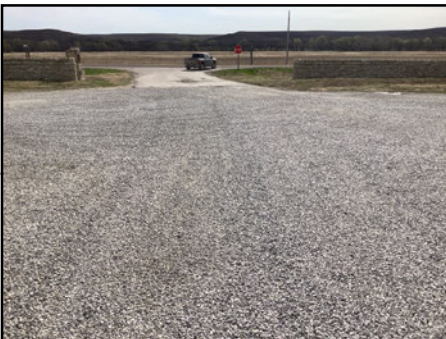
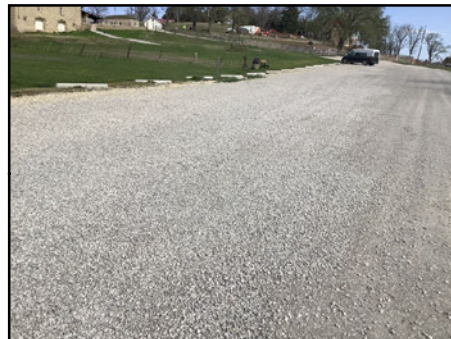
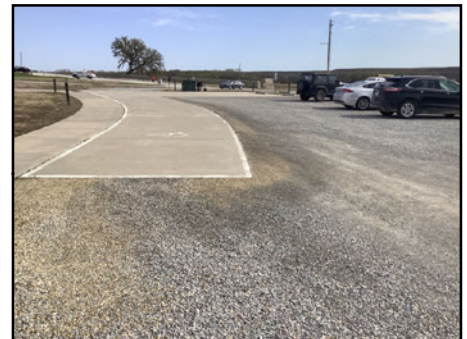
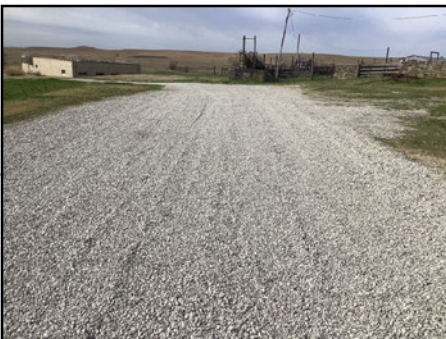
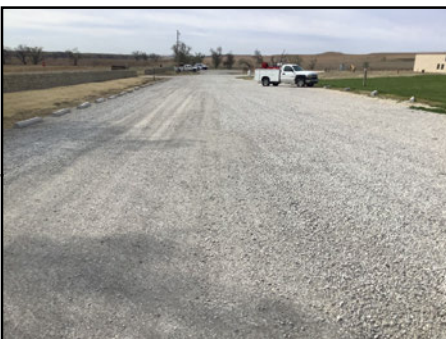
Rte. 0900

Inspection Date	FMSS Number	User Access	Surface Type
4/9/2021	76017	PUBLIC	GRAVEL
Area (Sq. Ft.)	Lane Miles (11' Widths)	Curb Reveal (Inches)	Curb Recommendation
68,068	1.172	NOT APPLICABLE	NOT APPLICABLE
Curb Type		Curb & Gutter Type	
NO CURB		NO CURB AND GUTTER	
Treatment Recommendation		Condition Rating	
Limited Local Maintenance		5

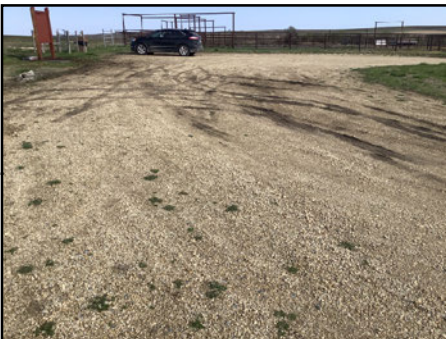
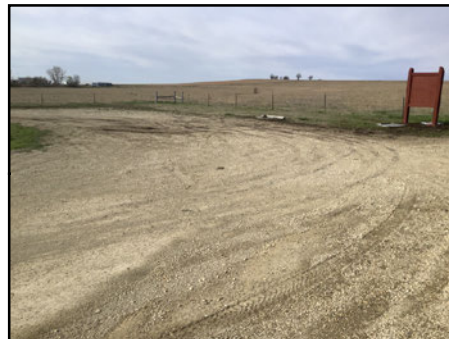
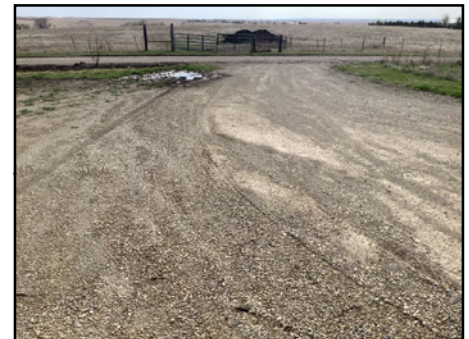
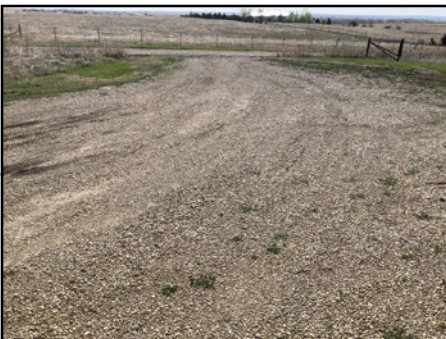
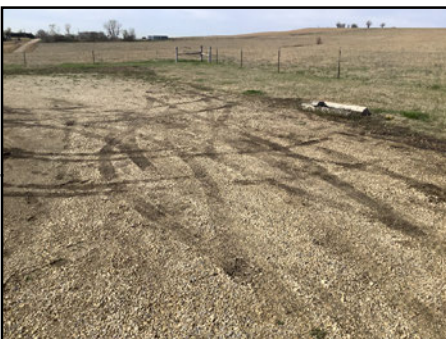
Inspection Date	FMSS Number	User Access	Surface Type
4/9/2021	225719	PUBLIC	GRAVEL
Area (Sq. Ft.)	Lane Miles (11' Widths)	Curb Reveal (Inches)	Curb Recommendation
10,098	0.174	NOT APPLICABLE	NOT APPLICABLE
Curb Type		Curb & Gutter Type	
NO CURB		NO CURB AND GUTTER	
Treatment Recommendation		Condition Rating	
Routine Maintenance		4

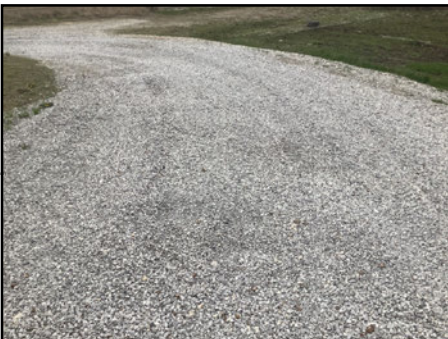
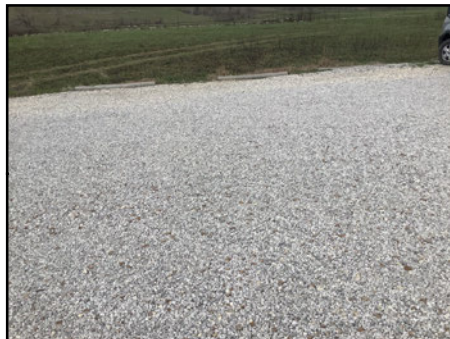
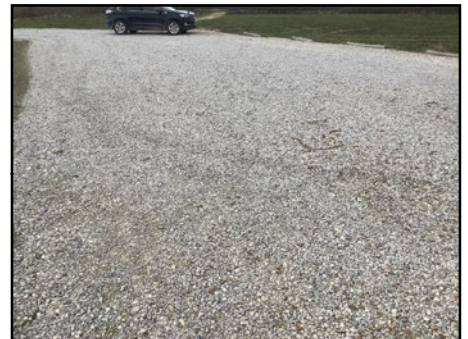
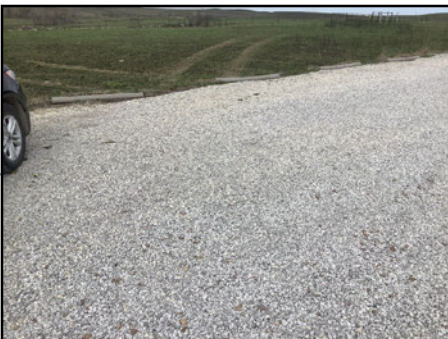
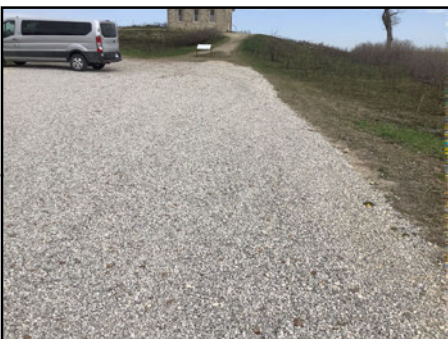
ROUTE 0902: LOWER FOX CREEK SCHOOLHOUSE PARKING

Inspection Date	FMSS Number	User Access	Surface Type
4/9/2021	99060	PUBLIC	GRAVEL
Area (Sq. Ft.)	Lane Miles (11' Widths)	Curb Reveal (Inches)	Curb Recommendation
3,372	0.058	NOT APPLICABLE	NOT APPLICABLE
Curb Type		Curb & Gutter Type	
NO CURB		NO CURB AND GUTTER	
Treatment Recommendation		Condition Rating	
Limited Local Maintenance		5

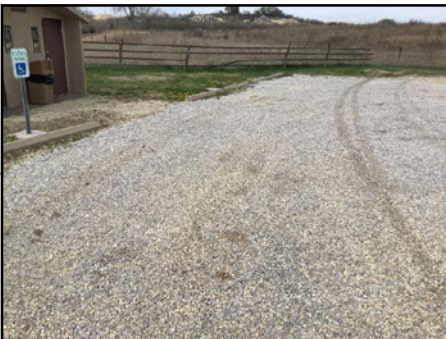
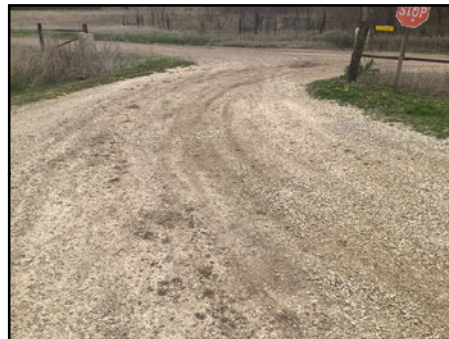
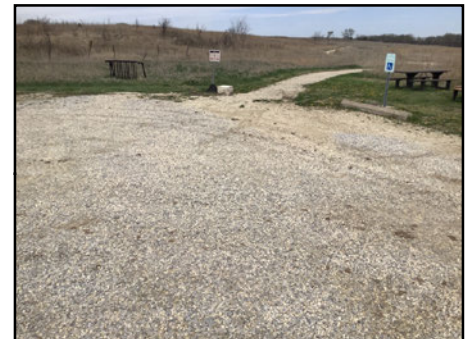
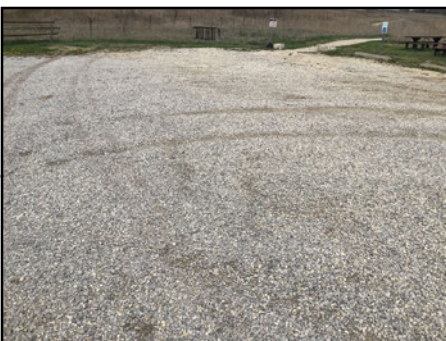
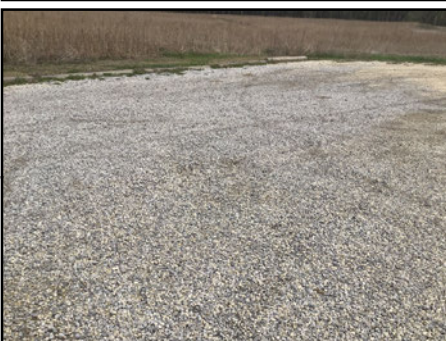
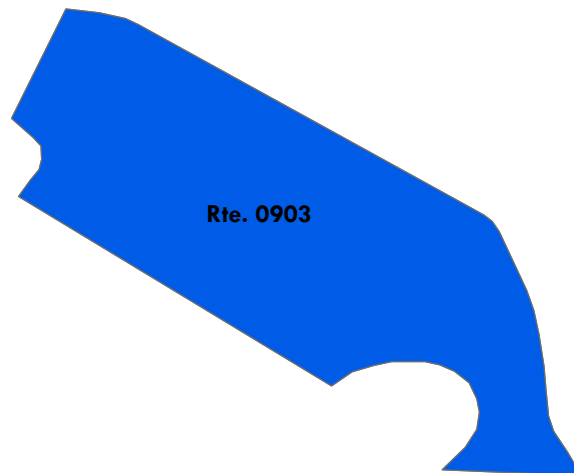
ROUTE 0903: BOTTOMLAND TRAIL PARKING

Inspection Date	FMSS Number	User Access	Surface Type
4/9/2021	253401	PUBLIC	GRAVEL
Area (Sq. Ft.)	Lane Miles (11' Widths)	Curb Reveal (Inches)	Curb Recommendation
7,559	0.13	NOT APPLICABLE	NOT APPLICABLE
Curb Type		Curb & Gutter Type	
NO CURB		NO CURB AND GUTTER	
Treatment Recommendation		Condition Rating	
Limited Local Maintenance		5
