TICA Cycle 6

Final Report

Road Inventory and Condition Assessment of Paved Routes Timpanogos Cave National Monument

Report Date: August 2017

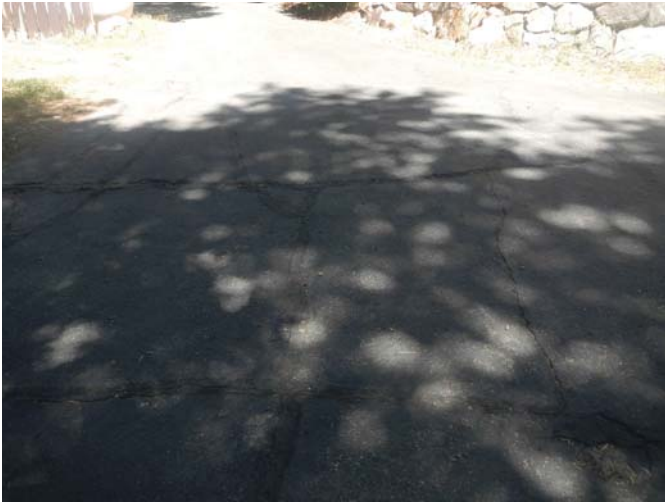
TICA_0401_8551.JPG

ROUTE 0401: WATER TANK ROAD

Route Condition Legend – Pavement Condition Rating (PCR)						
Poor (0 - 60)	Fair (61- 84)	Good (85 - 94)	Excellent (95 - 100)	Not Rated		
See Appendix for definitions and formulas						
Inspection Date: 6/24/2017	Beginning Section MP	0.00				
Paved Length (Miles): 0.05	Section Length (MI)	0.05				
Surface Type: ASPHALT	Route Summary					
Roadway Condition Information						
Pavement Condition Rating (PCR)	73	73				
Surface Condition Rating (SCR)	73	73				
Roughness Condition Index (RCI)	N/A	N/A				
Distress Index Values						
Structural Crack Index	N/A	N/A				
Alligator Crack Index	73	73				
Longitudinal Crack Index	90	90				
Transverse Cracking Index	73	73				
Patching Index	90	90				
Rutting Index	90	90				
International Roughness Index (IRI)	N/A	N/A				
Lane & Width Information						
Number of Lanes	1	1				
Paved Width (ft)	10	10				
Lane Width (ft)	10	10

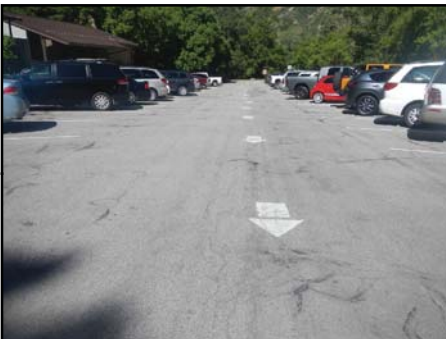
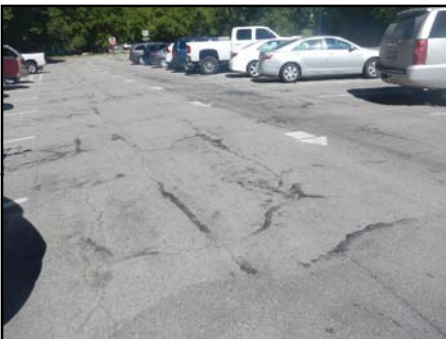
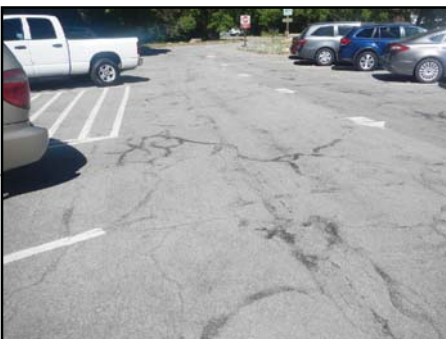
Inspection Date	FMSS Number	User Access	Surface Type
6/24/2017	82918	PUBLIC	ASPHALT
Area (Sq. Ft.)	Lane Miles (11' Widths)	Curb Reveal (Inches)	Curb Recommendation
18,984	0.327	5	LIGHT REPAIR
Curb Type		Curb & Gutter Type	
CONCRETE AND STONE		NO CURB AND GUTTER	
Pavement Recommendation		Condition Rating / PCR	
HEAVY 3R TREATMENTS		POOR / 53

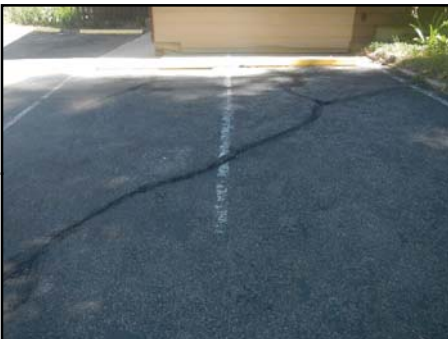
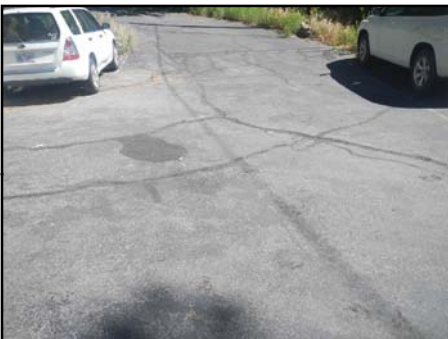
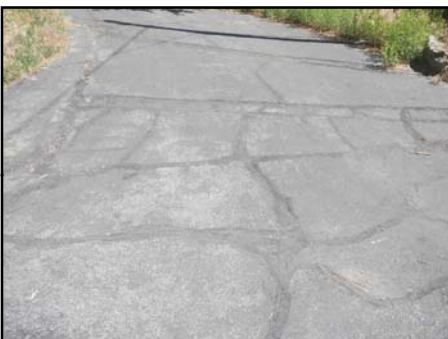
ROUTE 0901: RESIDENCE / HEADQUARTERS PARKING

Inspection Date	FMSS Number	User Access	Surface Type
6/24/2017	102597	NONPUBLIC	ASPHALT
Area (Sq. Ft.)	Lane Miles (11' Widths)	Curb Reveal (Inches)	Curb Recommendation
6,757	0.116	4	DO NOTHING
Curb Type		Curb & Gutter Type	
STONE		NO CURB AND GUTTER	
Pavement Recommendation		Condition Rating / PCR	
HEAVY 3R TREATMENTS		POOR / 53

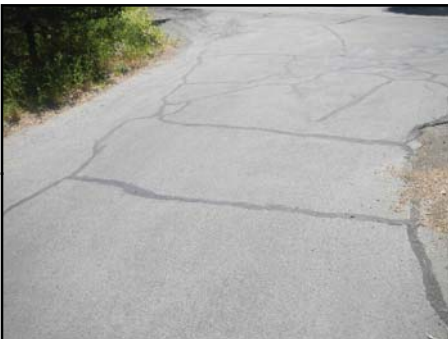
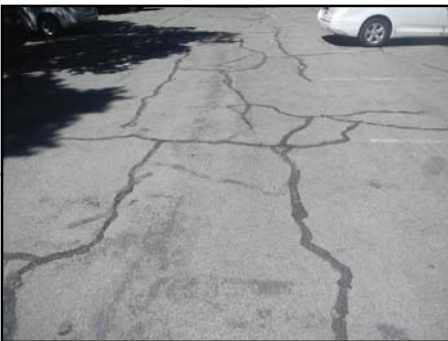
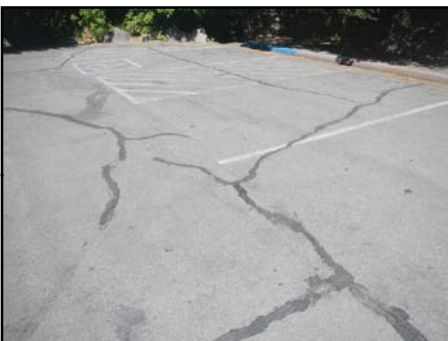
ROUTE 0902: SWINGING BRIDGE PICNIC PARKING

Inspection Date	FMSS Number	User Access	Surface Type
6/24/2017	82935	PUBLIC	ASPHALT
Area (Sq. Ft.)	Lane Miles (11' Widths)	Curb Reveal (Inches)	Curb Recommendation
7,414	0.128	NOT APPLICABLE	DO NOTHING
Curb Type		Curb & Gutter Type	
NO CURB		CONCRETE	
Pavement Recommendation		Condition Rating / PCR	
HEAVY 3R TREATMENTS		POOR / 53

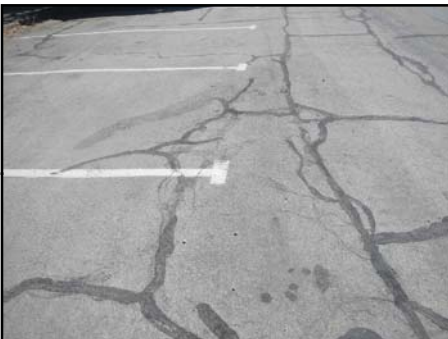
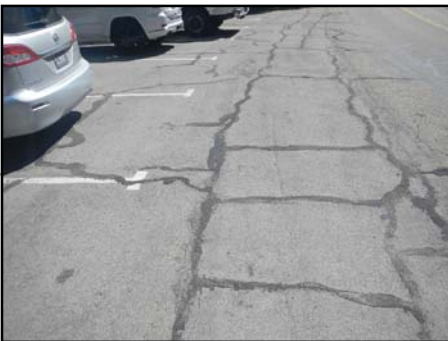
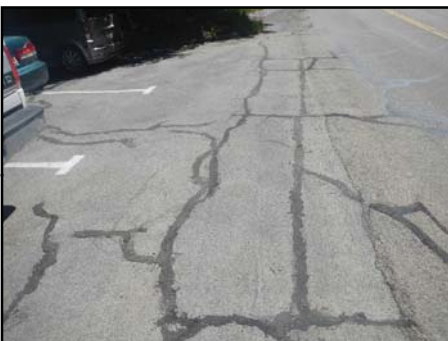
ROUTE 0903: CANYON NATURE TRAIL PARKING

Inspection Date	FMSS Number	User Access	Surface Type
6/24/2017	82932	PUBLIC	ASPHALT
Area (Sq. Ft.)	Lane Miles (11' Widths)	Curb Reveal (Inches)	Curb Recommendation
2,903	0.05	4	LIGHT REPAIR
Curb Type		Curb & Gutter Type	
STONE		NO CURB AND GUTTER	
Pavement Recommendation		Condition Rating / PCR	
HEAVY 3R TREATMENTS		POOR / 53

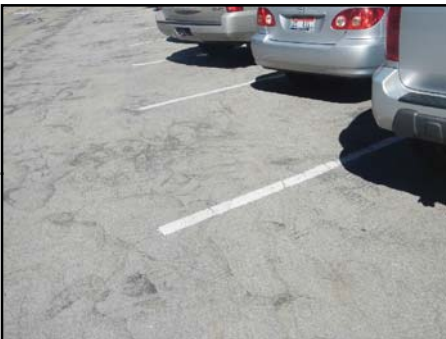
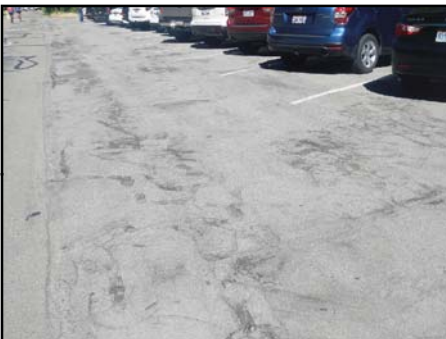
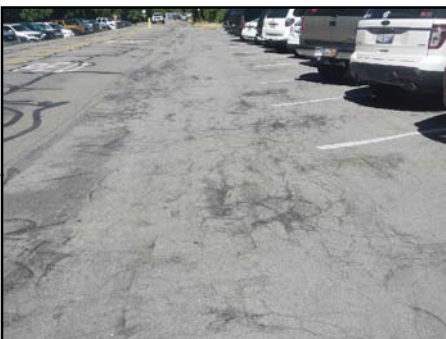
ROUTE 0904: CANYON VIEW PARKING

Inspection Date	FMSS Number	User Access	Surface Type
6/24/2017	102661	PUBLIC	ASPHALT
Area (Sq. Ft.)	Lane Miles (11' Widths)	Curb Reveal (Inches)	Curb Recommendation
9,663	0.166	4	DO NOTHING
Curb Type		Curb & Gutter Type	
STONE		NO CURB AND GUTTER	
Pavement Recommendation		Condition Rating / PCR	
RECONSTRUCTION		POOR / 30

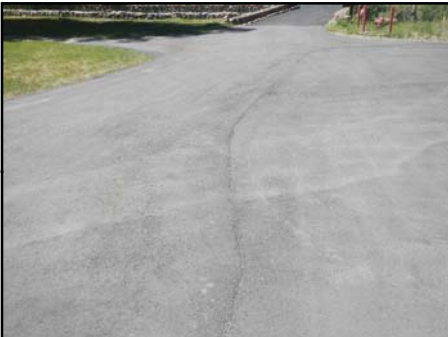
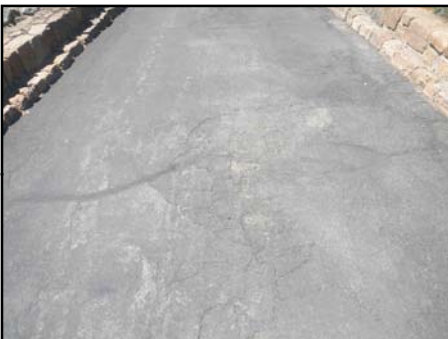
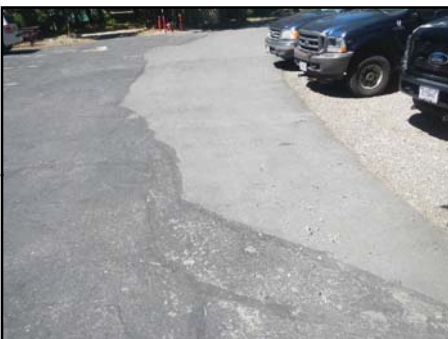
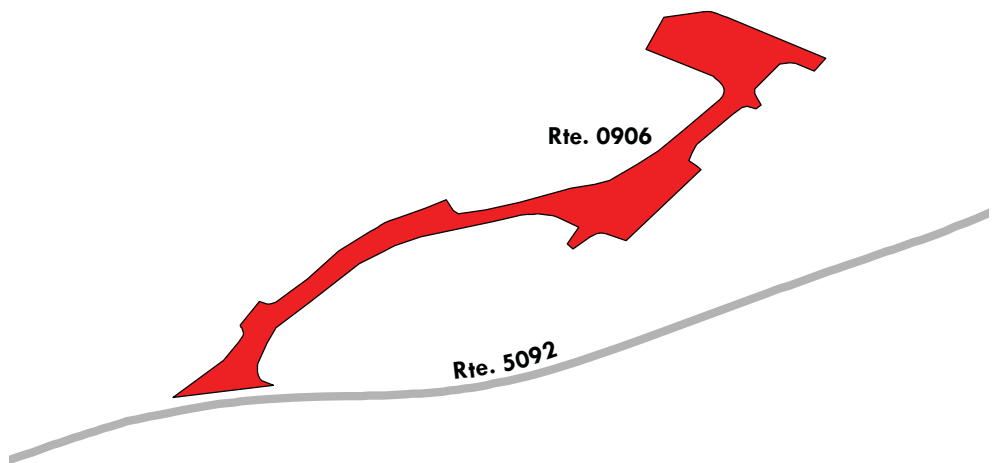
ROUTE 0906: MAINTENANCE PARKING

Inspection Date	FMSS Number	User Access	Surface Type
6/24/2017	82929	NONPUBLIC	ASPHALT
Area (Sq. Ft.)	Lane Miles (11' Widths)	Curb Reveal (Inches)	Curb Recommendation
14,568	0.251	3	DO NOTHING
Curb Type		Curb & Gutter Type	
STONE		NO CURB AND GUTTER	
Pavement Recommendation		Condition Rating / PCR	
HEAVY 3R TREATMENTS		POOR / 53
