TIMU Cycle 6

Final Report

Road Inventory and Condition Assessment of Paved Routes Timucuan Ecological and Historic Preserve

Report Date: March 2021

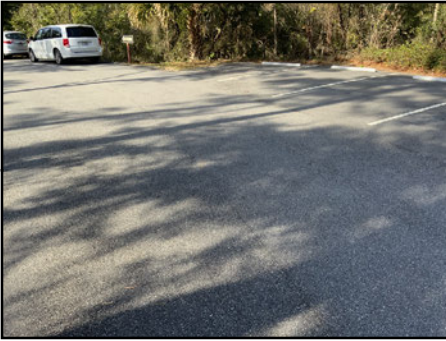
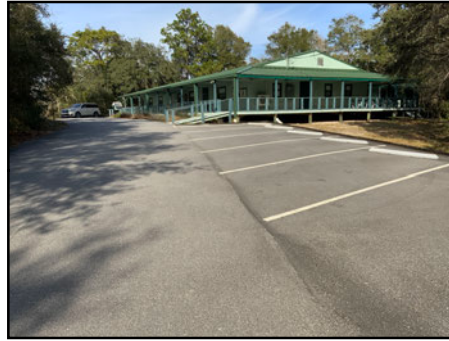
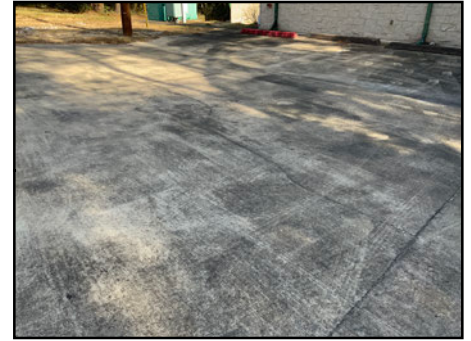
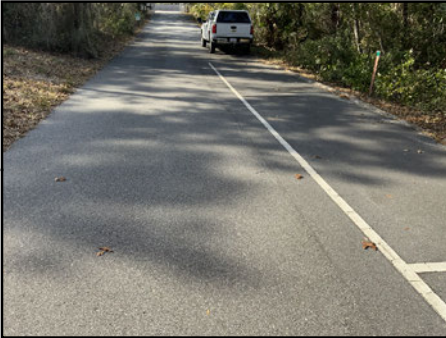
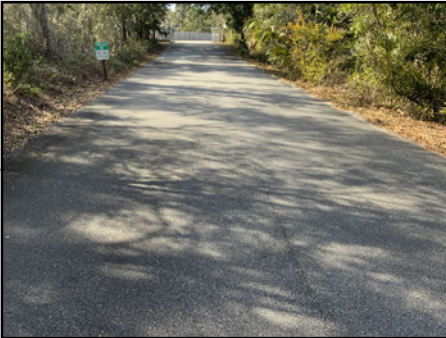
Inspection Date	FMSS Number	User Access	Surface Type
2/4/2021	11902	PUBLIC	ASPHALT
Area (Sq. Ft.)	Lane Miles (11' Widths)	Curb Reveal (Inches)	Curb Recommendation
22,261	0.383	2	LIGHT REPAIR
Curb Type		Curb & Gutter Type	
CONCRETE		NO CURB AND GUTTER	
Pavement Recommendation		Condition Rating / PCR	
PREVENTIVE MAINTENANCE		GOOD / 90

Multiple surface types:
Asphalt = 20,303 sq ft
Concrete = 1,958 sq ft

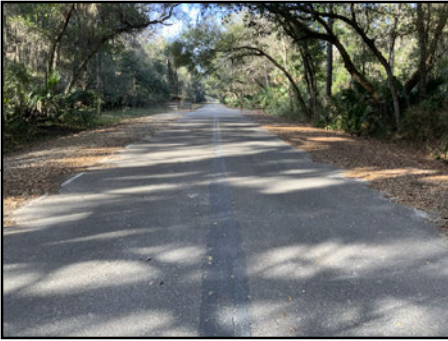
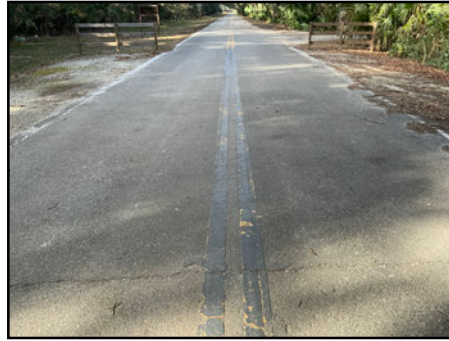
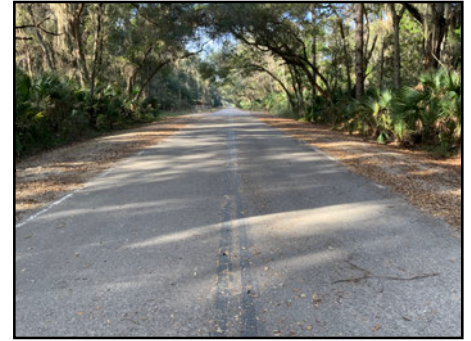
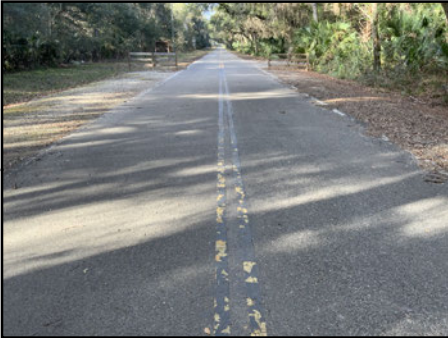
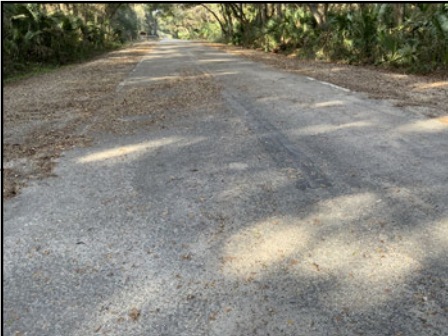
Inspection Date	FMSS Number	User Access	Surface Type
2/4/2021		PUBLIC	ASPHALT
Area (Sq. Ft.)	Lane Miles (11' Widths)	Curb Reveal (Inches)	Curb Recommendation
7,367	0.127	NOT APPLICABLE	NOT APPLICABLE
Curb Type		Curb & Gutter Type	
NO CURB		NO CURB AND GUTTER	
Pavement Recommendation		Condition Rating / PCR	
PREVENTIVE MAINTENANCE		GOOD / 90
