# TUAI Cycle 6

## Final Report

### Road Inventory and Condition Assessment of Paved Routes Tuskegee Airmen National Historic Site

**Report Date: May 2019**

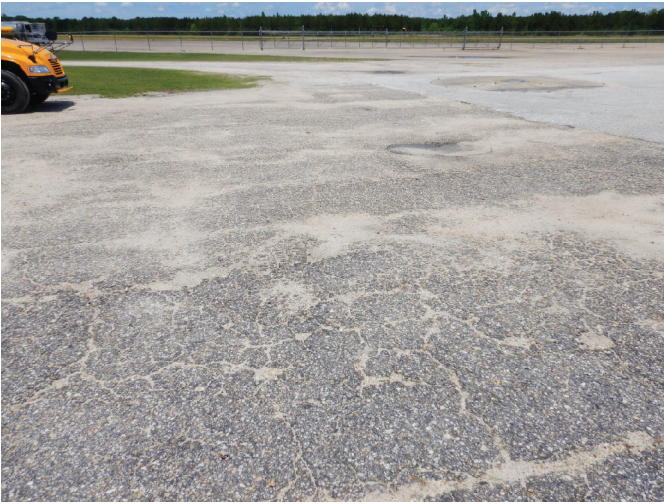
TUAI\_0901\_3108.JPG

Inspection Date	FMSS Number	User Access	Surface Type
5/10/2019	96970	PUBLIC	ASPHALT
Area (Sq. Ft.)	Lane Miles (11' Widths)	Curb Reveal (Inches)	Curb Recommendation
10,863	0.187	5	MODERATE REPAIR
Curb Type		Curb & Gutter Type	
CONCRETE		NO CURB AND GUTTER	
Pavement Recommendation		Condition Rating / PCR	
HEAVY 3R TREATMENTS		POOR / 53

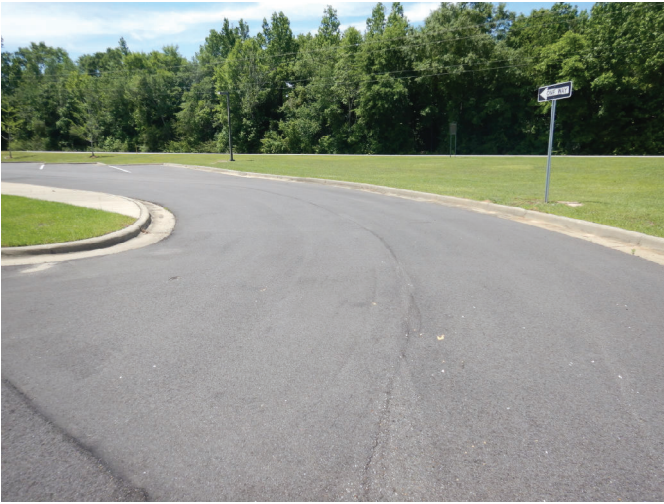
TUAI\_0902\_3066.JPG

Inspection Date	FMSS Number	User Access	Surface Type
5/10/2019	96963	PUBLIC	ASPHALT
Area (Sq. Ft.)	Lane Miles (11' Widths)	Curb Reveal (Inches)	Curb Recommendation
133,758	2.303	4	DO NOTHING
Curb Type		Curb & Gutter Type	
CONCRETE		CONCRETE	
Pavement Recommendation		Condition Rating / PCR	
PREVENTIVE MAINTENANCE		GOOD / 90

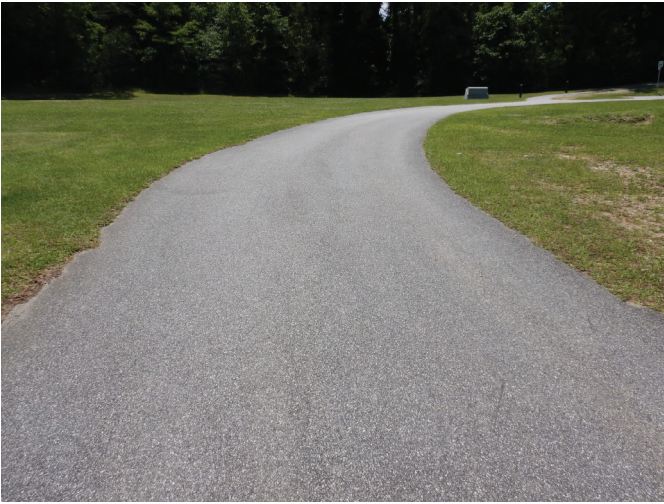
TUAI\_0904\_3085.JPG

Inspection Date	FMSS Number	User Access	Surface Type
5/10/2019	42320	NONPUBLIC	ASPHALT
Area (Sq. Ft.)	Lane Miles (11' Widths)	Curb Reveal (Inches)	Curb Recommendation
3,539	0.061	NOT APPLICABLE	NOT APPLICABLE
Curb Type		Curb & Gutter Type	
NO CURB		NO CURB AND GUTTER	
Pavement Recommendation		Condition Rating / PCR	
PREVENTIVE MAINTENANCE		GOOD / 90
