ULSG Cycle 6

Final Report

Road Inventory and Condition Assessment of Paved Routes Ulysses S. Grant National Historic Site

Report Date: December 2017

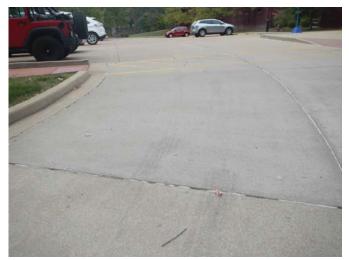
ULSG_0900_1766.JPG

Inspection Date	FMSS Number	User Access	Surface Type	
9/18/2017	19429	PUBLIC	CONCRETE	
Area (Sq. Ft.)	Lane Miles (11' Widths)	Curb Reveal (Inches)	Curb Recommendation	
24,679	0.425	NOT APPLICABLE	DO NOTHING	
Curb Type		Curb & Gutter Type		
NO CURB		CONCRETE		
Pavement Recommendation		Condition Rating / PCR		
PREVENTIVE MAINTENANCE		GOOD / 90		
\mathbf{p}_{-1} , \mathbf{c}_{-1} , \mathbf{r}_{-1} , r
