UPDE Cycle 6

Final Report

Road Inventory and Condition Assessment of Paved Routes Upper Delaware Scenic and Recreational River

**Federal Highway Administration
Eastern Federal Lands Highway Division
Road Inventory Program (RIP)**

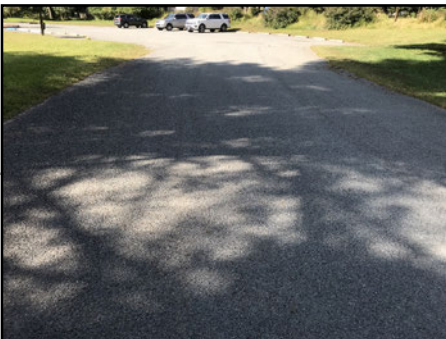
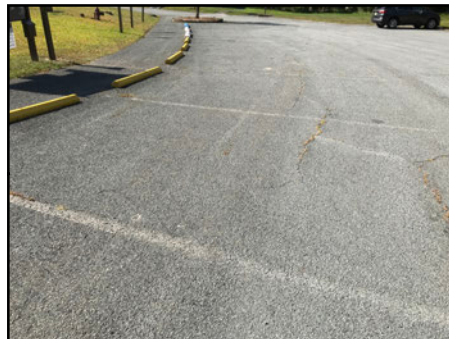
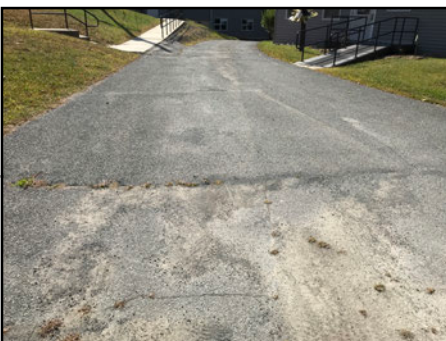
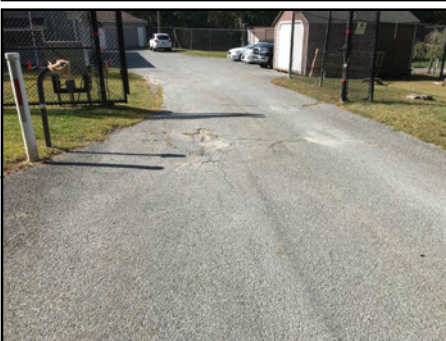
Inspection Date	FMSS Number	User Access	Surface Type
9/23/2020	68616	PUBLIC	ASPHALT
Area (Sq. Ft.)	Lane Miles (11' Widths)	Curb Reveal (Inches)	Curb Recommendation
23,433	0.403	NOT APPLICABLE	NOT APPLICABLE
Curb Type		Curb & Gutter Type	
NO CURB		NO CURB AND GUTTER	
Pavement Recommendation		Condition Rating / PCR	
HEAVY 3R TREATMENTS		POOR / 53

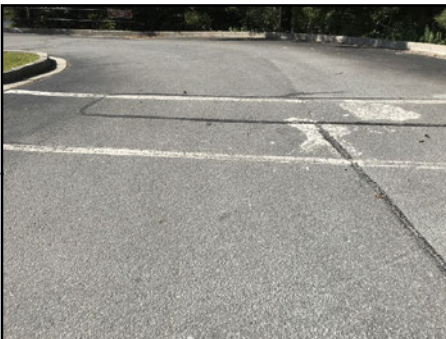
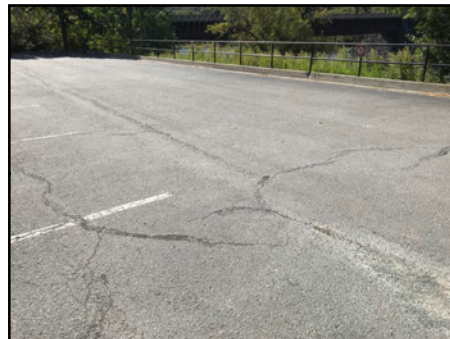
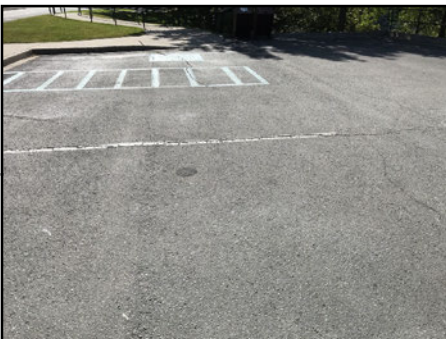
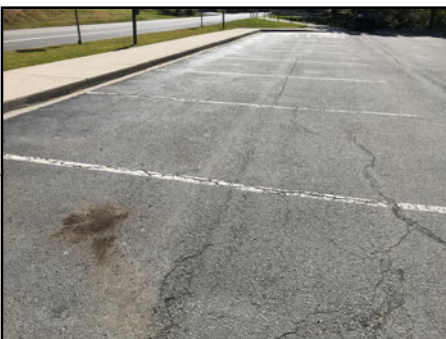
ROUTE 0903: MINISINK FORD PARKING

Inspection Date	FMSS Number	User Access	Surface Type
9/23/2020	68563	PUBLIC	ASPHALT
Area (Sq. Ft.)	Lane Miles (11' Widths)	Curb Reveal (Inches)	Curb Recommendation
6,027	0.104	NOT APPLICABLE	LIGHT REPAIR
Curb Type		Curb & Gutter Type	
NO CURB		CONCRETE	
Pavement Recommendation		Condition Rating / PCR	
LIGHT 3R TREATMENTS		FAIR / 73

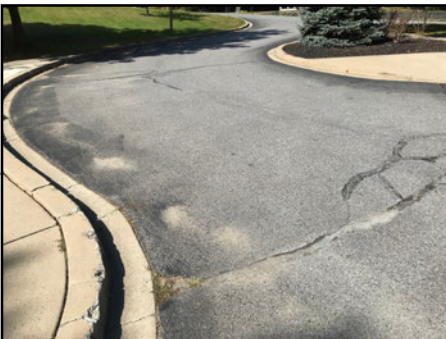
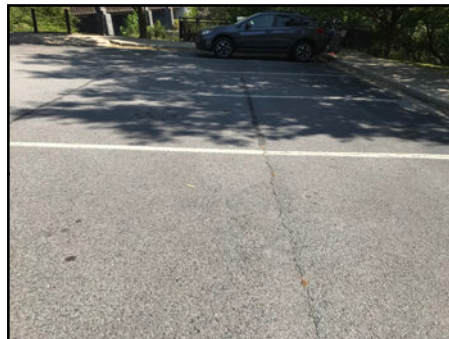
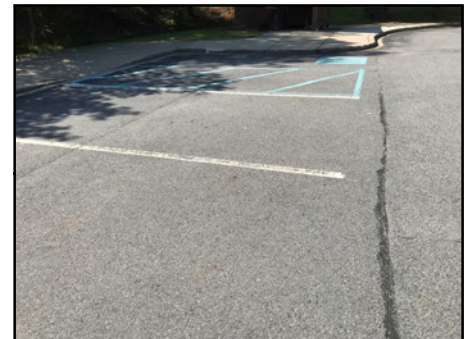
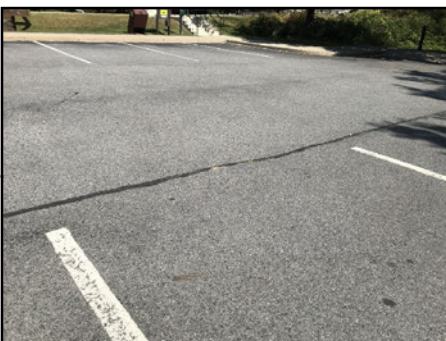
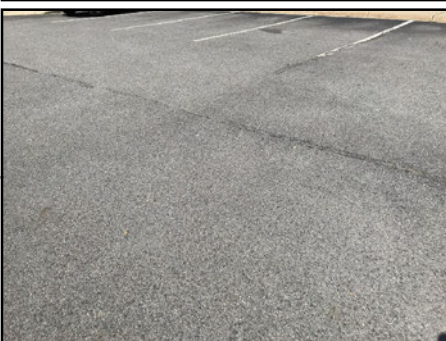
ROUTE 0904: LACKAWAXEN PARKING

Inspection Date	FMSS Number	User Access	Surface Type
9/23/2020	68038	PUBLIC	ASPHALT
Area (Sq. Ft.)	Lane Miles (11' Widths)	Curb Reveal (Inches)	Curb Recommendation
7,736	0.133	NOT APPLICABLE	REPLACE
Curb Type		Curb & Gutter Type	
NO CURB		CONCRETE	
Pavement Recommendation		Condition Rating / PCR	
PREVENTIVE MAINTENANCE		GOOD / 90

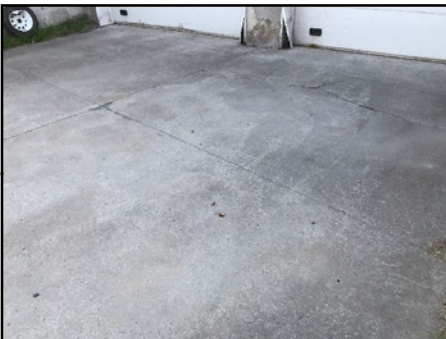
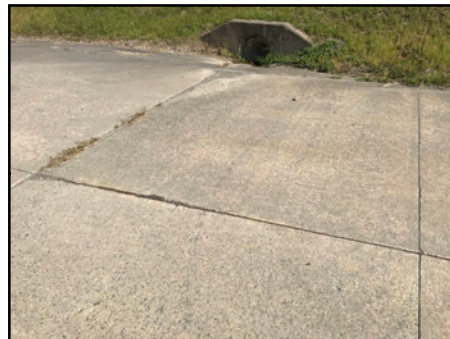
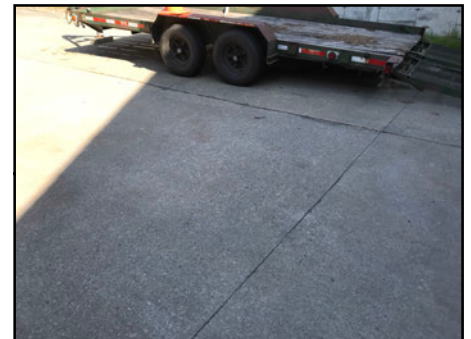
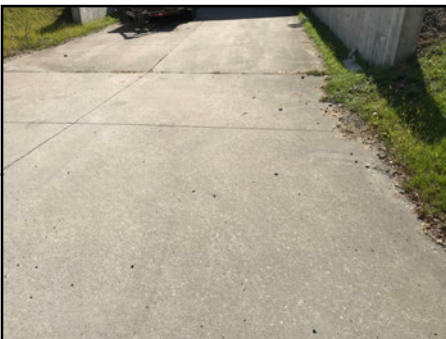
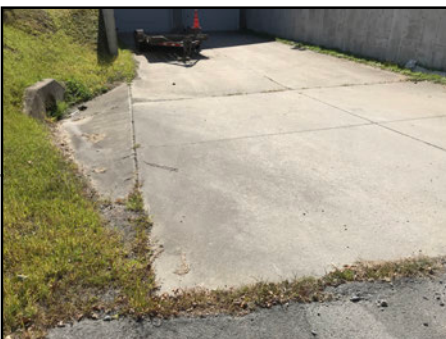
ROUTE 0905Z: MAINTENANCE OFFICE LOWER DRIVEWAY

Inspection Date	FMSS Number	User Access	Surface Type
9/23/2020	102623	NONPUBLIC	CONCRETE
Area (Sq. Ft.)	Lane Miles (11' Widths)	Curb Reveal (Inches)	Curb Recommendation
1,833	0.032	NOT APPLICABLE	NOT APPLICABLE
Curb Type		Curb & Gutter Type	
NO CURB		NO CURB AND GUTTER	
Pavement Recommendation		Condition Rating / PCR	
LIGHT 3R TREATMENTS		FAIR / 73

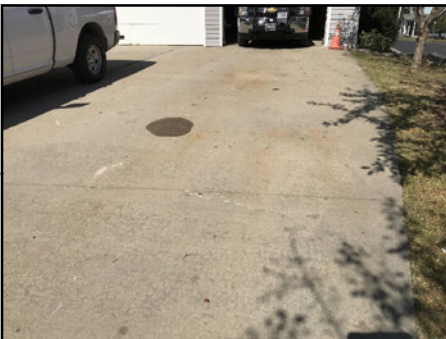
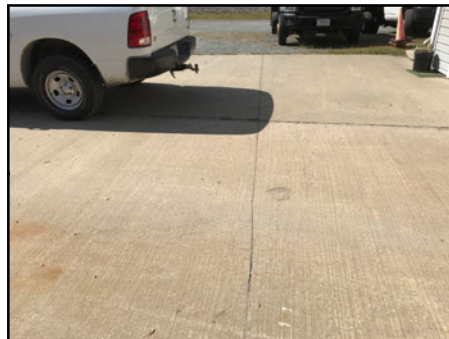
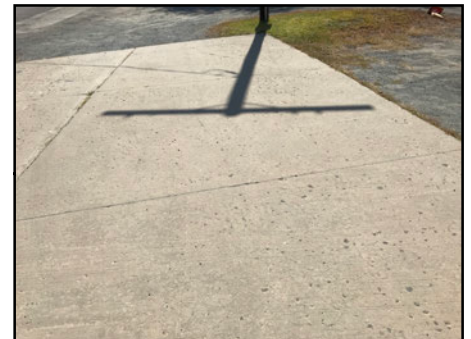
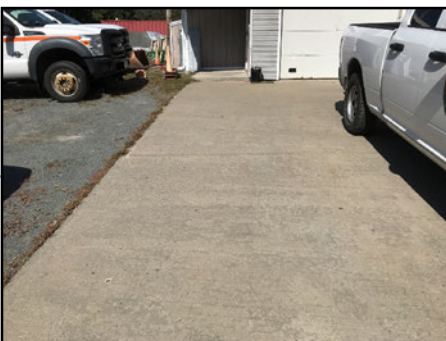
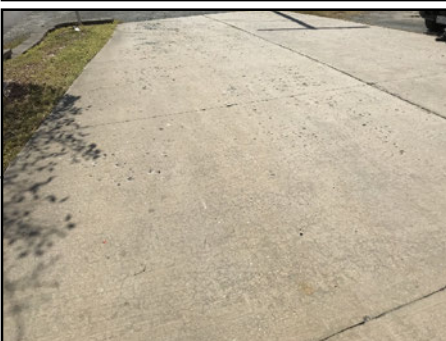
ROUTE 0906Z: MAINTENANCE OFFICE UPPER DRIVEWAY

Inspection Date	FMSS Number	User Access	Surface Type
9/23/2020	102623	NONPUBLIC	CONCRETE
Area (Sq. Ft.)	Lane Miles (11' Widths)	Curb Reveal (Inches)	Curb Recommendation
1,910	0.033	NOT APPLICABLE	NOT APPLICABLE
Curb Type		Curb & Gutter Type	
NO CURB		NO CURB AND GUTTER	
Pavement Recommendation		Condition Rating / PCR	
LIGHT 3R TREATMENTS		FAIR / 73
